Report/Article Title Memorandum: Herbicide Damage to Vegetable Plots
Vicinity Da Nang Air Base, from John Moran to 7th Air
Force, TACC, ATT: Ltc. Robert McCollester, October
31, 1968

SUBJECT: Herbicide Damage to Vegetable Plots Vicinity Da Nang Air Base

Trip Report - Danang - October 25-26, 1968

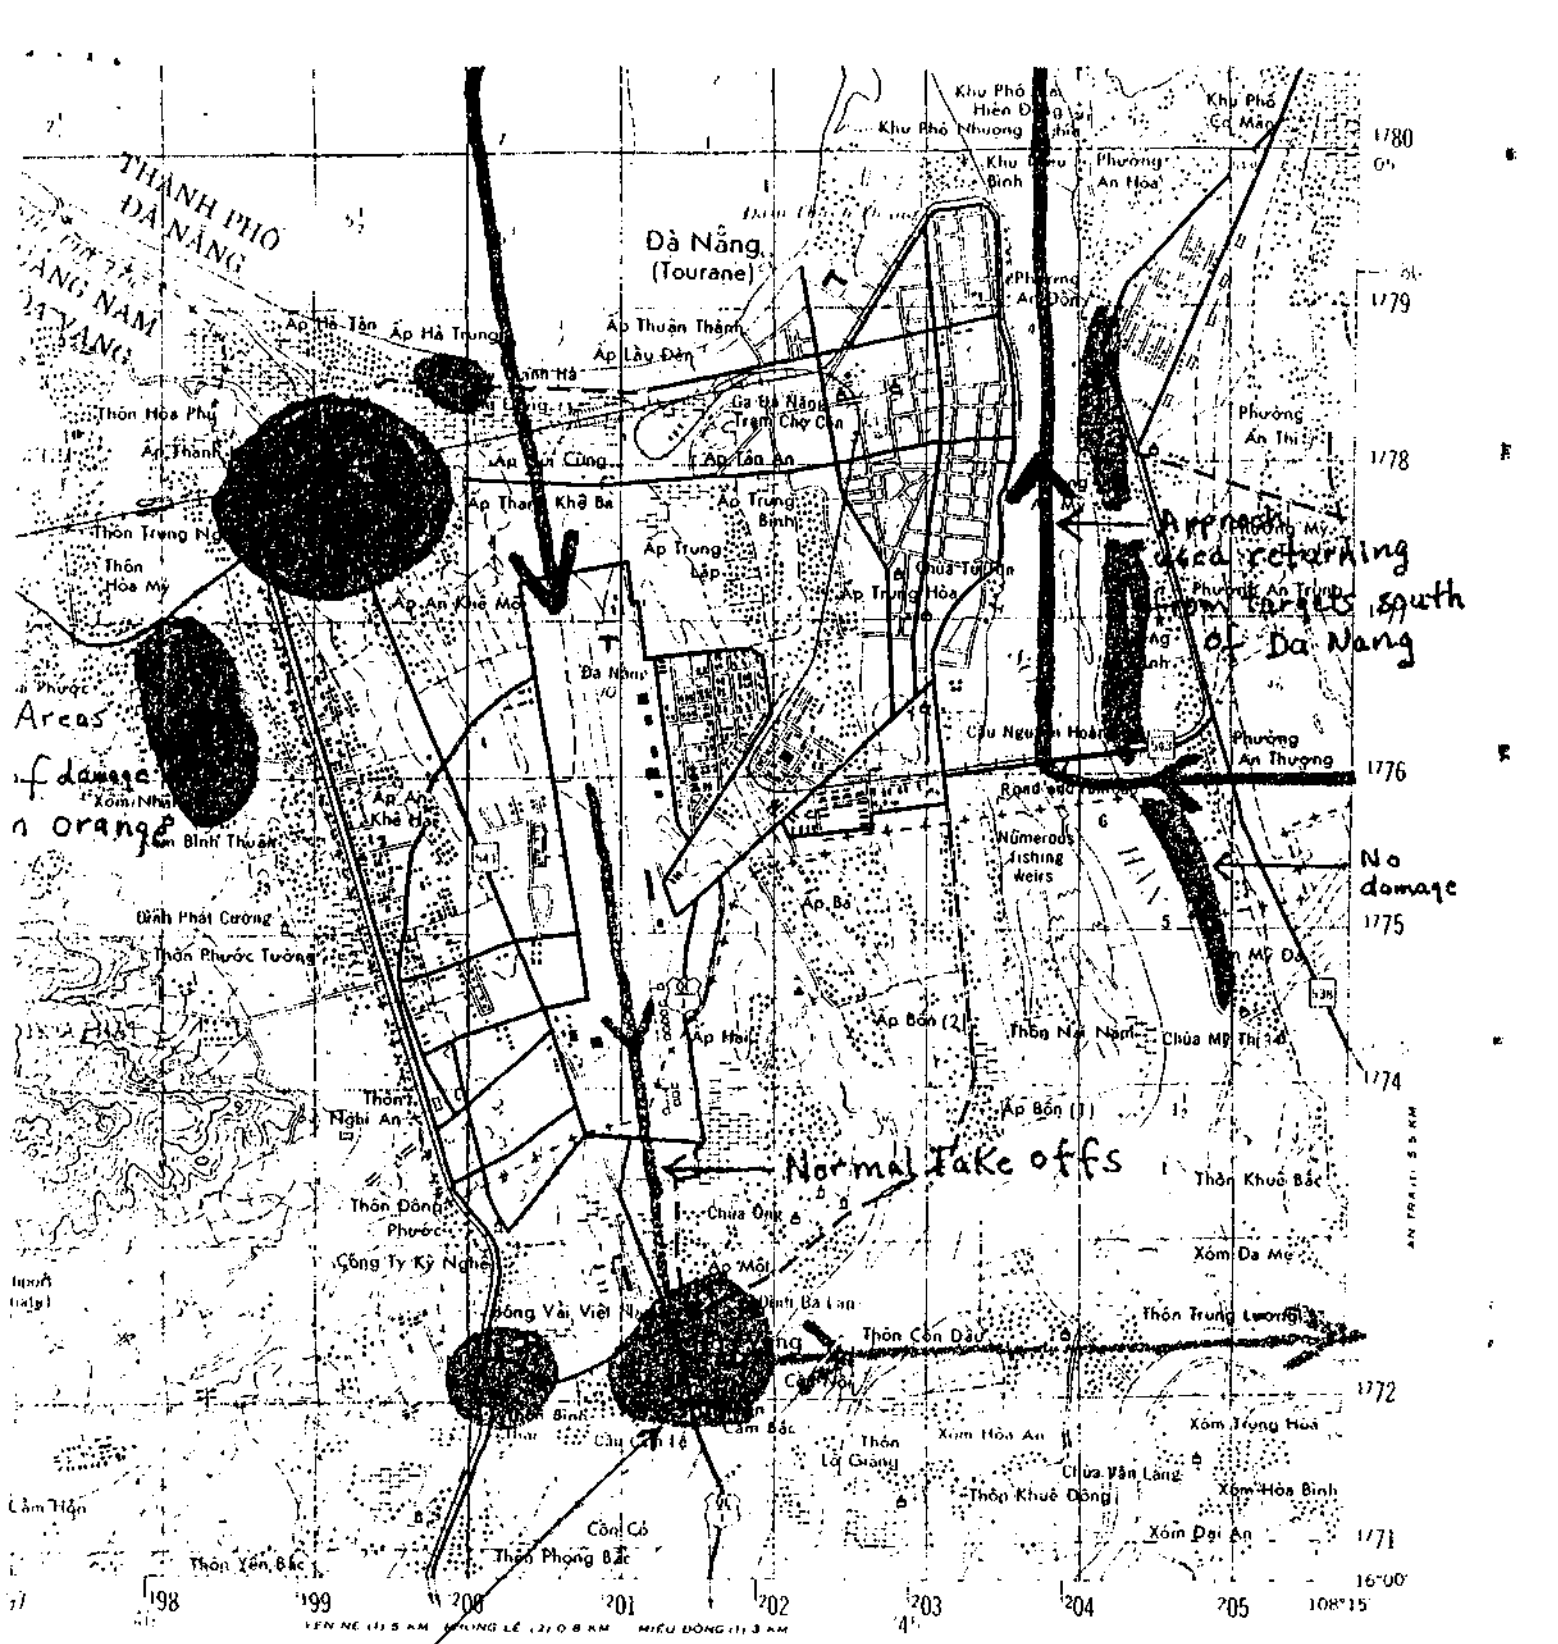
vegetable plot. (Note: This was the area of heaviest damage and is located directly south of the airbase) According to Mr. Stickney, the area had previously contained a variety of healthy young vegetable plants (tomatoes, chinese cabbage, ect.). On or about 28 September, the plants began to show signs of damage, and at the time of the inspection all the plants were dead. Some trees in the area, notably jak and palm, also showed signs of damage. There was no discernible pattern to damage such as a discrete swath, but rather the damage seemed to cover the entire area. CPT Watts noted that the damage in this particular area could have been due to aircraft leakage especially on those infrequent occasions when the aircraft make their final approach over Hoa Vang. It is highly unlikely that leakage would occur on take off or at any time prior to actual spraying in the target area. When leakage does occur it is due to faulty valve operation after the spray mission.

A. It is possible that some of the vegetable damage in the vicinity of Da Nang Air Base was caused by herbicide leakage from Ranch Hand aircraft, especially in the Hoa Vang demonstration plot.

Damage in the Hoa-Vang area is principally from occasional leaky valves on spray planes returning from missions.

Area of heaviest damage

A. That Ranch Hand continue to exercise close supervision over the maintenance of spray nozzle valves in order to prevent leakage.

B. That in the future, demonstration vegetable plots not be located in proximity to the Ranch Hand flight pattern.
