## **SECTION 1**

### **INTRODUCTION**

The U.S. Army Corps of Engineers, Far East District (FED), has contracted with Samsung Corporation under Contract Number DACA81-00-D-0049 to perform a Site Investigation (SI) at Camp Carroll Area D and Area 41, located in the Republic of Korea. The investigation was initiated as a response to potential contamination in the subject areas.

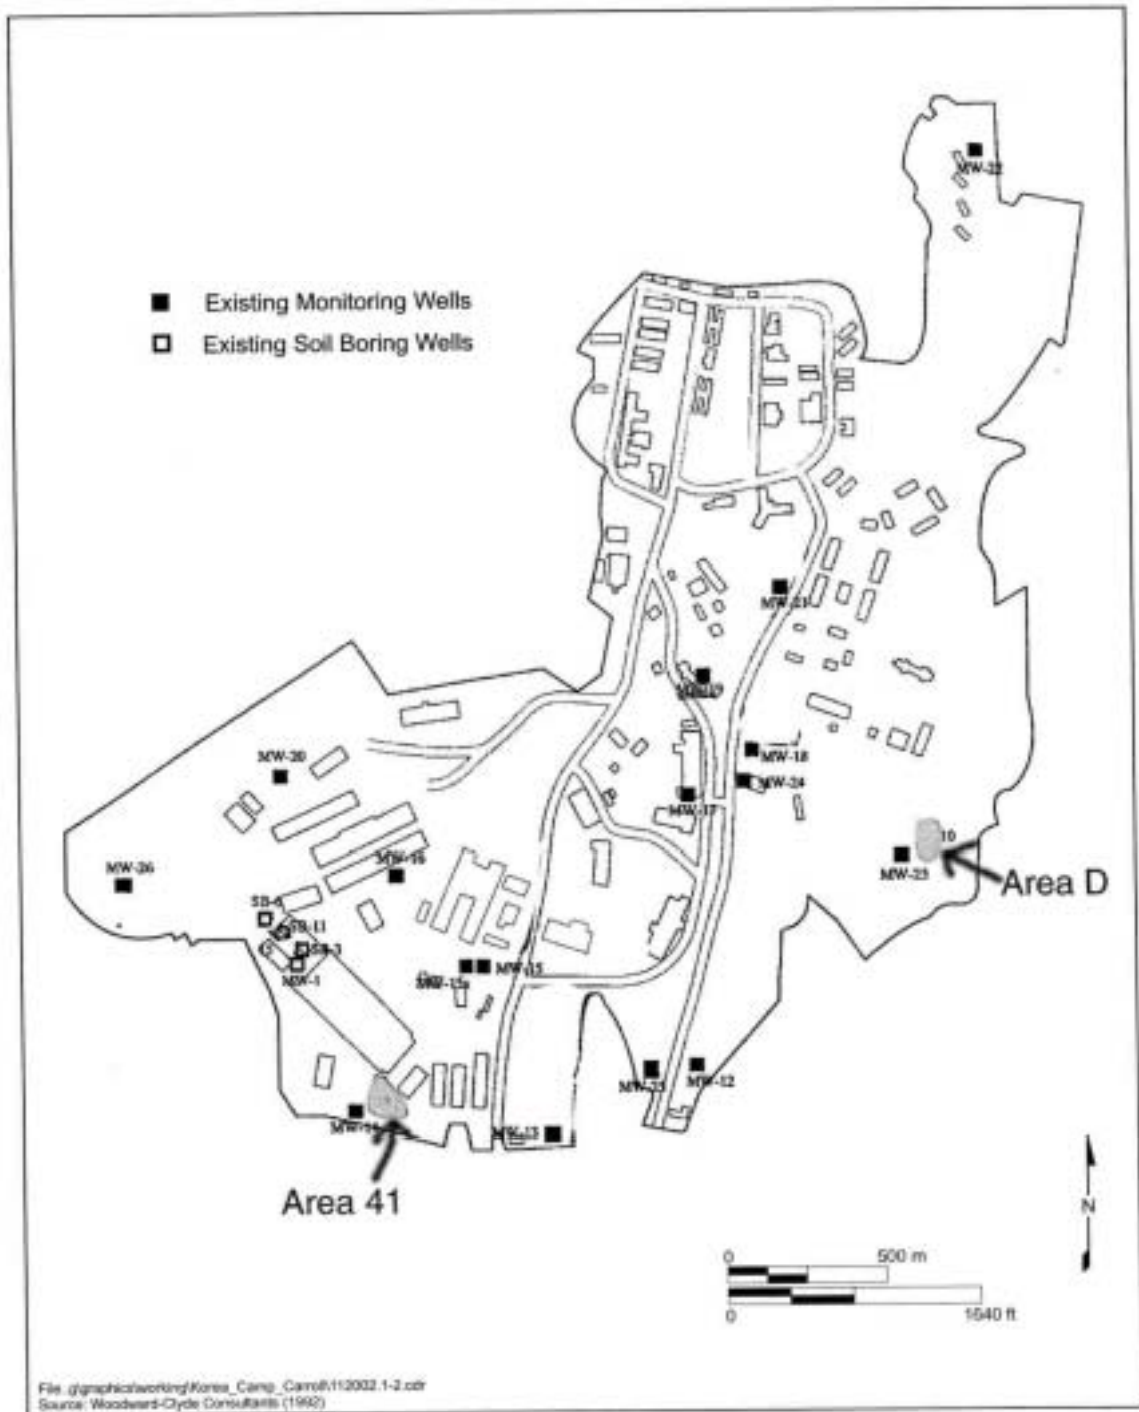
Figure 1-2 Site Plan, Camp Carroll, Korea

The potential contaminant sources identified for Area D are comprised of containers of materials previously buried at the site. One origin of the buried containers may have been the materials previously stored at Area 41. Reportedly, the buried containers were later excavated and removed from the site to an unknown destination. Source materials remaining at Area D are likely to consist primarily of residual contaminants in the soil and groundwater underlying the site, however, some of the buried containers may still be present in the previous landfill area.

The approximate locations of these potential sources are depicted on Figure 1-2. The evaluation processes regarding these potential sources are presented in Section 2-2.
