Appendix 1. Report of Groundwater Monitoring Well Installation at Land Farm of Camp Carroll in 2007.

**GROUNDWATER MONITORING WELL INSTALLATION
AT LAND FARM AREA, CAMP CARROLL,
KOREA (G&E 06-075E/E07-44)**

1 **Draft Report for**
2 **Remedial Investigation/Feasibility Study at Land Farm**
3 **and Area D of Camp Carroll, Republic of Korea**
4
5

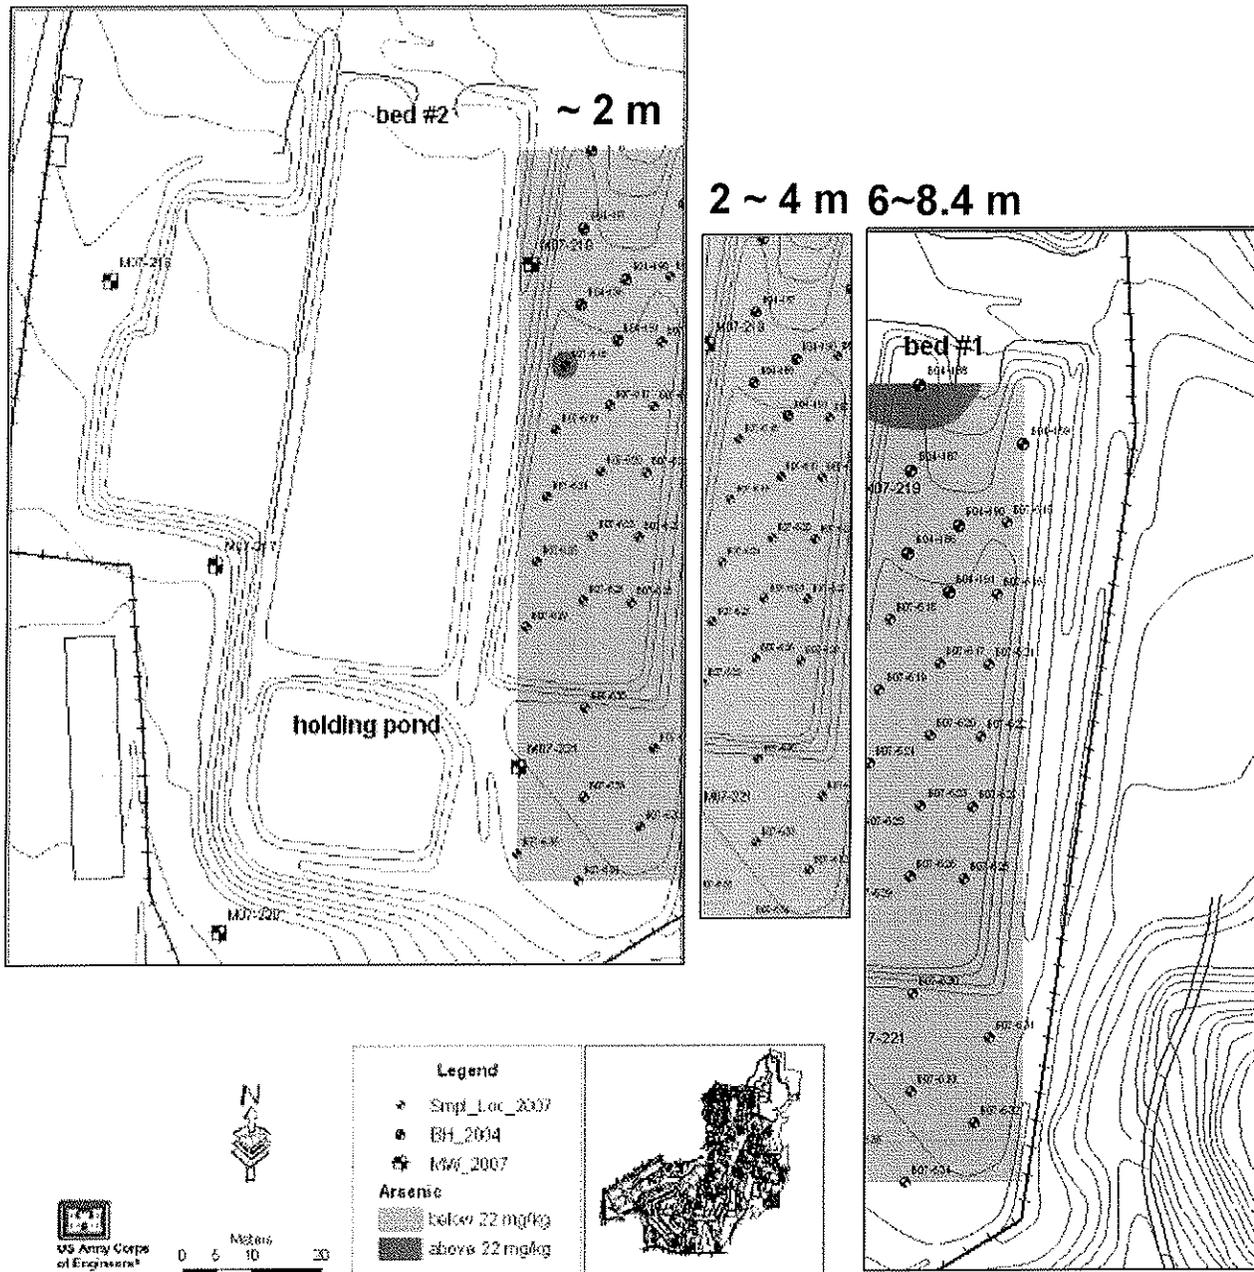
Figure 4. Arsenic Distribution at the Land Farm Bed#1 of Camp Carroll.

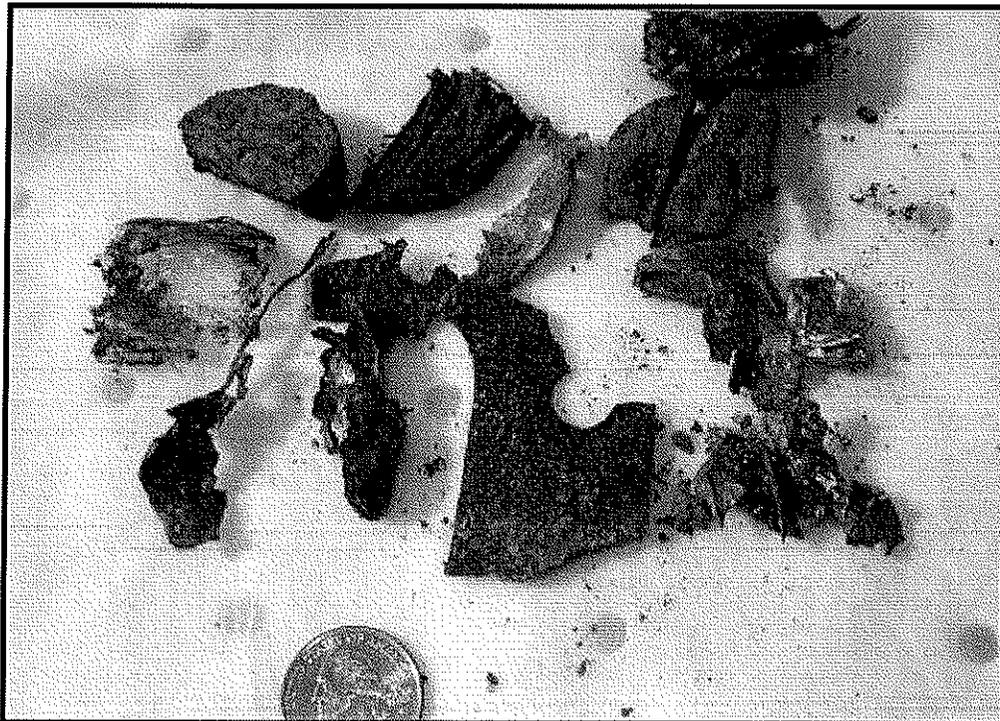
Figure 4. Materials Brought from Subsurface (1~3 m) at M07-221 During Soil Boring.

A total of five boreholes were drilled to a depth of approximately 12 meters bgs at the land farm. Highly weathered biotite granite was encountered at about 8 meters bgs within the sampled area during this assessment. Approximately 4 to 6.5 meter thick layer of residual soil consisting of fat clay and clayey/silty sand covers the bedrock. Fill materials of clayey/silty sand and clayey sand with gravel were encountered in boreholes with thicknesses ranging from 3 to 6 meters. Depths to groundwater ranged from 2.96 to 9.6 meters in drilled boreholes with the deepest level measured in the monitoring well M07-218. Fat clays were encountered in three of five boreholes ranging in depth from 5.5 to 8 meters bgs. No fat clay was encountered in boreholes M07-217 and M07-218. A strange chemical odor was detected in return cuttings from boreholes M07-221 between 1 and 9 meters bgs. Pieces of metal, wood and vinyl were recovered from depths between 1 to 3 meters deep while drilling soil boring at M07-221 (Figure 4).
