FINAL REPORT

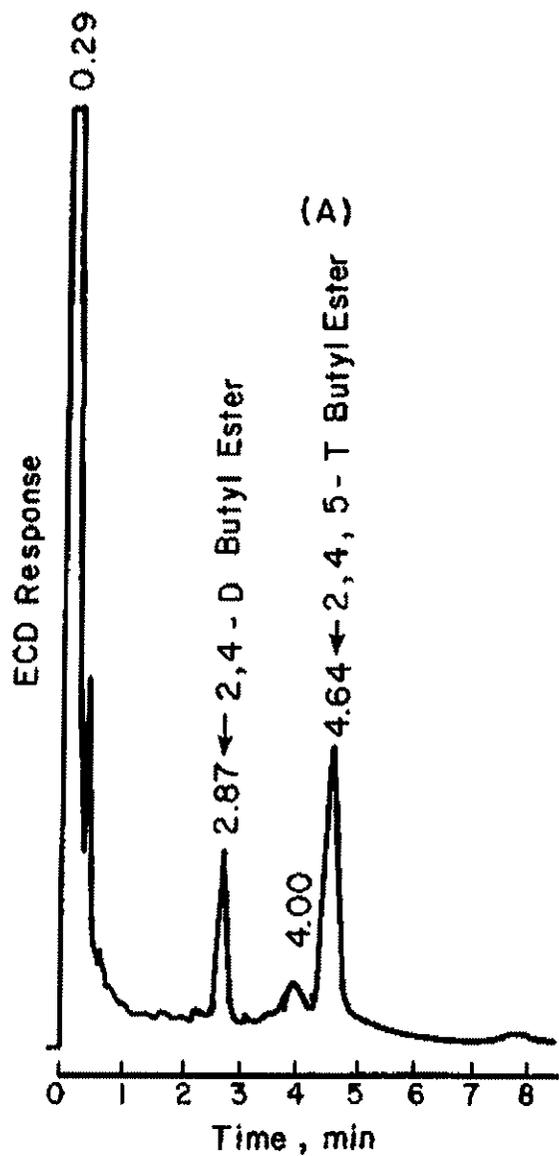
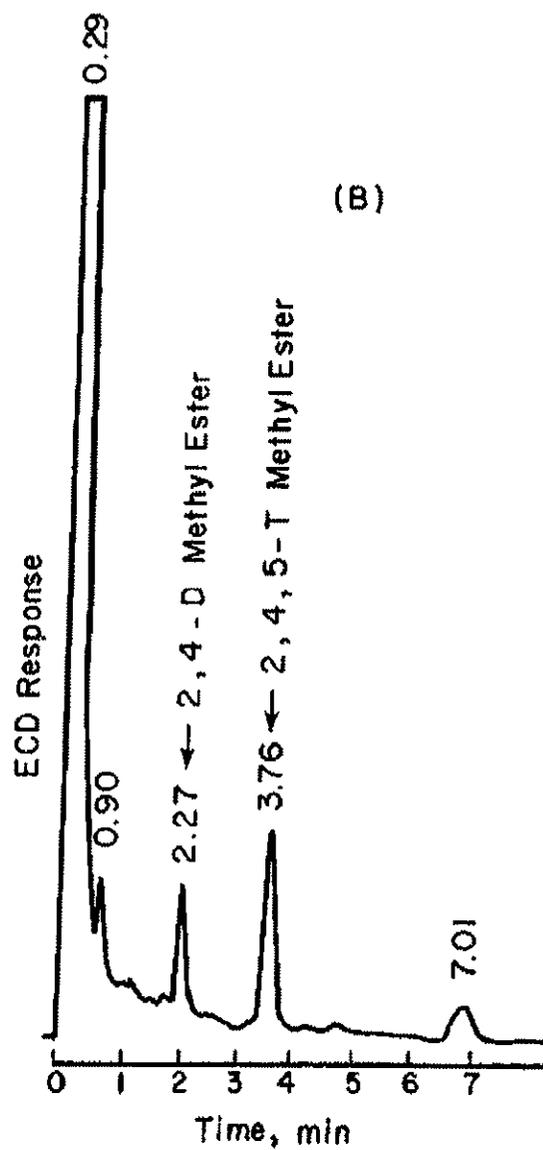
FIGURE 26. GC CHROMATOGRAMS OF (A) CHROMOSORB SAMPLE CD 29Y707J AND (B) WATER SAMPLE WS 30Y700J

Samples were processed in groups of four with a distilled water blank being included after approximately every tenth sample. A typical chromatogram is shown in Figure 26. All reagents were freshly prepared each week.

The cellulose Soxhlet extraction thimbles were extracted and examined for interferences. As a great many electron-capturing species were observed in the chromatograms of the blank thimble extracts, thimbles were routinely soaked in hexane in a dessicator overnight which was found to be sufficient for removal of these interferences. A typical chromatography of these chromosorb samples is shown in Figure 26.

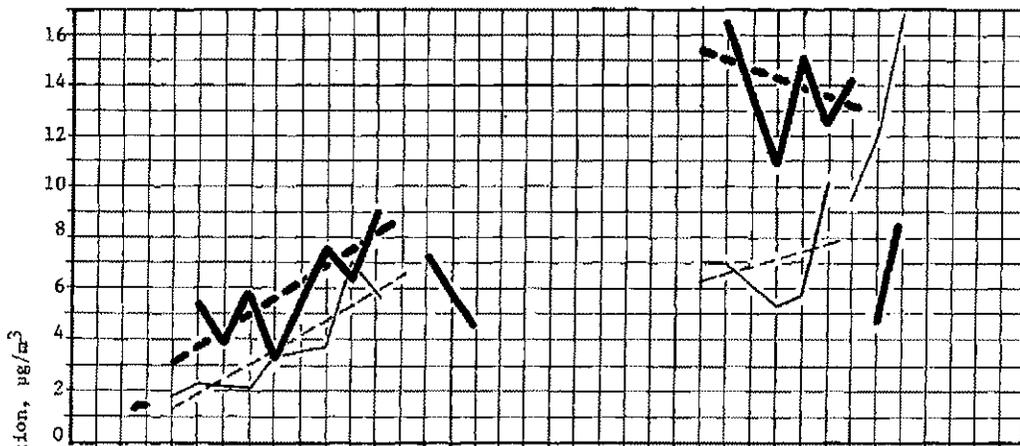
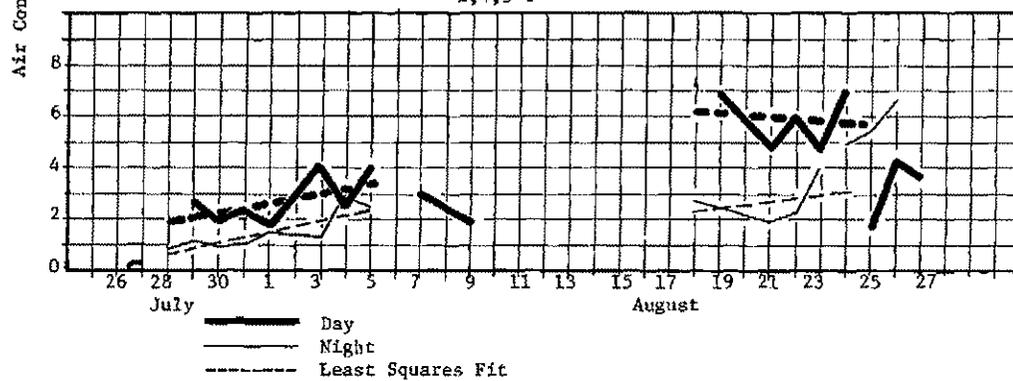
FIGURE 27. CONCENTRATIONS MEASURED AT DOWNWIND STATION

Figure 27 was prepared to help visualize the causes of the observed concentrations. In addition to the plotted concentrations, the trend lines for the two dedrumming periods (least squares fit) are attached.

The initial concentrations were trace amounts. On the 26th of July, measurable concentrations were found: during that day dedrumming activities were demonstrated to the dedrumming staff.

On these days, as in the second dedrumming period, concentrations during the day were noticeably higher than at night. Several conditions could have accounted for this, as noted below:

Reference (40) shows that the evaporation rates are approximately related to the logarithm of the temperature, and that the rate may double or even triple between 60 F and 80 F. This factor is sufficient to explain the differences between observed day and night concentrations.

The increasing concentrations are interesting. The most likely explanation of these is that, in removing barrels for dedrumming, the ground underneath the barrels, which in many cases had absorbed H<sub>2</sub>O, was freshly exposed to the elements. The ever increasing area thus allowed more and more evaporation to take place, increasing observed concentrations.

If this explanation were correct, it would be expected that concentrations would decrease when dedrumming activities ceased. This is in fact observed in the first days after completion of the first dedrumming.

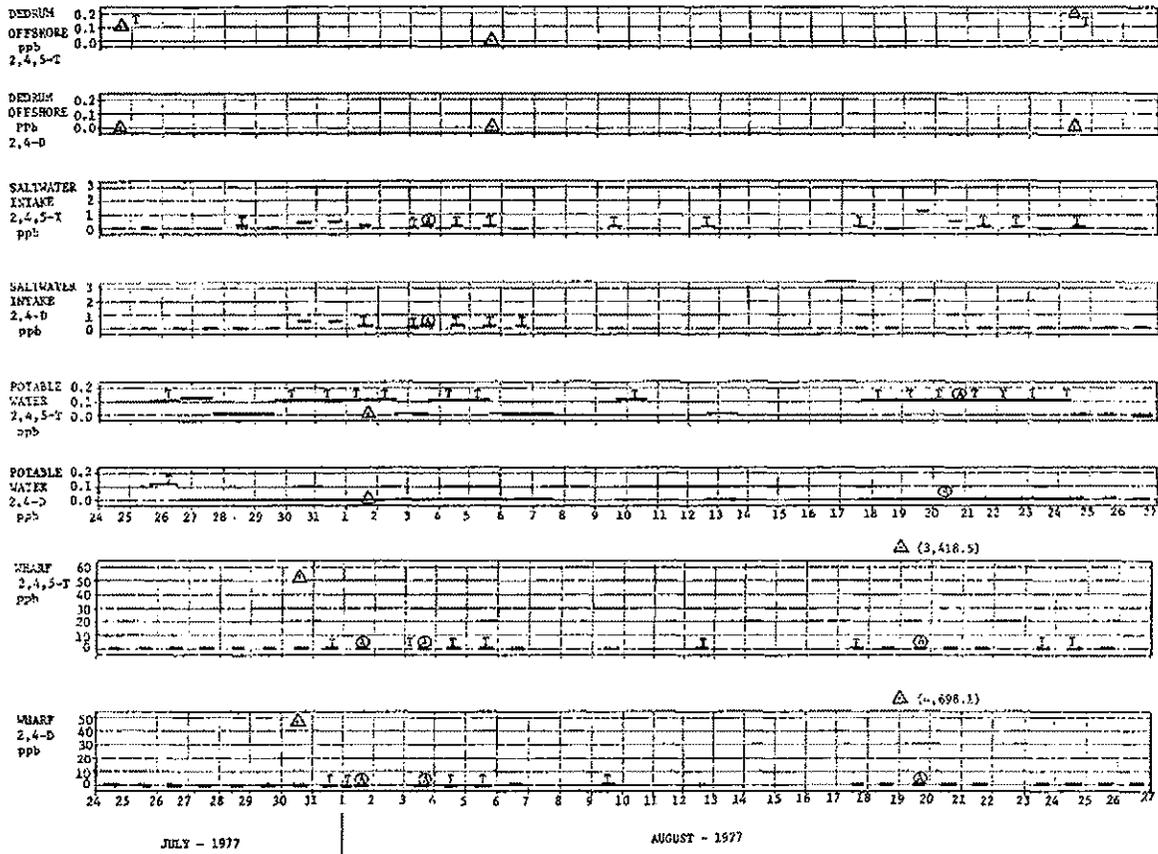
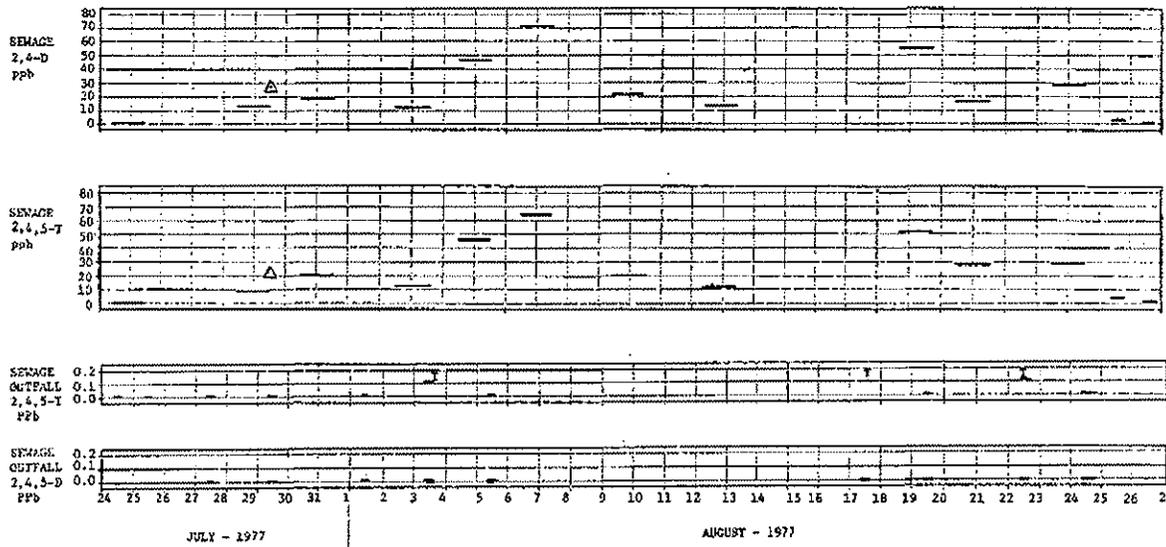
FIGURE 28. CHRONOLOGICAL PROFILE OF WATER CONCENTRATIONS CONTRASTED WITH THE DEDRUMMING ACTIVITIES

T = TRACE  
⊕ = ASSIGNED THE TIME  
△ = GRAB SAMPLE

The chronological profile of concentrations of herbicide at the various sites is contrasted in Figure 28 with the number of barrels dextrummed per shift during the operation period. Quantifiable levels of Orange Herbicide observed during the assessment period are well correlated with activities at the wharf leading to the conclusion that the M/V Vulcanus was the source of the contamination (see previous discussion in Section 4.1.3.2 above). All concentrations were well below the suggested aquatic life criteria.

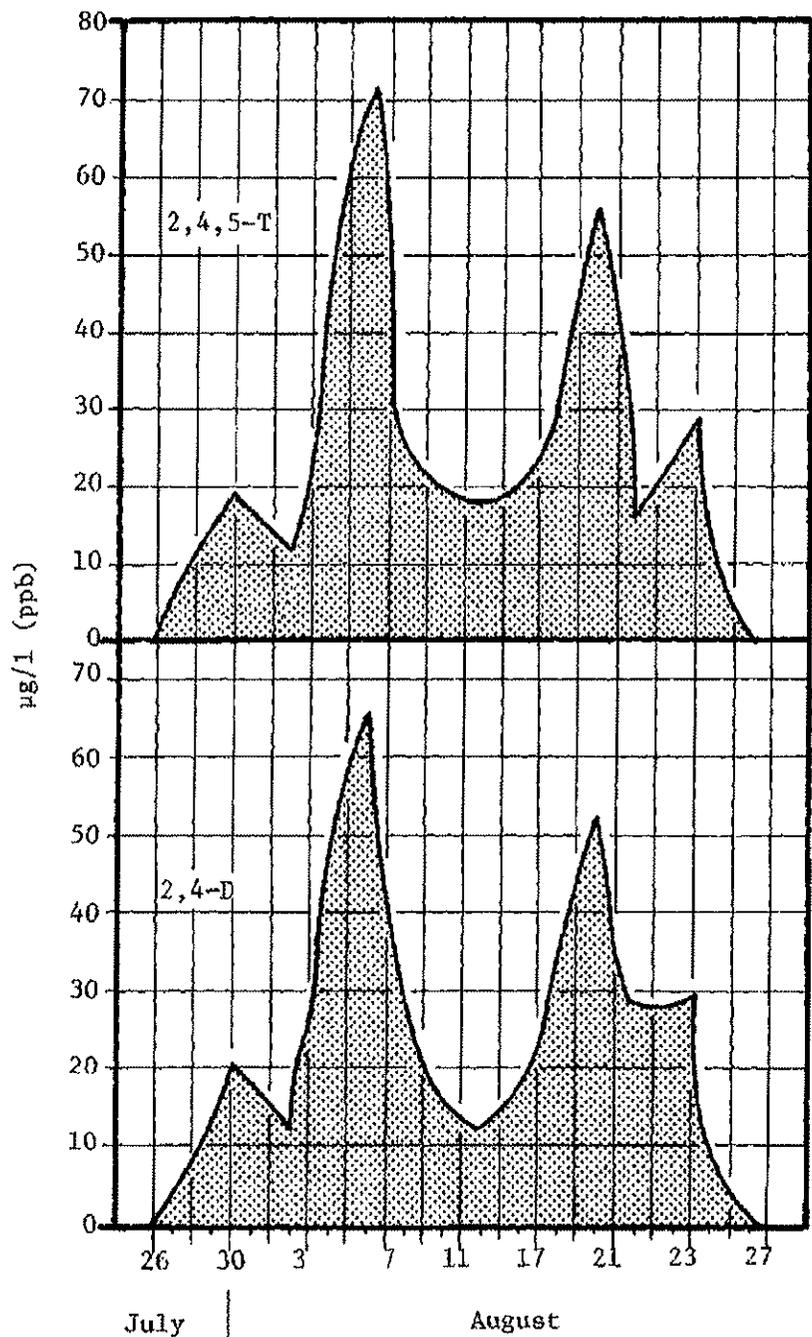
FIGURE 29. SEWAGE SYSTEM DISCHARGES OF 2,4-D AND 2,4,5-T TO THE OFFSHORE AREA SOUTH OF JOHNSTON ISLAND

One grab sample taken at noon on July 29, was analyzed and exhibited 2,4-D concentrations about 10 percent higher than the corresponding 24-hour average. Similarly, the grab sample showed 43 percent higher 2,4,5-T levels than the composite. July 29 was in the peak dextrumming activity period for the first loading operation.

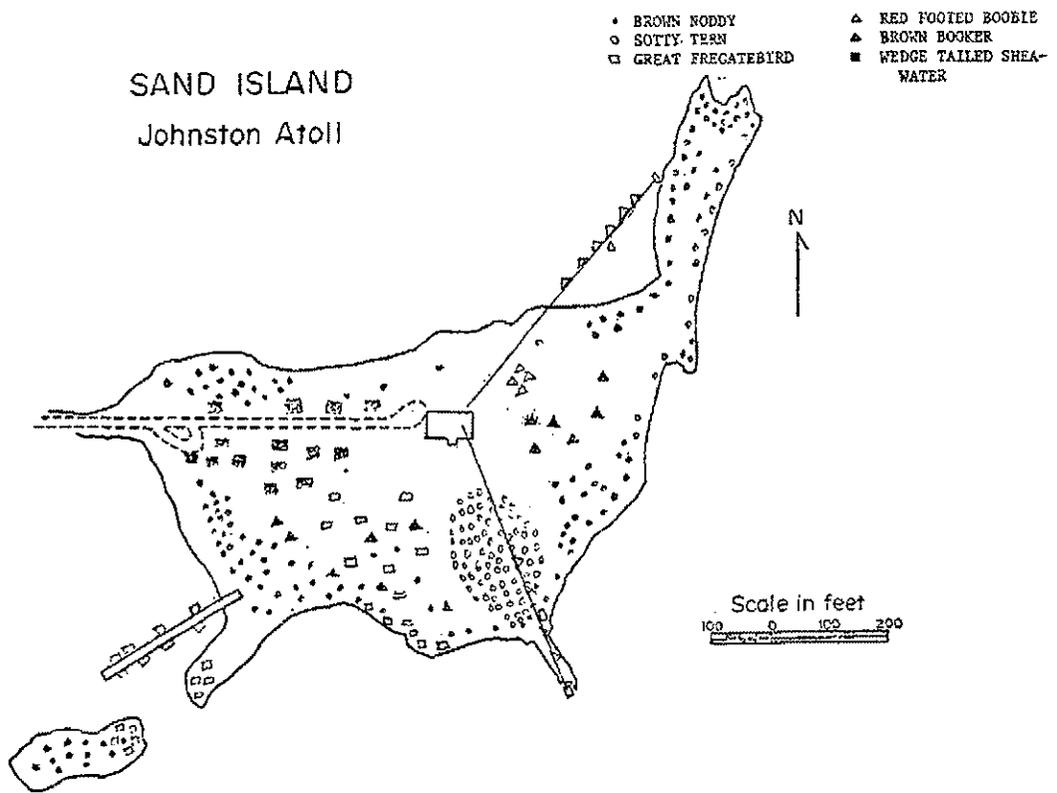
FIGURE 30. THE DISTRIBUTION OF SIX SEABIRD SPECIES ON THE ORIGINAL PORTION OF SAND ISLAND, JOHNSTON ATOLL, 1977

During the initial survey, and subsequent ones a total of 11 species was observed on Johnston Atoll (Table 14). Of these 11 species, seven comprised the breeding population of Sand Island. The distribution of six species on the original portion of Sand Island is shown in Figure 30. Brown Noddy, the most dominant of the six species, nested over most of the island particularly along the perimeter of the island. Many Brown Noddies could be seen either sitting on eggs or with very young chicks. Sooty Tern the second most dominant species, nested in a rather confined area southeast of the Loran antenna. Wedge-tailed Shearwater nested in burrows along both sides of the road leading to the antenna. Frigatebirds were limited to the southern shore and the southwest islet. Brown boobies were found on the hillside south and east of the antenna. Red-footed Boobies were found nesting on the Tournefortia bush northeast of the antenna. They could also be seen on the guywires northeast and southeast of the antenna. A seventh species of sea bird, Red-tailed tropicbird, was found nesting under low vegetation on the man-made portion of Sand Island. Several chicks of this species were seen at various stages of maturity.

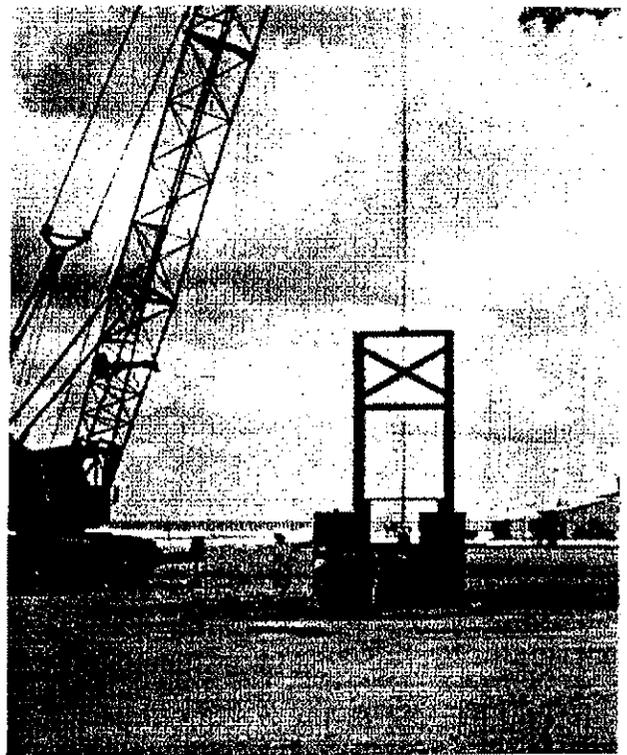
PLATE 3. TWO VIEWS OF DRUM CRUSHER. LEFT HAND VIEW SHOWS STANDING WATER IMMEDIATELY AFTER SHOWER, AND STAIN FROM RESIDUAL DIESEL FUEL EXPELLED FROM DRUMS

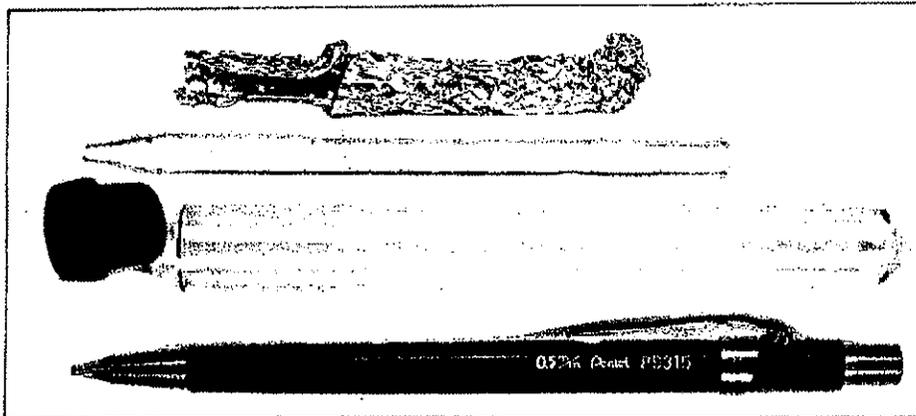
PLATE 6. CHROMOSORB TUBE, ALUMINUM FOIL WRAP, AND STORAGE TUBE.  
PENCIL ADDED FOR SCALE. CHROMOSORB MATERIAL IN LEFT  
1/3 OF TUBE

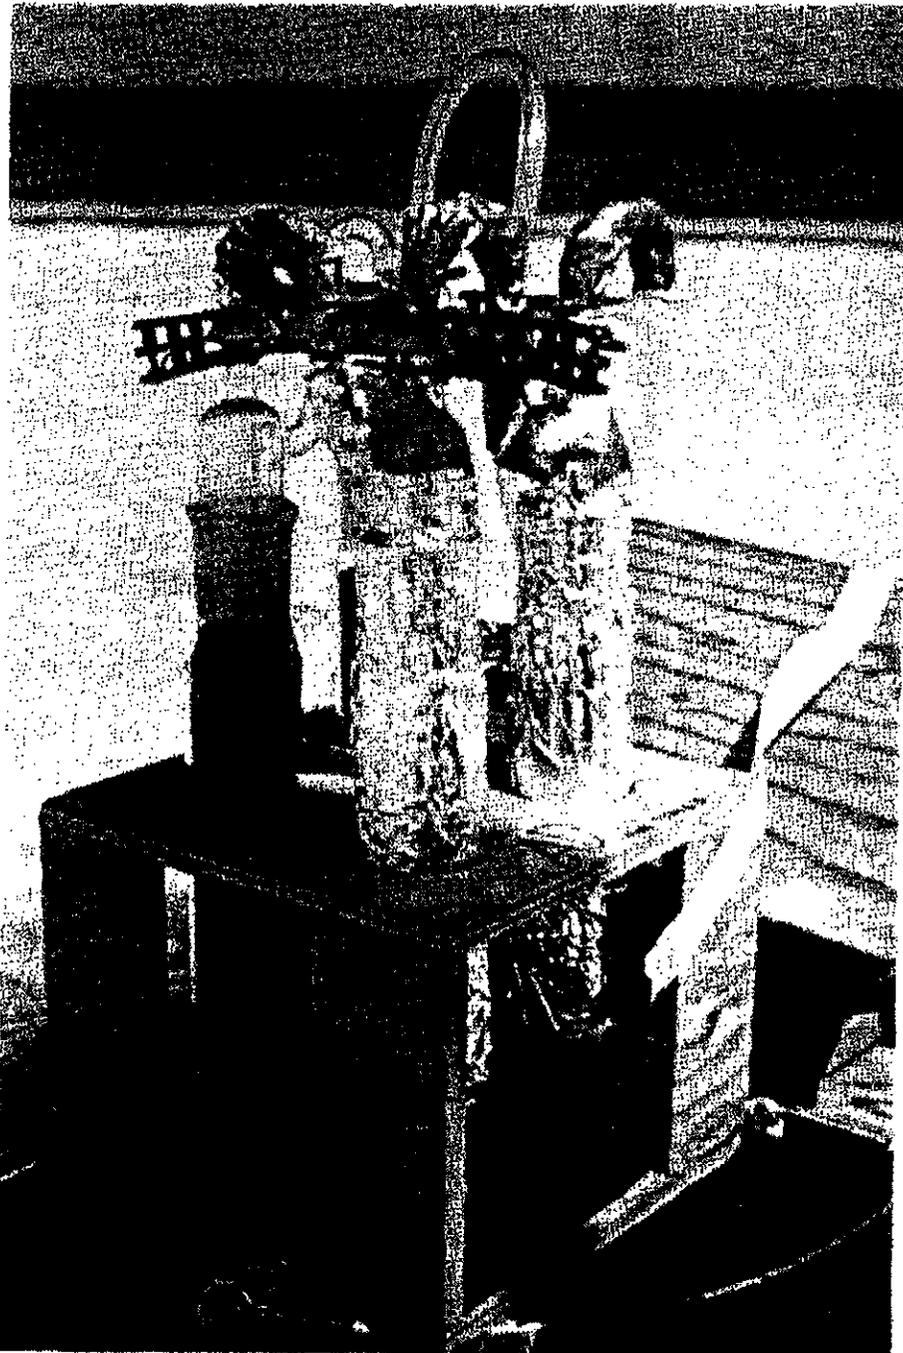
PLATE 7. BENZENE IMPINGER SETUP. BENZENE FLASKS ARE WRAPPED IN ALUMINUM FOIL TO PREVENT PHOTO-DECOMPOSITION OF TRAPPED SPECIES

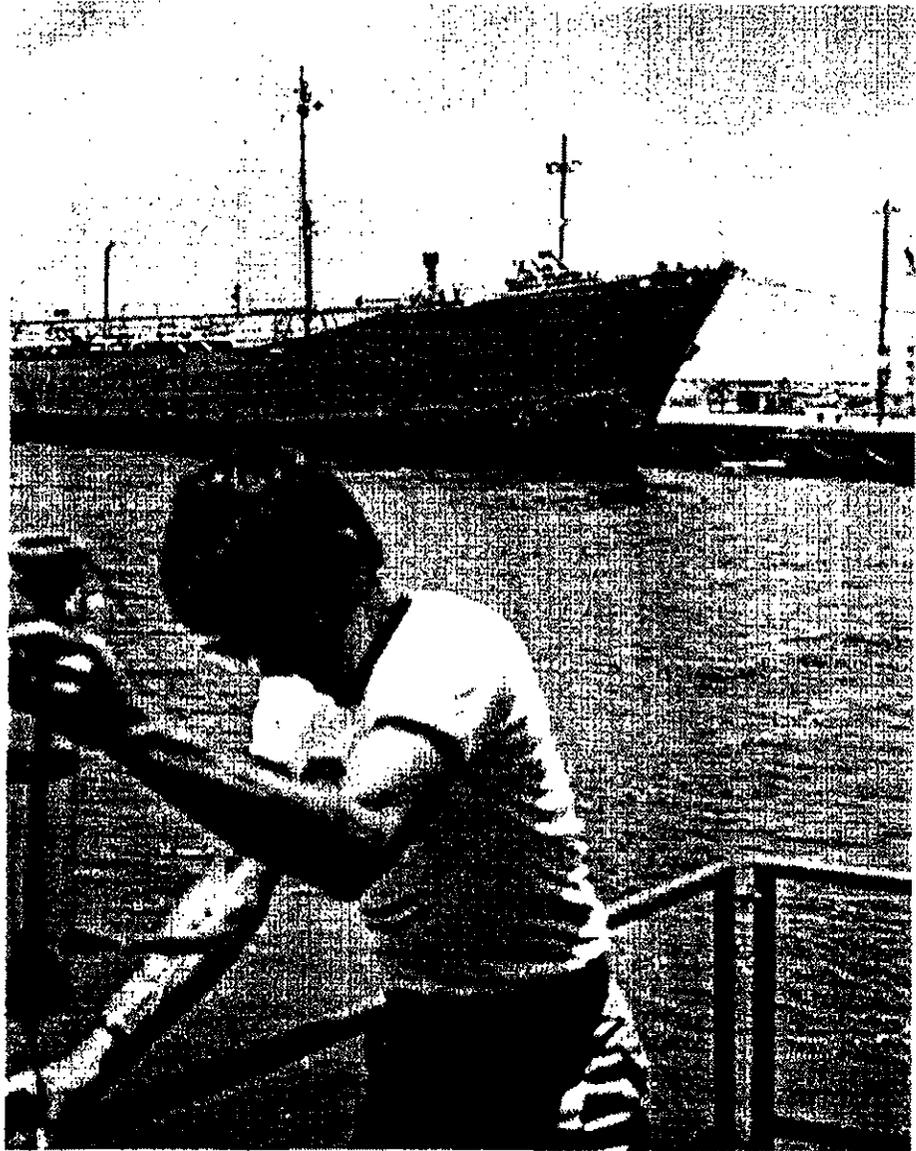
PLATE 8. WATER SAMPLING LOCATION OFF SHIP BOW. ANOTHER SITE WAS LOCATED APPROXIMATELY 10 METERS OFF THE BOW

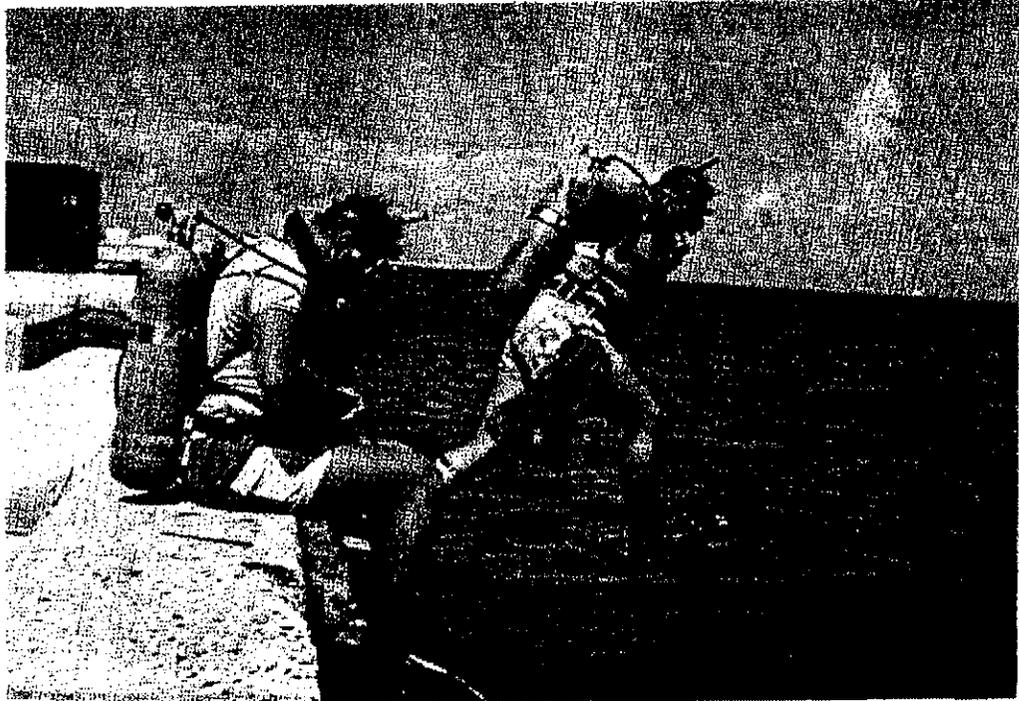
PLATE 9. SEDIMENT SAMPLING. SCUBA GEAR REQUIRED BECAUSE OF DEPTH. OBSERVATION OF DIVERS LED TO UNDERSTANDING OF SURFACE CURRENTS

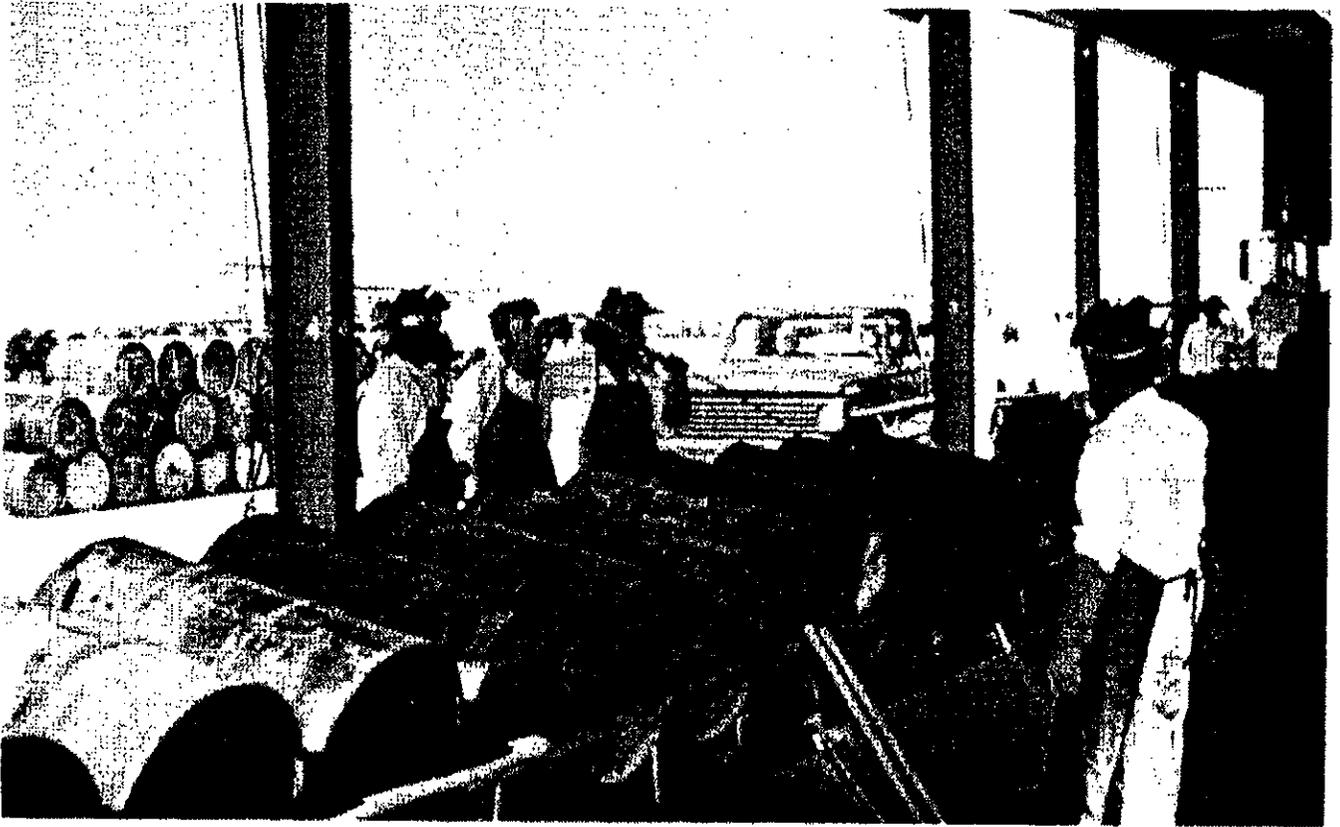
PLATE 13. SAFETY EQUIPMENT. TAKEN IN DEDRUM FACILITY, SHOWING RESPIRATOR, FACE SHIELD, GLOVES AND APRON

(1) All personnel working inside the dedruming facility were supplied with coveralls, rubber gloves, splash aprons, rubber boots, face shields, and respirators. Use of this protective equipment was mandatory throughout the entire operation (Plate 13).

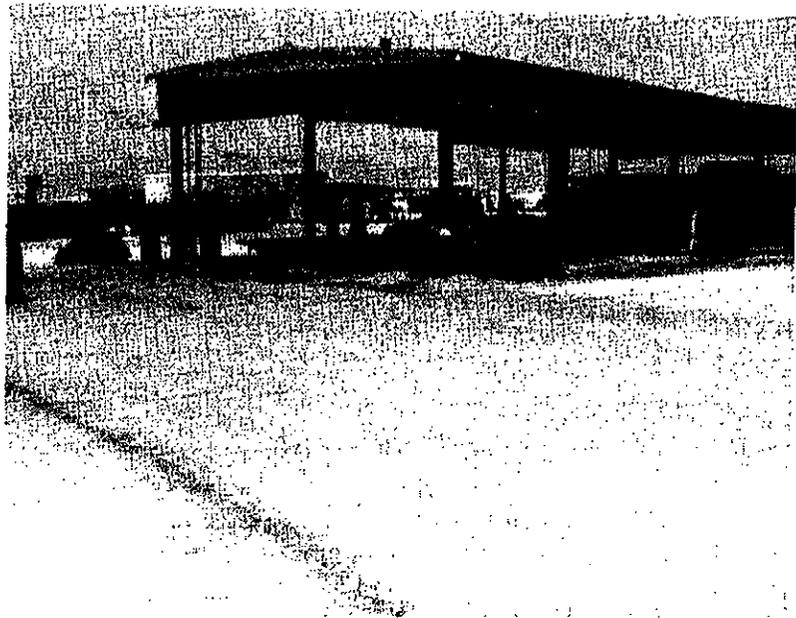
PLATE 15. AIR MONITORING SITE AT DEDRUM. TWO VIEWS SHOWING  
EQUIPMENT ON BARREL. LOWER VIEW SHOWS SECOND  
SITE AT FAR CORNER, ON BARREL

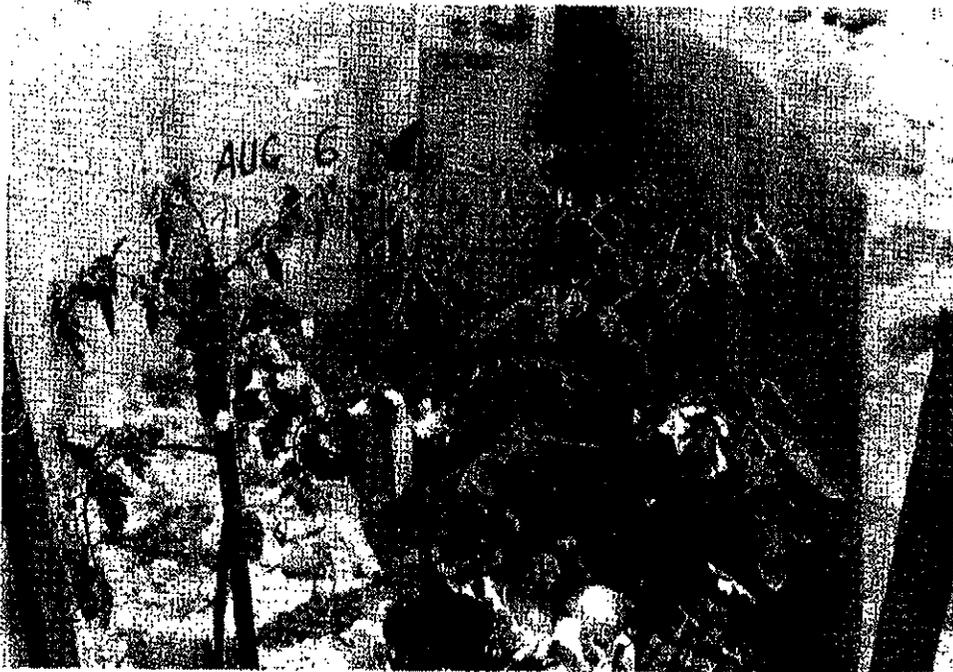
PLATE 16. NORMAL TOMATO PLANT

A rating system was devised to evaluate plant damage. Photographs showing the actual damage are presented in Plates 15 through 18.

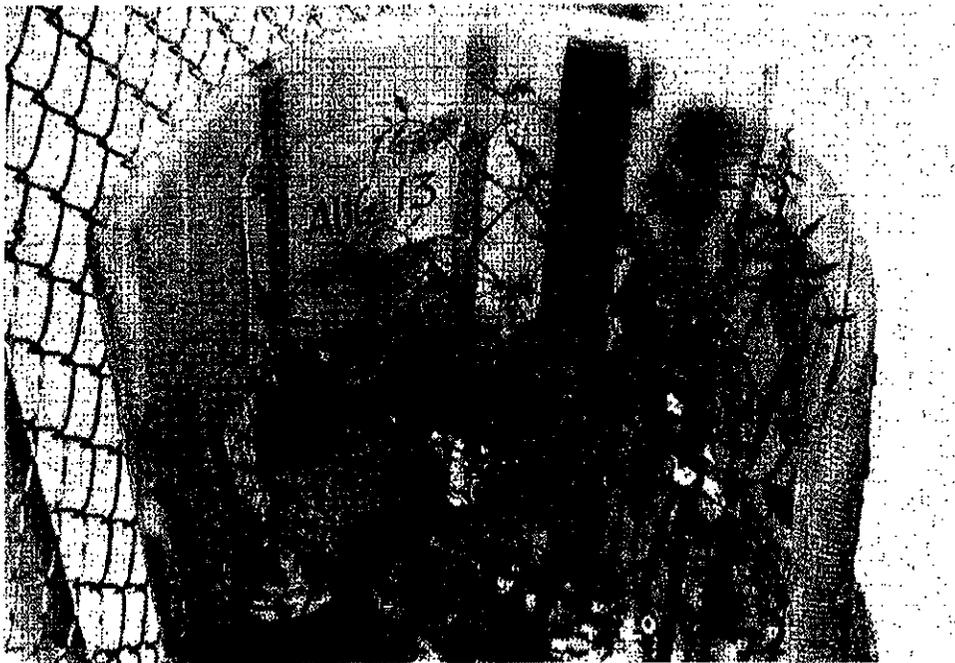
PLATE 17. TOMATO PLANTS WITH LEVEL 2  
INJURY (TIP CURLING)

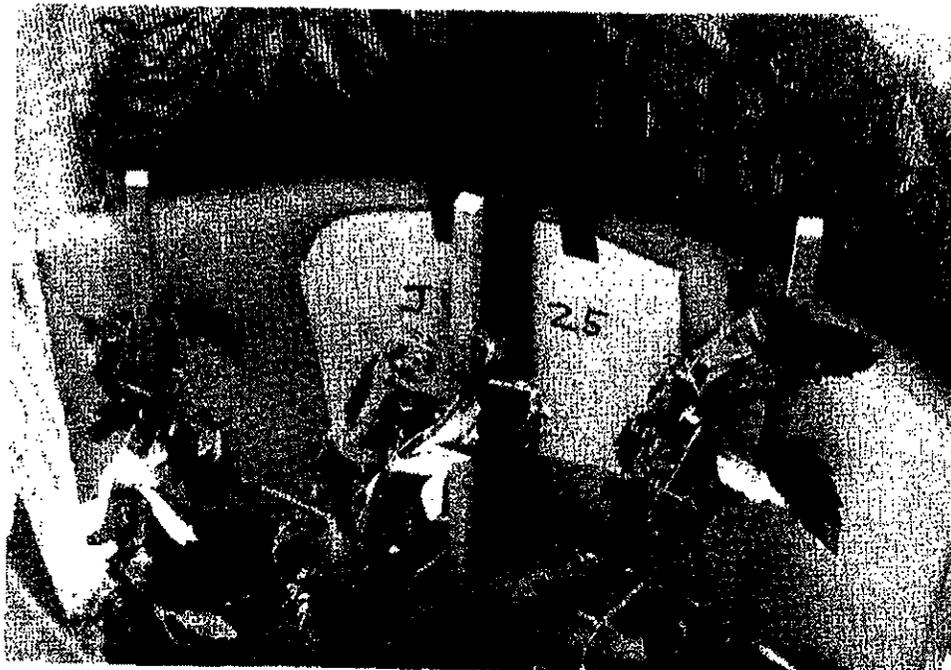
PLATE 18. TOMATO PLANT WITH LEVEL 3  
INJURY (STEM CURLING)
