AFATL-TR-79-20

**Residual Levels of
2,3,7,8-Tetrachlorodibenzo-p-Dioxin
(TCDD) Near Herbicide Storage and
Loading Areas at Eglin AFB, Florida**

FEBRUARY 1979

FINAL REPORT FOR PERIOD JANUARY 1976-DECEMBER 1978

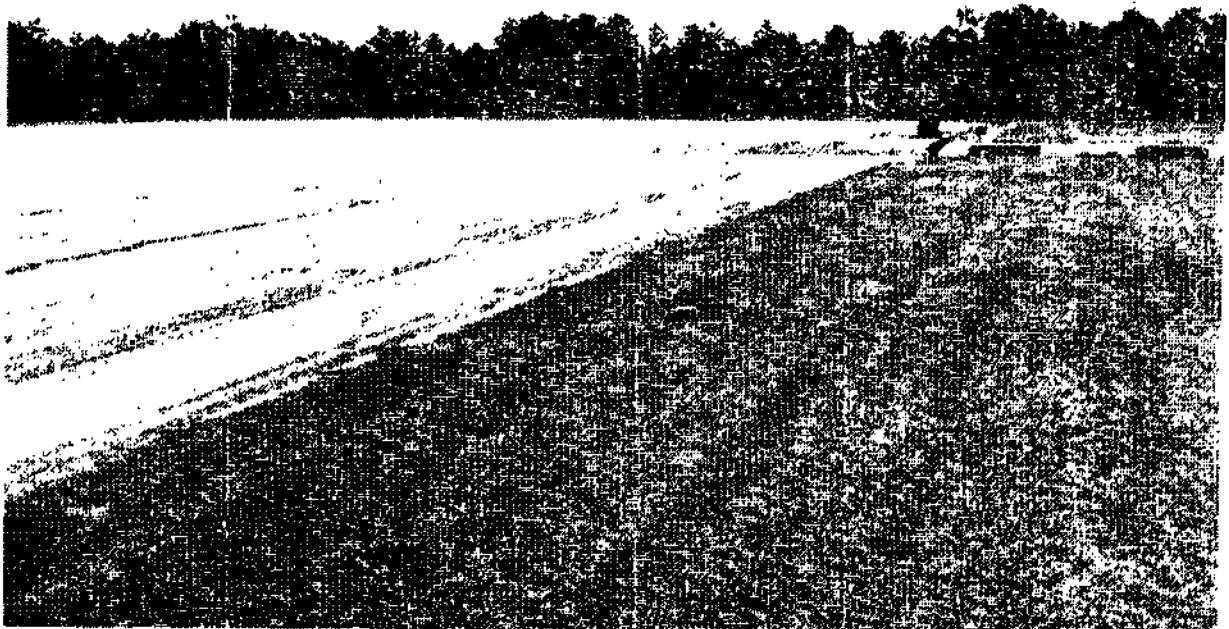
Figure 1. East End of Taxiway Number 9, Eglin AFB, Florida

This area is the end of a taxiway that was used briefly during the beginning of the defoliation test program at Eglin (Figure 1). The quantity of herbicide previously stored or loaded at this location is unknown but is suspected to be small. However, at the time that this location was used, the herbicides involved were predominantly Purple and Orange, both of which contained TCDD as a contaminant. The concrete runway area is bordered by an asphalt strip and is approximately 55 feet (17 meters) above sea level. The soil surrounding the area is sandy with excellent drainage potential. Excess water is drained by a storm sewer into a bayhead to the east of the runway. This bayhead forms a stream which empties into Tom's Bayou approximately 1000 meters downstream (Figure 2).

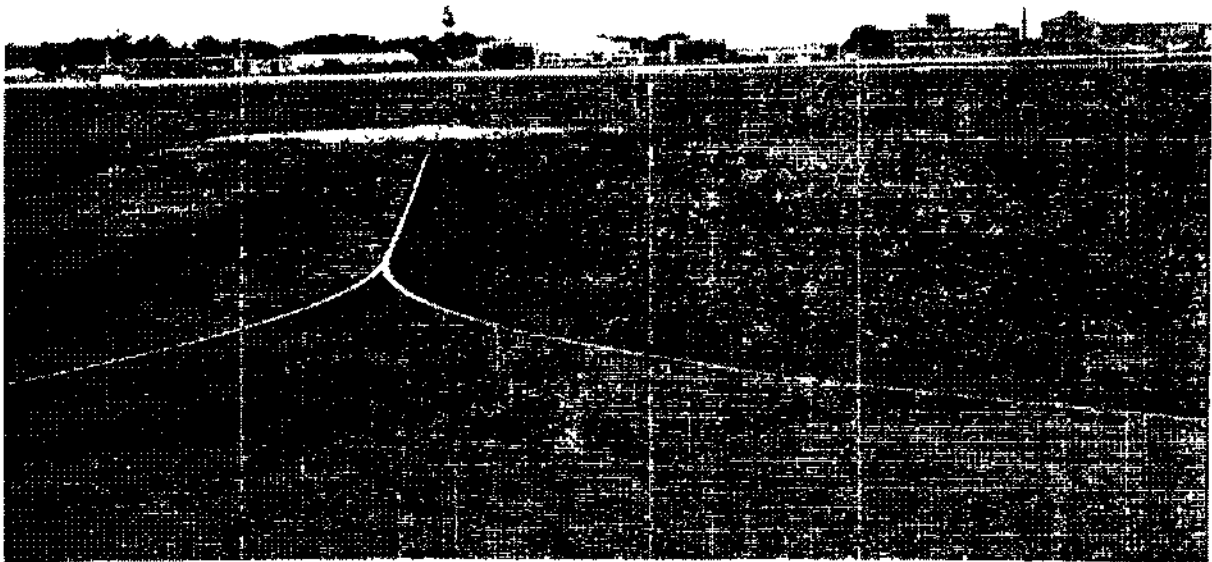
Figure 3. Hardstand 8, Eglin AFB, Florida

Hardstand 8 (Figure 3) is an asphalt and concrete aircraft parking area located west of the north-south runway on the main Eglin airdrome (Figure 2), approximately 65 feet (20 meters) above sea level. The hardstand is connected to the airdrome by an asphalt taxiway. This hardstand was used for limited herbicide storage and loading during the latter portion of the spray program. The area surrounding Hardstand 8 is level with very little runoff occurring. The soil of this area is sandy with excellent drainage potential.

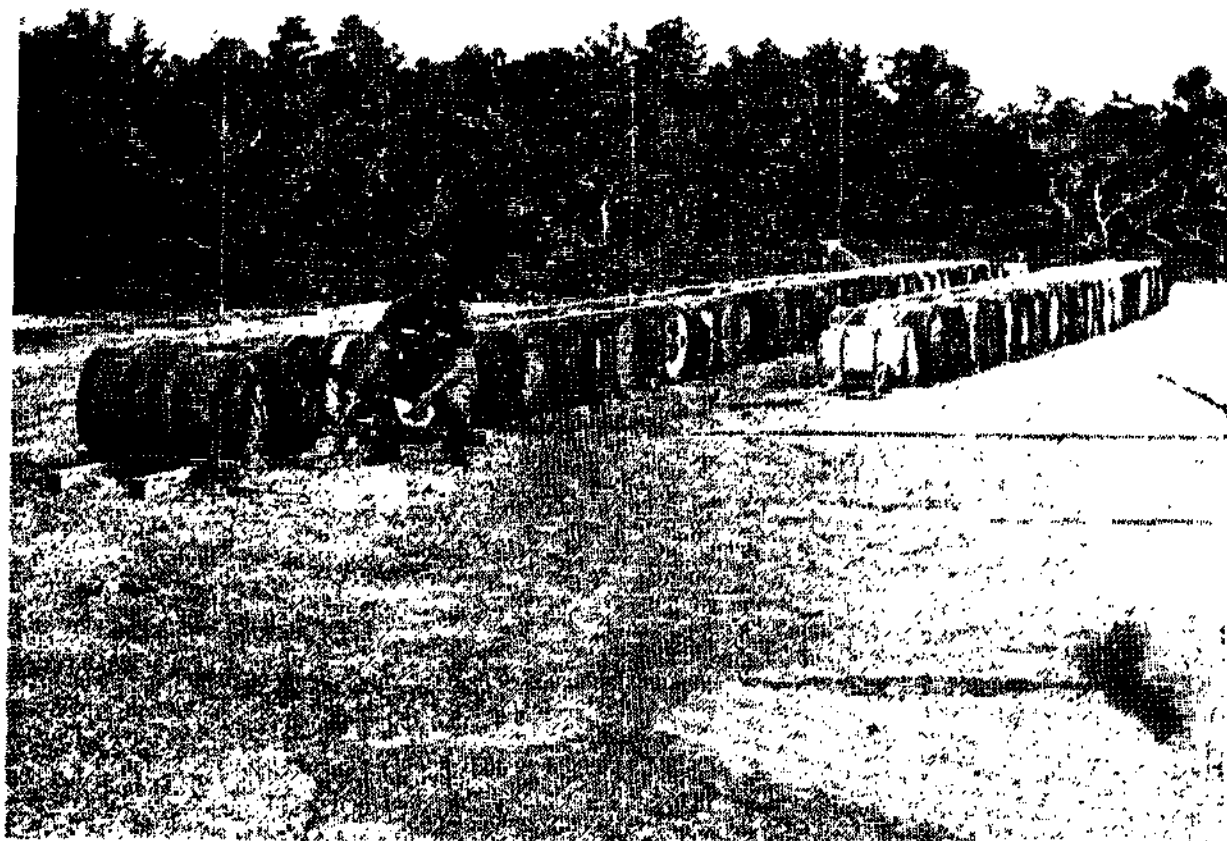
Figure 7. Typical Storage of Herbicide on Hardstand 7

Several hundred 55-gallon drums of various types of herbicide were stored around Hardstand 7 for later transfer of their contents into tanks aboard spray aircraft (Figure 7). Known storage locations are shown in Figure 8. Much of the area immediately surrounding this hardstand was contaminated with herbicide due to accidental spills during loading operations and transfer procedures, leaking drums, and purging of spray systems before and after missions. A pit was dug in 1969 (according to the best available information) to the southwest of the hardstand as a temporary means of preventing the excess herbicides from entering the stream back of the hardstand (Figure 8). After several months of use, the pit was filled with soil.

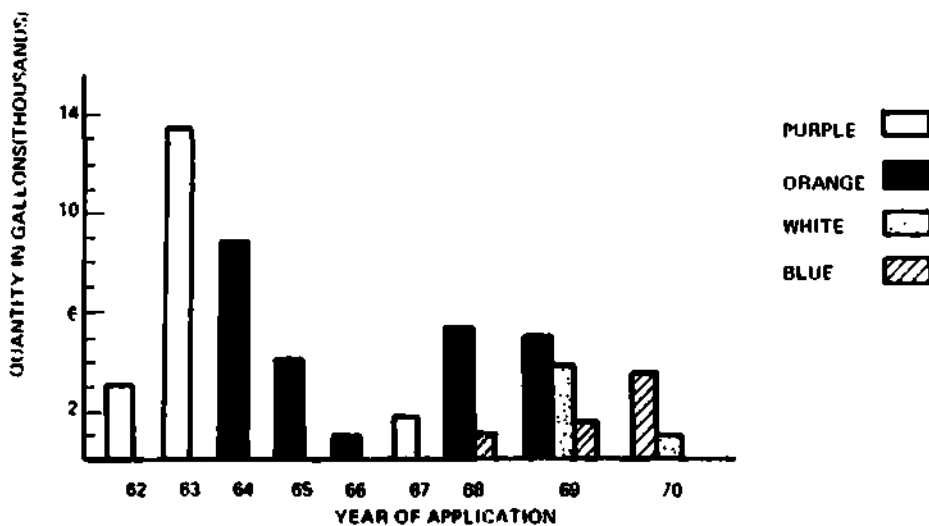
Figure 9. Total Herbicide Application on Test Area C-52A, Eglin AFB, Florida, 1962 Through 1970

Although other formulations of 2,4,5-T were also used (e.g., Pink, Green), the formulations listed below were the predominant ones used in Eglin test programs. As seen in Tables 1 and 2 and Figure 9, massive quantities of these herbicides were stored and disseminated on Eglin test ranges during the period 1962 through 1970 (Reference 7).

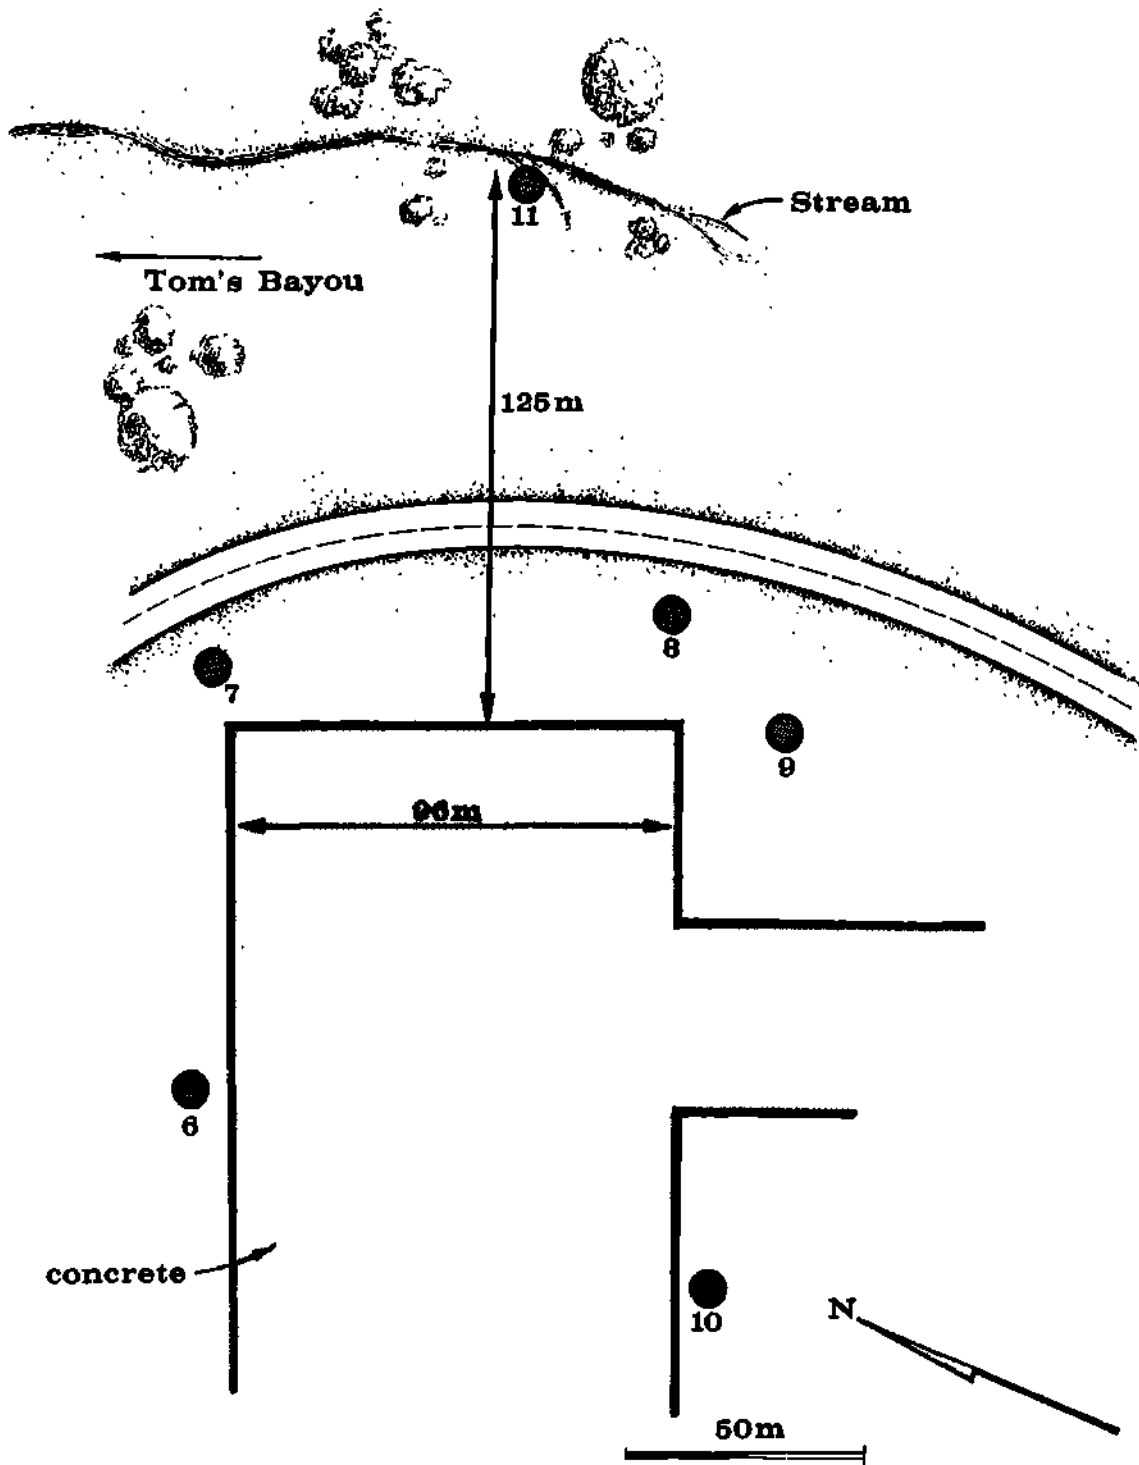
Figure 10. Soil Sampling Sites at East End of Taxiway Number 9, Eglin AFB, Florida

In January 1976, five soil samples were taken from the east end of Taxiway Number 9 and one sediment sample from the exit of the storm sewer drain (Figure 10). The soil samples were taken from the top 10 cm at sites considered to be likely areas for herbicide contamination. No TCDD was found in any of the samples (Table 3).

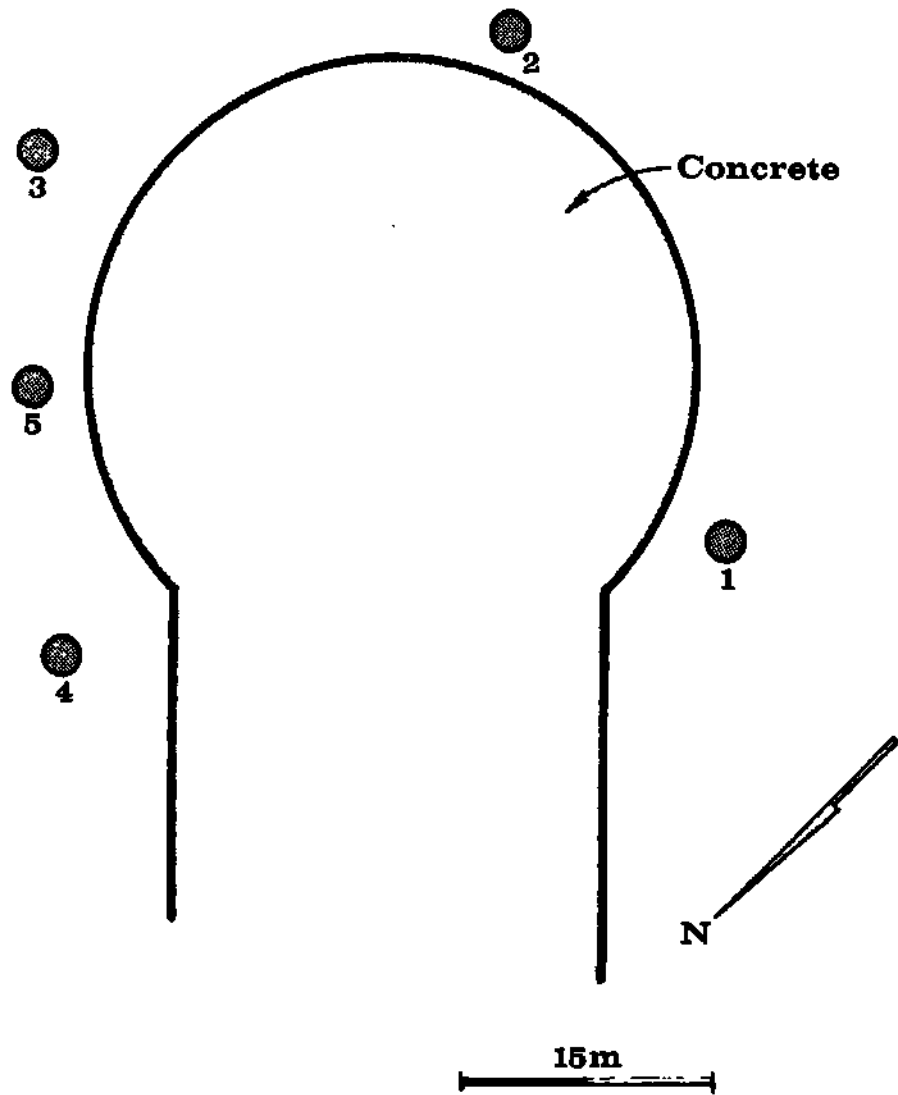
Figure 11. Soil Sampling Sites at Hardstand 8, Eglin AFB, Florida

Five soil samples from the top 10 cm were also collected in January 1976, from Hardstand 8 (Figure 11). Site Number 5, with 0.034 ppb, was the only sampling point around this hardstand that contained a detectable quantity of TCDD (Table 4).

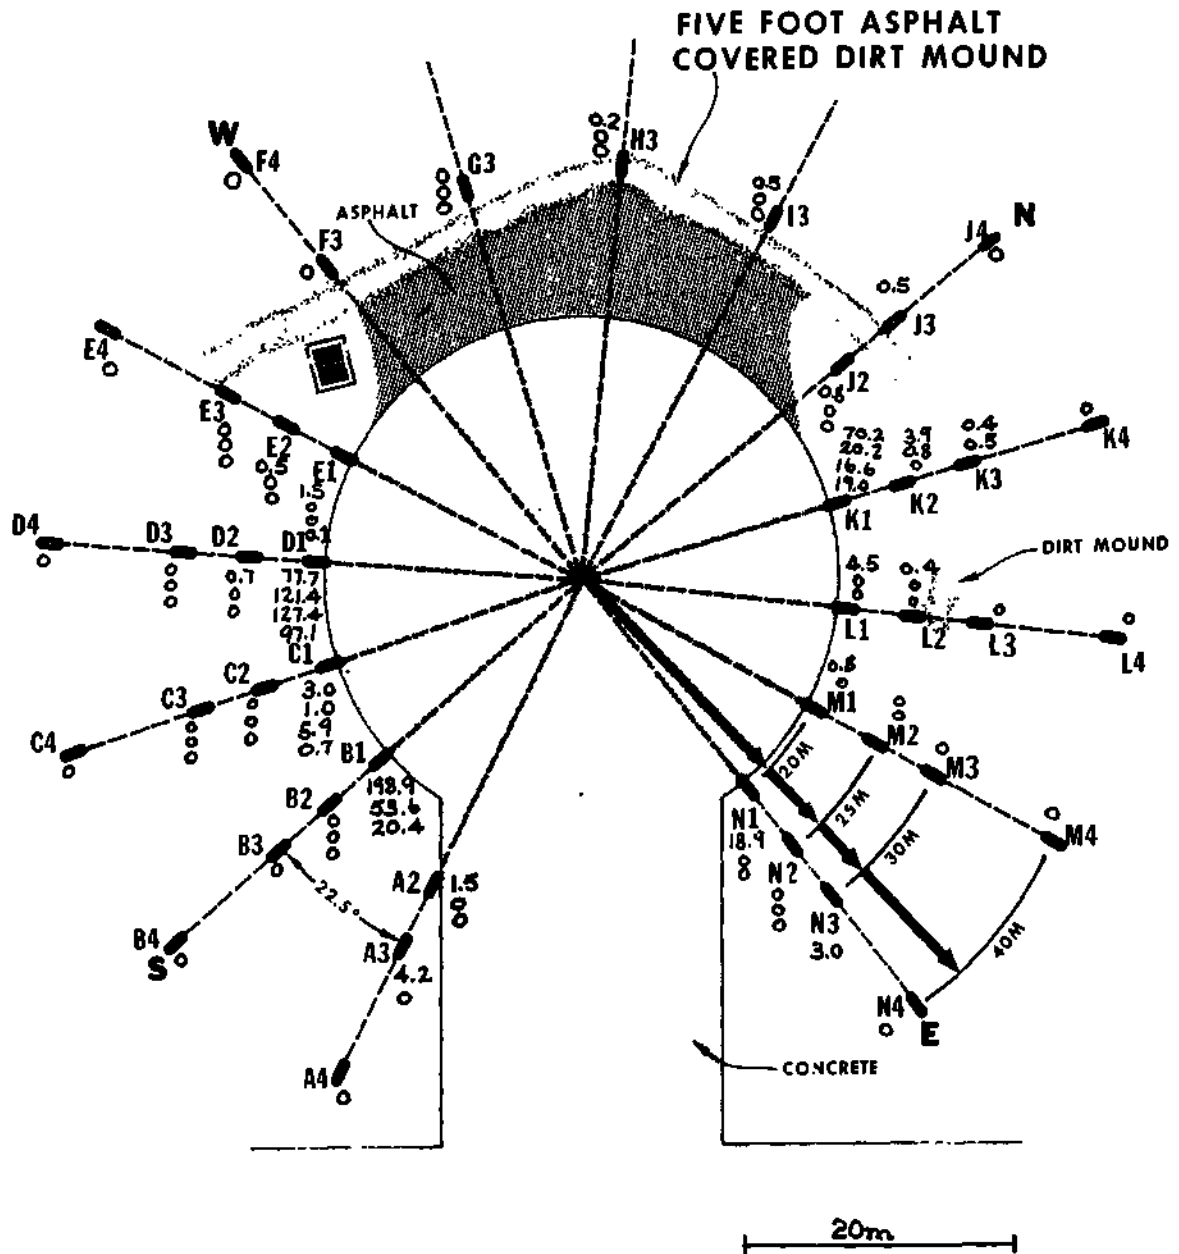
Figure 12. Sampling Sites at Hardstand 7, Eglin AFB, Florida

Since relatively high levels of TCDD were found in soils around Hardstand 7, it was decided to conduct a more thorough monitoring effort at this hardstand. A grid system was established around Hardstand 7 (Figure 12) in order to facilitate the monitoring effort. Beginning at the center of the hardstand pad, 14 radians were established at 22.5 degree intervals, designated A through N, with A being the south southeast radian and proceeding clockwise. Sampling points on each radian were established at 20, 25, 30, and 40 meters from the center point. These sampling points were designated by the numbers 1, 2, 3, or 4, respectively, following the letter designating the radian. The third designation for each sample identification indicates the depth at which the sample was taken: 1 = 0 through 10 cm, 2 = 20 through 30 cm, 3 = 55 through 70 cm, and 4 = 95 through 110 cm. Soil samples were collected using this grid system during January 1978. All designated sampling sites were not actually sampled since asphalt covered some areas, and other areas had been covered with overfill to the extent that the sample would have been meaningless. Those sites used and the TCDD concentrations found at those sites are presented in Table 6 and Figure 12.

Note: Soil concentrations of TCDD in ppb are given at each site by depth from top to bottom. Depths sampled were 0-10 cm, 20-30 cm, 55-70 cm, and 95-110 cm. All depths were not sampled at each site, however.

The highest concentration of TCDD found in the soil surrounding Hardstand 7 from this set of samples was 198.9 ppb. This was found in the surface sample at site B1. Several other sampling sites nearest the concrete pad were also heavily contaminated. This was expected, however, since drainage of spills from the concrete pad would migrate to those areas and also because of leakage from drums that had been stored at those areas. The presence of TCDD at depths down to 100 cm at site D1 was also expected because of the pit which had been dug in that area to restrain herbicide runoff.

The high concentrations in the deeper samples at sites B1 and K1, however, are not as easily explained. Probably several factors are involved. The most obvious explanation is the probable saturation of the soil with herbicide to a considerable depth when the hardstand was being used for loading operations. TCDD could have been transported to those depths via the herbicide solvent. After the degradation of the herbicide, the TCDD remained at the lower depths. The vertical movement of TCDD in the soil probably decreased greatly at that time, however. Although it is recognized that TCDD has little vertical mobility in soil, some vertical movement probably has occurred around Hardstand 7 because of the high concentrations.

An important finding in this study was that soils containing high levels of TCDD contamination around Hardstand 7 were in a very confined area. TCDD contamination above 1 ppb was found predominantly in an area 3 to 4 meters wide surrounding the perimeter of the concrete pad. Soils outside this area were largely below the detection limit of 1 ppb. Although soil levels of TCDD below 1 ppb cannot be dismissed as insignificant, the magnitude of concern is obviously different from soils with much higher levels.

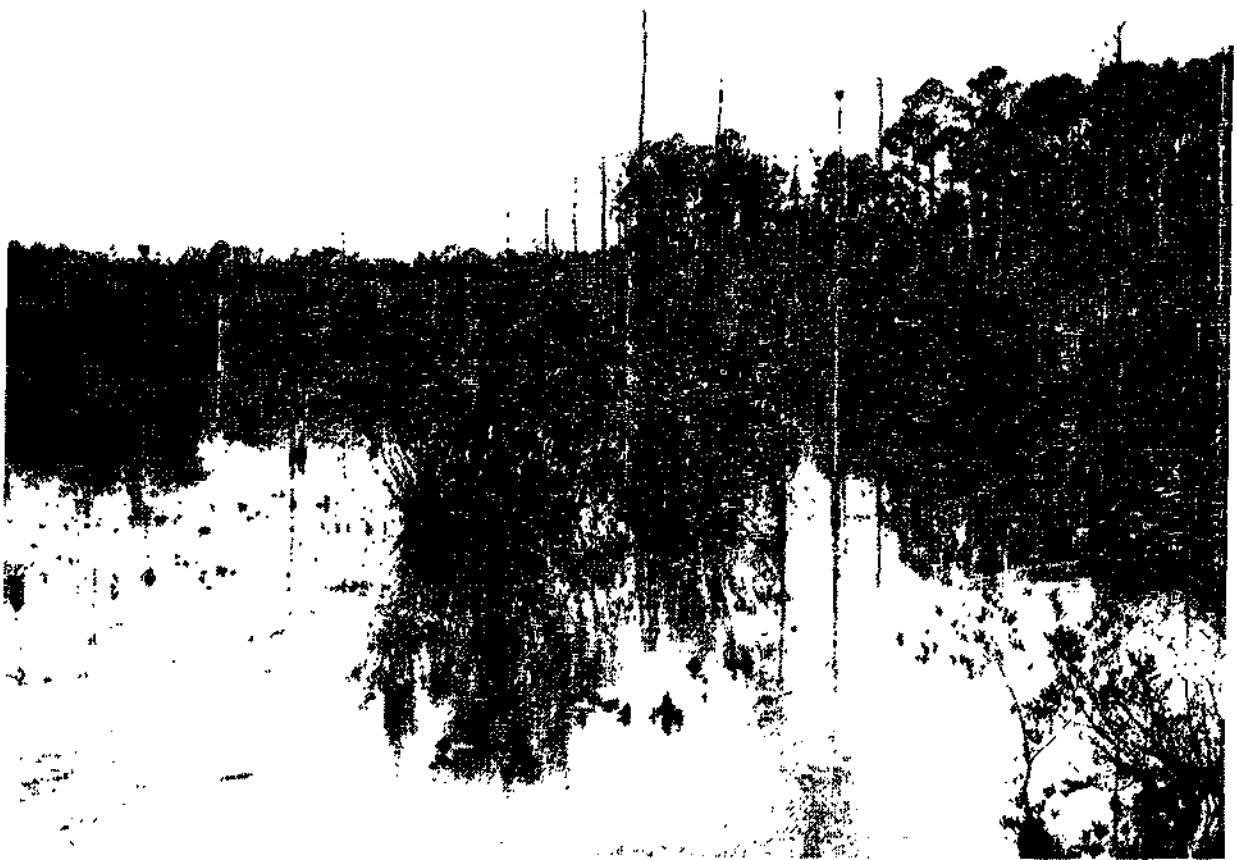
Figure 13. Tom's Pond, Eglin AFB, Florida

c. Biological Samples. Biological organisms were collected from Hardstand 7, the Hardstand Pond, Beaver Pond, Tom's Pond (Figure 13) and Tom's Bayou (Table 7). No TCDD was detected in any of the samples collected from Tom's Bayou, Tom's Pond, or Beaver Pond. However a large snapping turtle (Figure 14) collected from the Hardstand Pond contained 1.5 ppb TCDD in fat tissue. TCDD was not detected in muscle, liver, or testes of the turtle, although it should be remembered that the detection limit in the liver tissue was high (0.260 ppb) due to high levels of interfering compounds. The turtle was not subjected to pathological examination, but no gross abnormal pathological findings were noted during visual observations. It is interesting and perhaps of some significance to note that the turtle was collected immediately after having been observed in the act of copulation. The fact that TCDD was found in fat tissue yet absent
