Vietnam: Environmental Remediation of Dioxin Contamination at Danang Airport

Progress Report: August 1, 2014 to August 31, 2014

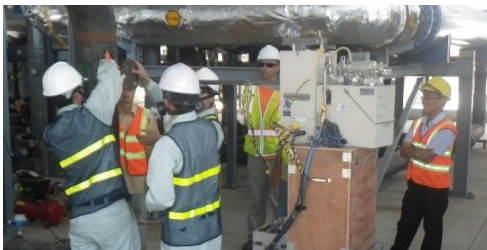
GVN collecting vapor samples from treatment system effluent Photo: CDM Smith)

USAID contractors conduct extensive monitoring, inspection and testing of environmental media (i.e., air, water, soil) to protect the environment and health and safety of the community outside the Project site. In close coordination with USAID, the Vietnamese Ministry of National Defense also conducts its own independent soil, air and water monitoring of Project activities.

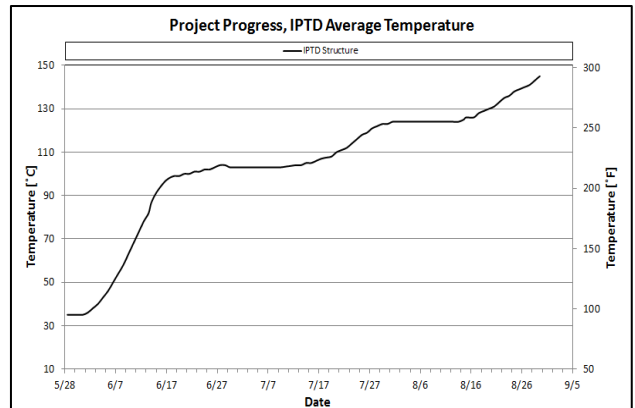
Temperature measurements inside the treatment structure (Graph: TerraTherm)

USAID contractors restarted the treatment system on August 8 by returning power to the heater cans throughout the treatment structure. After a controlled ramp up, full power in the heating system was reached on August 28.

The average temperature of the contaminated soil and sediment inside the treatment structure reached 145 degrees Celsius by the end of August, which is nearly halfway to the target treatment temperature of 335 degrees Celsius (the temperature to destroy dioxin). It is currently estimated that the target treatment temperature will be reached in mid-late October.

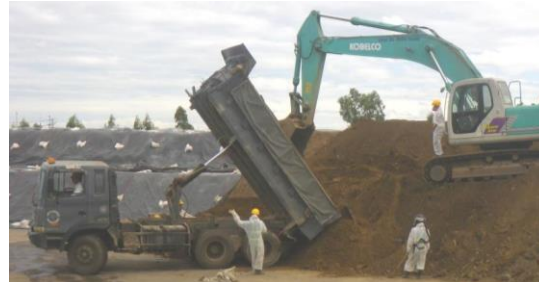
Stockpiling Phase 2 material (Photo: CDM Smith)

While Phase 1 soil and sediment is being treated, USAID contractors continued to excavate Phase 2 soil and sediment from Sen Lake and the surrounding wetlands in the northern portion of the Project site. The excavated material is being temporarily stored in two lined and covered piles while it awaits treatment.

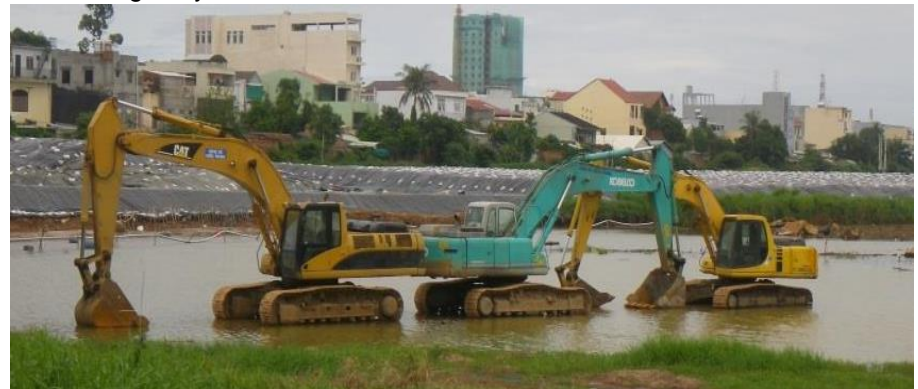
Sen Lake after heavy rain

With the Danang rainy season quickly approaching, remaining excavation activities have been suspended until the 2015 dry season. Preparations have begun to secure the site for the rainy season, including several erosion control measures.

The temporary stockpiles will be maintained and monitored for the duration of the Danang rainy season.

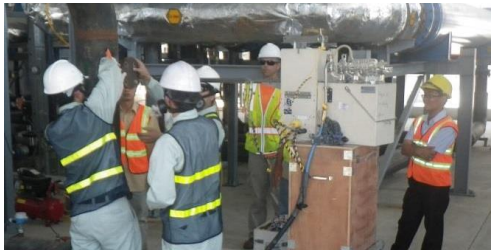
CPVN lấy mẫu hơi từ dòng chảy ra của hệ thống xử lý (Ảnh: CDM Smith)

Các nhà thầu của USAID quan trắc, kiểm tra và thử nghiệm rộng rãi môi trường (không khí, nước, đất) nhằm bảo vệ môi trường cùng sức khỏe và an toàn của cộng đồng bên ngoài vùng Dự án. Phối hợp chặt chẽ với các nhà thầu của USAID, Bộ Quốc phòng Việt Nam cũng thực hiện quan trắc độc lập các hoạt động của Dự án đối với đất,

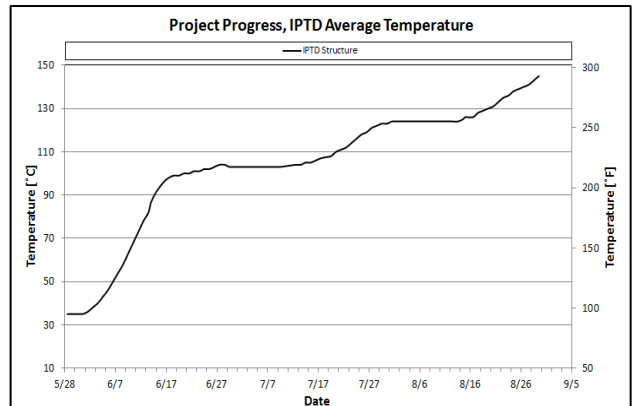
Nhiệt độ đo được bên trong kết cấu xử lý (Hình: TerraTherm)

Vào ngày 8/8/2014, các nhà thầu của USAID tái khởi động hệ thống xử lý bằng cách cấp lại nguồn điện cho các giếng truyền nhiệt được đặt khắp kết cấu xử lý. Sau thời gian khởi động được kiểm soát, vào ngày 28 tháng 8 hệ thống xử lý đã đạt được đủ công suất điện.

Vào cuối tháng 8, nhiệt độ trung bình của đất và bùn trong kết cấu xử lý đạt 145 độ C, đạt gần ½ mức nhiệt độ xử lý cần thiết 335 độ C (mức nhiệt độ để phá hủy dioxin). Dự kiến đến nửa cuối tháng 10 sẽ đạt đến nhiệt độ xử lý cần thiết.

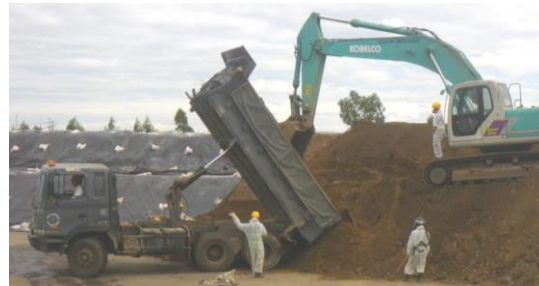
Tập kết vật liệu Giai đoạn 2

Trong khi đất và bùn Giai đoạn 1 đang được nung nóng, các nhà thầu của USAID tiếp tục đào xúc đất và bùn Giai đoạn 2 từ Hồ Sen và vùng đất ngập phía bắc khu vực Dự án. Đất và bùn đào xúc được tập kết tạm thời ở hai bãi được lót nền và che phủ trên bề mặt trong khi chờ xử lý.

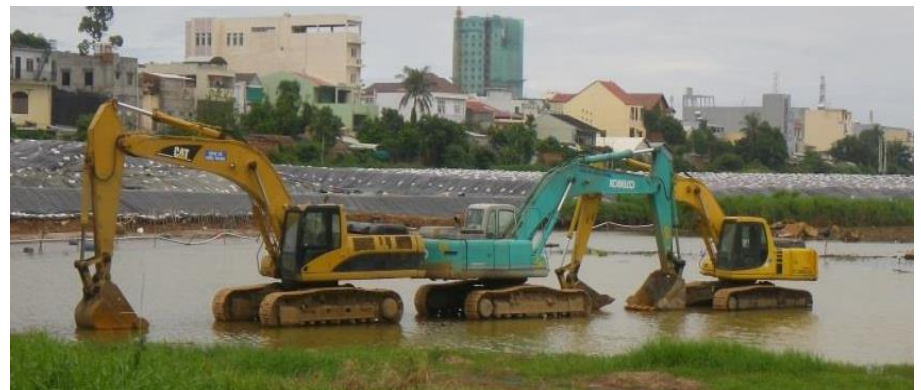
Hồ Sen sau cơn mưa lớn

Trong khi mùa mưa ở Đà Nẵng đang đến nhanh, các hoạt động đào xúc còn lại tạm thời được dừng lại chờ đến mùa khô năm 2015. Công tác chuẩn bị nhằm bảo vệ công trường trong mùa mưa, bao gồm cả các biện pháp kiểm soát sự xói lở đang được bắt đầu tiến hành.

Hai bãi tập kết tạm sẽ được duy trì và theo dõi trong suốt mùa mưa ở Đà Nẵng.
