Progress Report: February 1, 2013, to February 28, 2013

USAID contractors continued implementing the Environmental Remediation of Dioxin Contamination at Danang Airport project launched in August 2012.

CONSTRUCTION – THERMAL DESORPTION TREATMENT PILE CONTAINMENT STRUCTURE

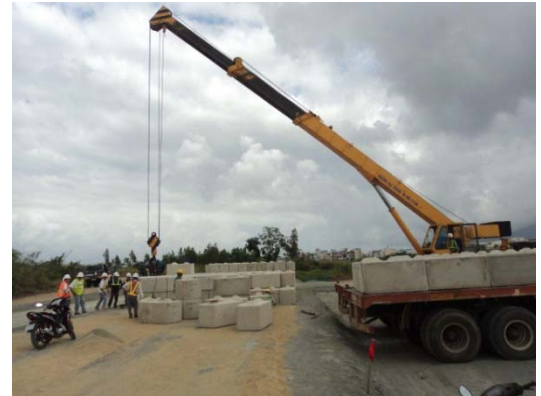
As of February 28, 2013, USAID contractors had established approximately 85% of the pile structure foundation. The walls of the pile containment structure are being built out of concrete masonry unit (CMU) blocks manufactured in Danang. Thus far, USAID contractors have made 5,206 CMU blocks and began erecting the walls of the pile containment structure in February 2013.

Constructing walls of the pile containment structure with CMU blocks
(Photo: CDM Smith)

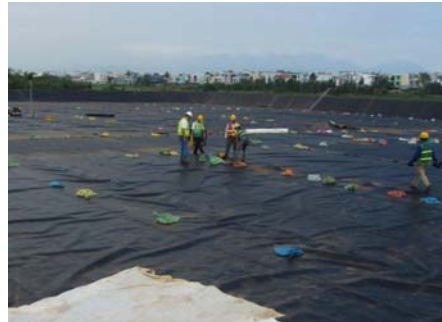
USAID contractors are constructing a drying pad to hold dioxin-contaminated sediments excavated from Sen Lake and associated wetlands. High-density polyethylene (HDPE), a very strong, thick plastic material, will line the bottom of the drying pad to prevent water draining from the contaminated sediments from being released into the environment. All water will be captured in a sump inside the drying pad and tested before it is discharged.

Installing HDPE liner at the bottom of the drying pad
(Photo: CDM Smith)

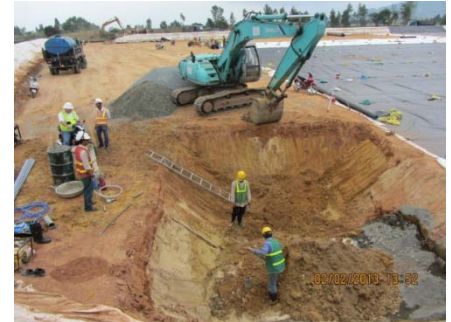
Constructing the sump in the drying pad to capture water
(Photo: CDM Smith)

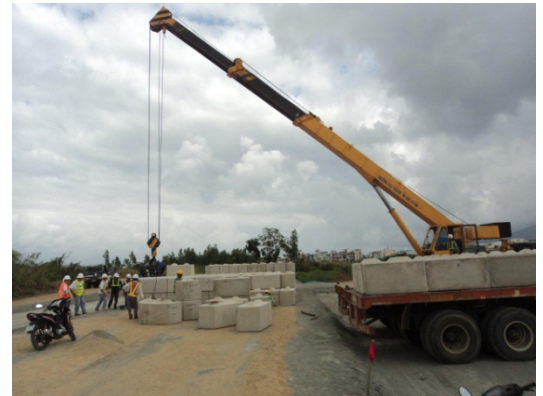
Tính đến ngày 28/2/2013, các nhà thầu của USAID đã hoàn tất khoảng 85% phần nền cho kết cấu của mố. Các bức tường của kết cấu mố đang được lắp đặt bằng những khối bê tông CMU được sản xuất tại Đà Nẵng. Cho đến nay, các nhà thầu của USAID đã sản xuất được 5.206 khối bê tông CMU, và vào Tháng Hai năm 2013 đã bắt đầu lắp đặt tường của kết cấu mố.

Lắp đặt tường của kết cấu mố bằng khối bê tông CMU
(Ảnh: CDM Smith)

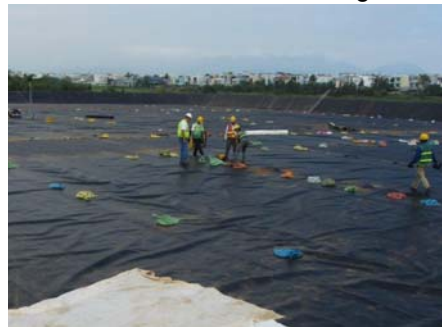
Các nhà thầu của USAID đang thi công sân phơi để tập kết bùn nhiễm dioxin sẽ được đào lên từ Hồ Sen và các khu đất ngập. Nhựa polyetilen mật độ cao (HDPE), loại vật liệu dày và rất dai, sẽ được dùng để lót đáy sân phơi nhằm ngăn nước rỉ từ bùn bị nhiễm bẩn thoát ra môi trường. Tất cả các loại nước sẽ được thu vào một bể gom bên trong sân phơi, và sẽ được thử nghiệm trước khi cho xả ra môi trường.

Lắp đặt lớp nhựa HDPE trên đáy sân phơi
(Ảnh: CDM Smith)

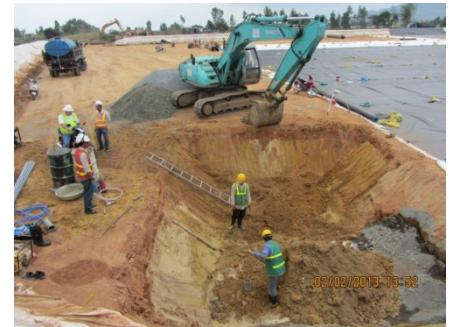
Thi công hồ gom trong sân phơi để thu gom nước
(Ảnh: CDM Smith)
