This is a current satellite photo of the POL area at Andersen AFB, Guam. There has been some changes in the last forty years but many things are the same. The yellow square marks one of the drum storage lots used by the POL squadron.

Site No. 27
Hazardous
Waste
Storage
Area No.1
(HW-1)

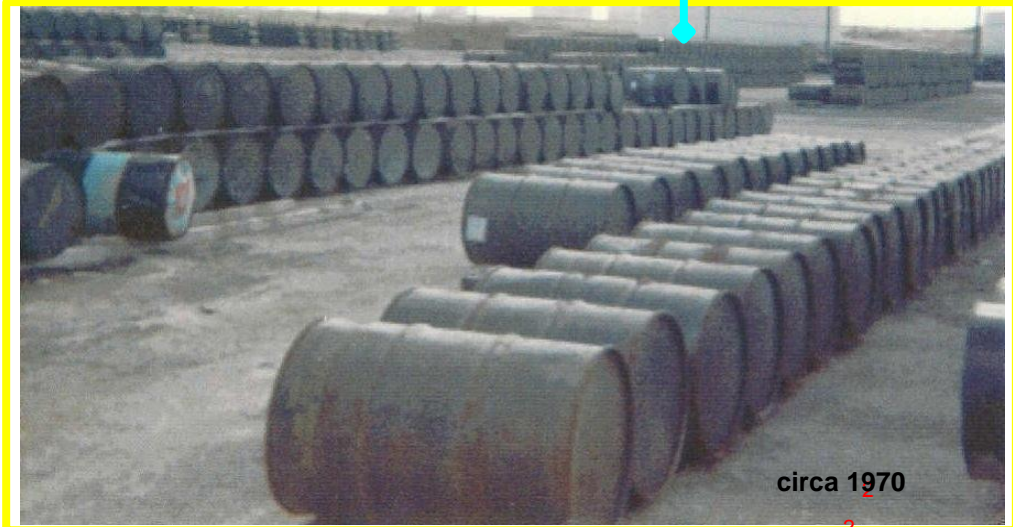
Here is a photo from circa 1970 inside the drum storage lot showing the fuel storage tanks in the back ground. This later became EPA Super-fund Site # 27. The site is outline in yellow, above.
