HHRA No. 39-DA-0ESM-11, Camp Carroll, Teagu, South Korea, 15 Jun through 16 Aug 11

APPENDIX H  
GEOPHYSICAL REPORT

## **SLOPE SITE GEOPHYSICAL SURVEY REPORT**

### **Camp Carroll** **U.S. Army Garrison Daegu, Republic of Korea**

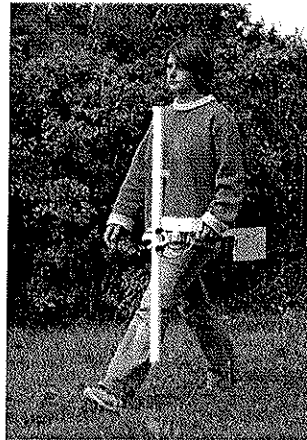
#### Magnetic Gradiometer(Bartington Instruments Co., Ltd England)

Grad601 single-sensor

- Fluxgate sensor
- Selectable 0.01nT or 1nT resolution
- 125k readings
- Low power : 24 hour operation

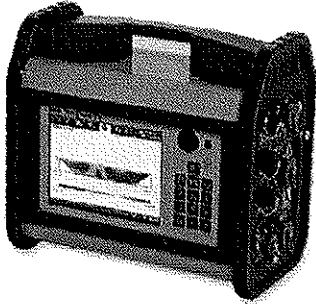
<p>Terrameter LS</p> <ul style="list-style-type: none"> <li>- Output : 2,500 mA</li> <li>- Ch. No. : 12 Channel Auto.</li> <li>- USB port(2EA)</li> <li>- LAN(PC connect)</li> </ul>

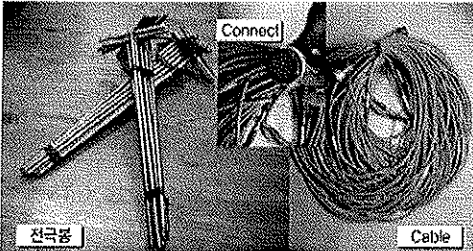
<p>Poles &amp; Cables</p>

<p>Dipro for Windows v.4.0</p>
<p>Electric Poles(41pcs) Cables(21 take out, 2set)</p> <p>Interpretation S/W</p> <ul style="list-style-type: none"> <li>- Dipro for Windows v.4.0</li> </ul>
