# **Letter Health Consultation**

**Evaluation of Physical Hazards at the Tarheel Army Missile Plant (TAMP) Site**

**TARHEEL ARMY MISSILE PLANT (TAMP) SITE**

**ALAMANCE COUNTY, NORTH CAROLINA**

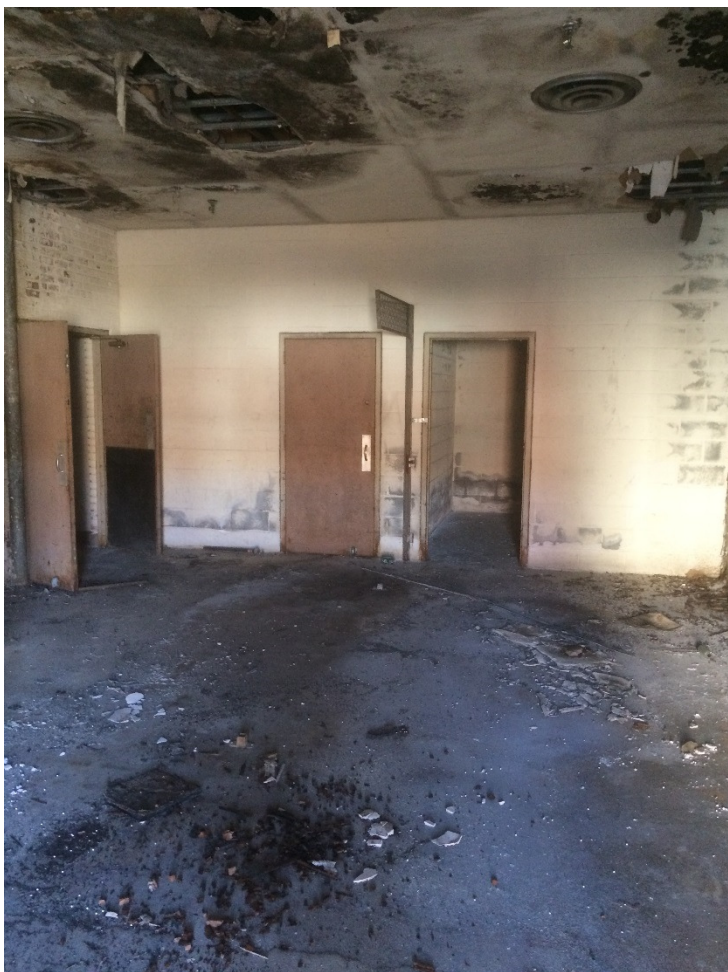
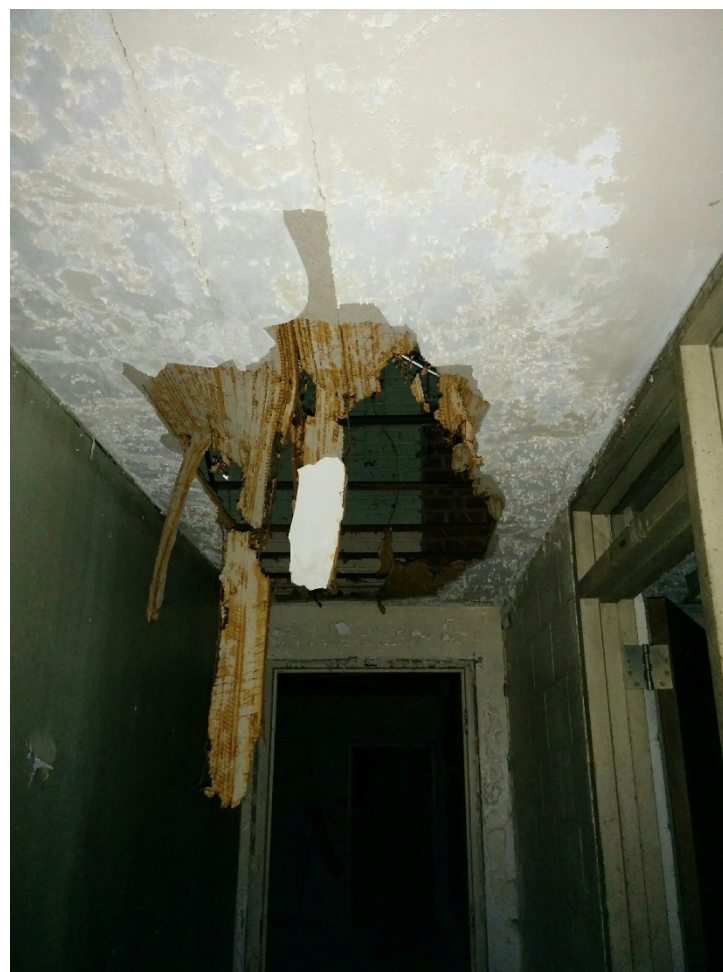
**Photos 1 & 2.** Evidence of deteriorating ceiling and falling debris in Building No. 2. Source: DPH, October 25, 2016.

- property owner immediately restricts remedial workers' access to the buildings on-site until roofs and other potentially falling materials are stabilized or removed. Due to the age of the buildings on site, the presence of asbestos in building materials should be evaluated prior to any demolition or remodel work.

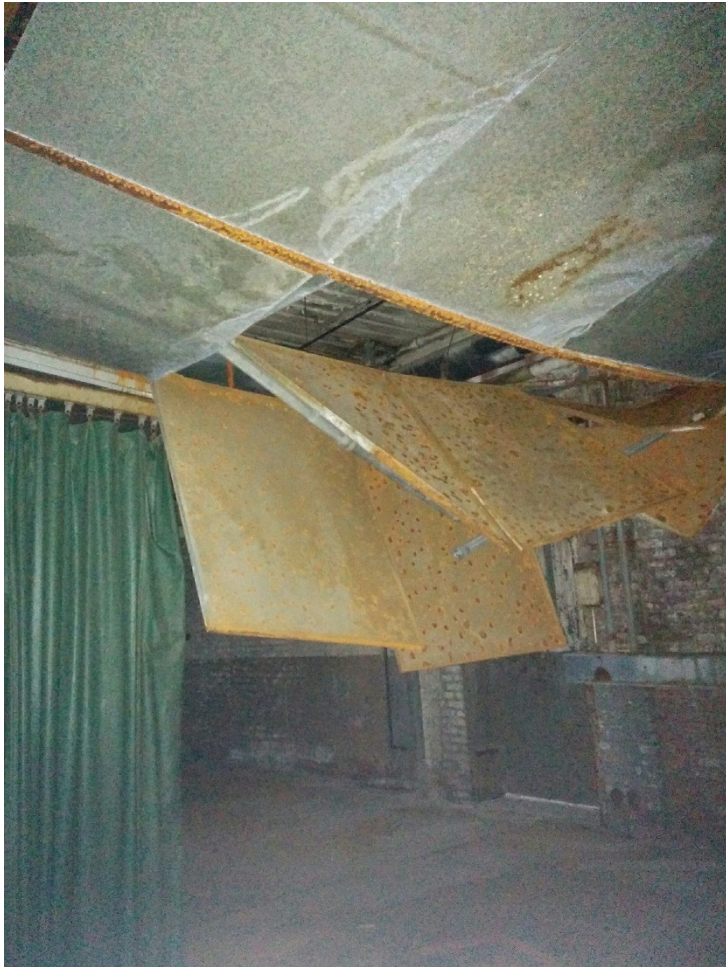
As shown in the photos provided in Attachment B, many physical hazards exist on the site for trespassers and workers, and evidence shows that the site is frequently accessed. The roofs in Buildings No. 1, 2, 3 and 4 are caving in and collapsing under the weight of large air conditioning units on top of the buildings. Additionally, ceiling tiles in these buildings are degrading and electric fixtures have begun to fall from the ceiling. Portions of the interior wall of Building No. 4 are beginning to collapse. Building 16 contains large sharp metal poles hanging from the ceiling, which could pose a threat given the deteriorating ceilings and roofs. Due to the age of the buildings on site, the presence of asbestos in building materials should be evaluated prior to any demolition or remodel work.

**Photo 3 (left).** Collapsing roof in Building No. 2. Source: DPH, October 25, 2016.

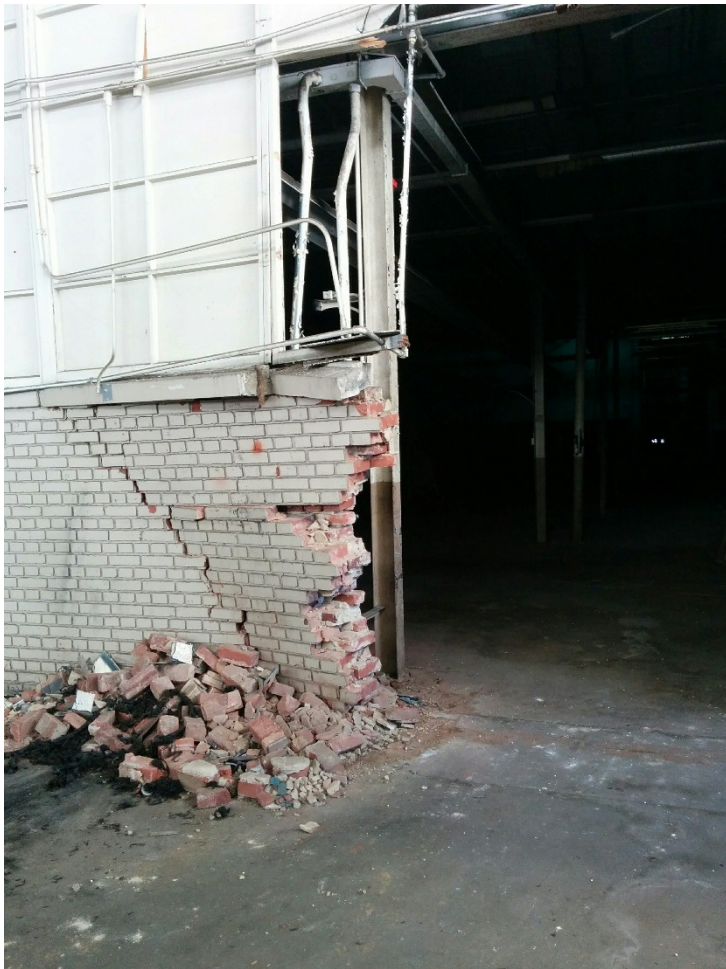
**Photo 5 (left).** Collapsing interior wall on Building No. 4. Source: DPH, October 25, 2016.

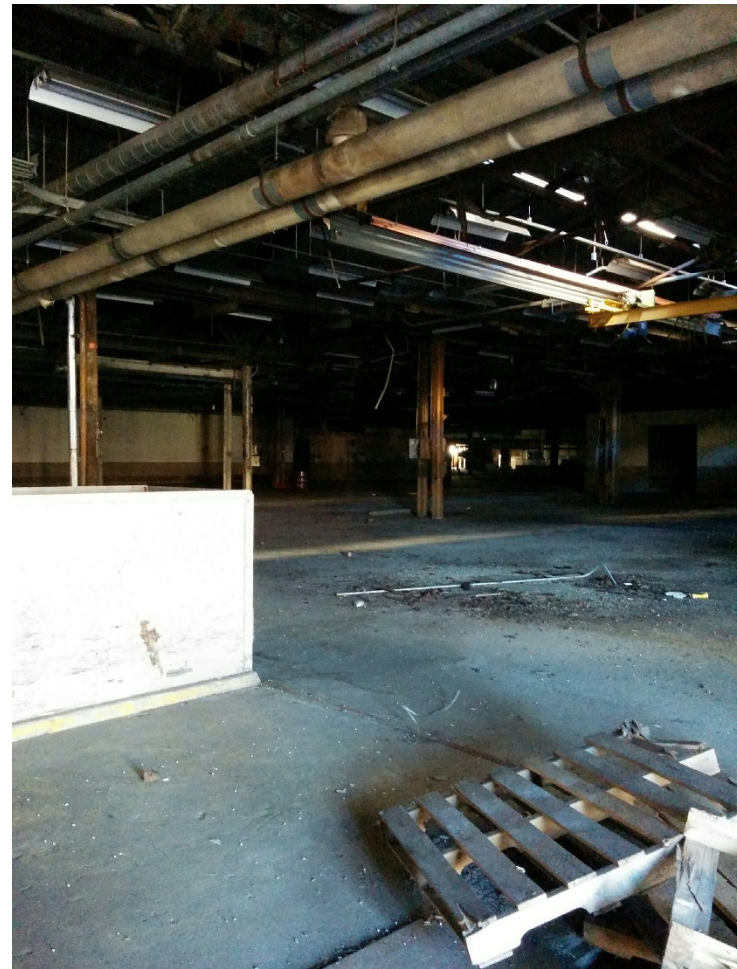
In addition to the physical hazards posed by collapsing buildings, sharp debris scattered throughout central site areas and walking paths is a health hazard due to the potential of being cut or punctured while walking around the site. Broken glass, broken wood, loose bricks, large empty barrels, other debris and unmarked wellheads pose a tripping hazard, which could lead to serious injury to trespassers or workers. Finally, the site currently has no electricity and most buildings lack natural light, making it difficult to navigate the property safely.

**Photo 6 (right).** Debris strewn on floor in Building No. 2. Source: DPH, October 25, 2016.

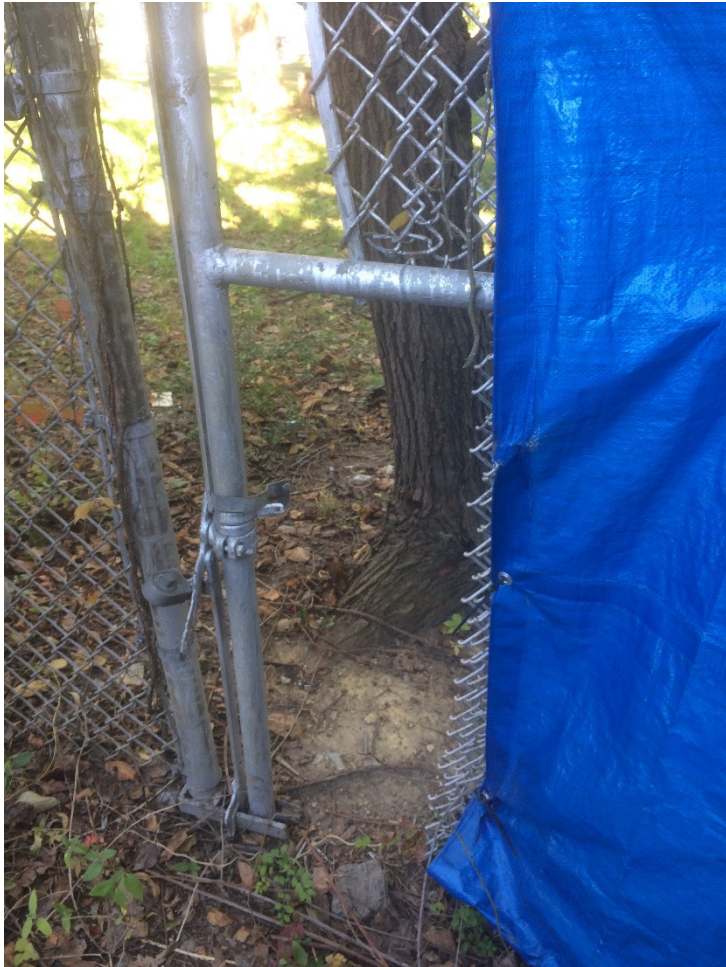
While visiting the site, DPH staff noticed a large hole in the fence located in the northwest corner of the property near Building No. 22 and neighboring residents, indicating that trespassers are gaining access to the site. Additionally, the property has a known history of being trespassed on. While DPH staff were on site, they were not required to wear any PPE or take any precautions while moving about the site. All buildings were able to be accessed and no areas of the site were blocked off due to potential hazards. Finally, a recreational event was held on site in October 2015, with people accessing many of the buildings on site for the event, even in their unsafe condition.

**Photo 7 (left).** Hole in fence surrounding property in northwest corner near residences. Source: DPH, October 25, 2016.

- property owner immediately restrict access to the site to only those who are involved in the site investigation or remedial activities. This includes repairing any breaches in the fence surrounding the site and monitoring the fence to ensure trespassers cannot gain access to the site.

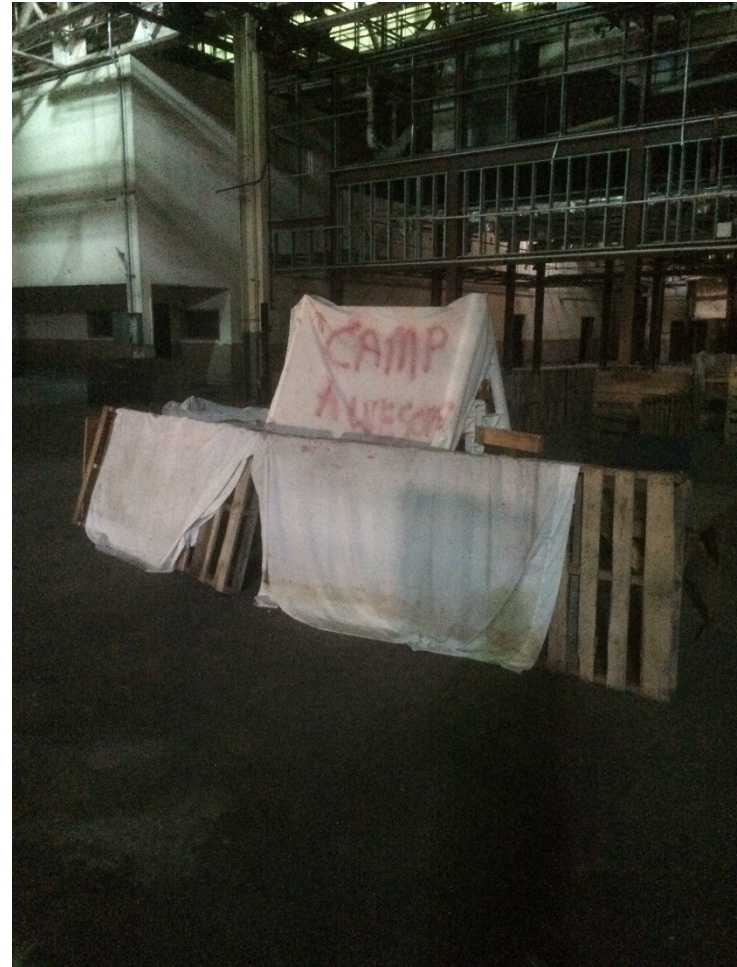
**Photo 8 (right).** Materials remaining from recreational event held on-site in October 2015. Source: DPH, October 25, 2016.
