INSTALLATION RESTORATION PROGRAM

PHASE I - RECORDS SEARCH

LACKLAND AFB TEXAS

FEBRUARY 1985

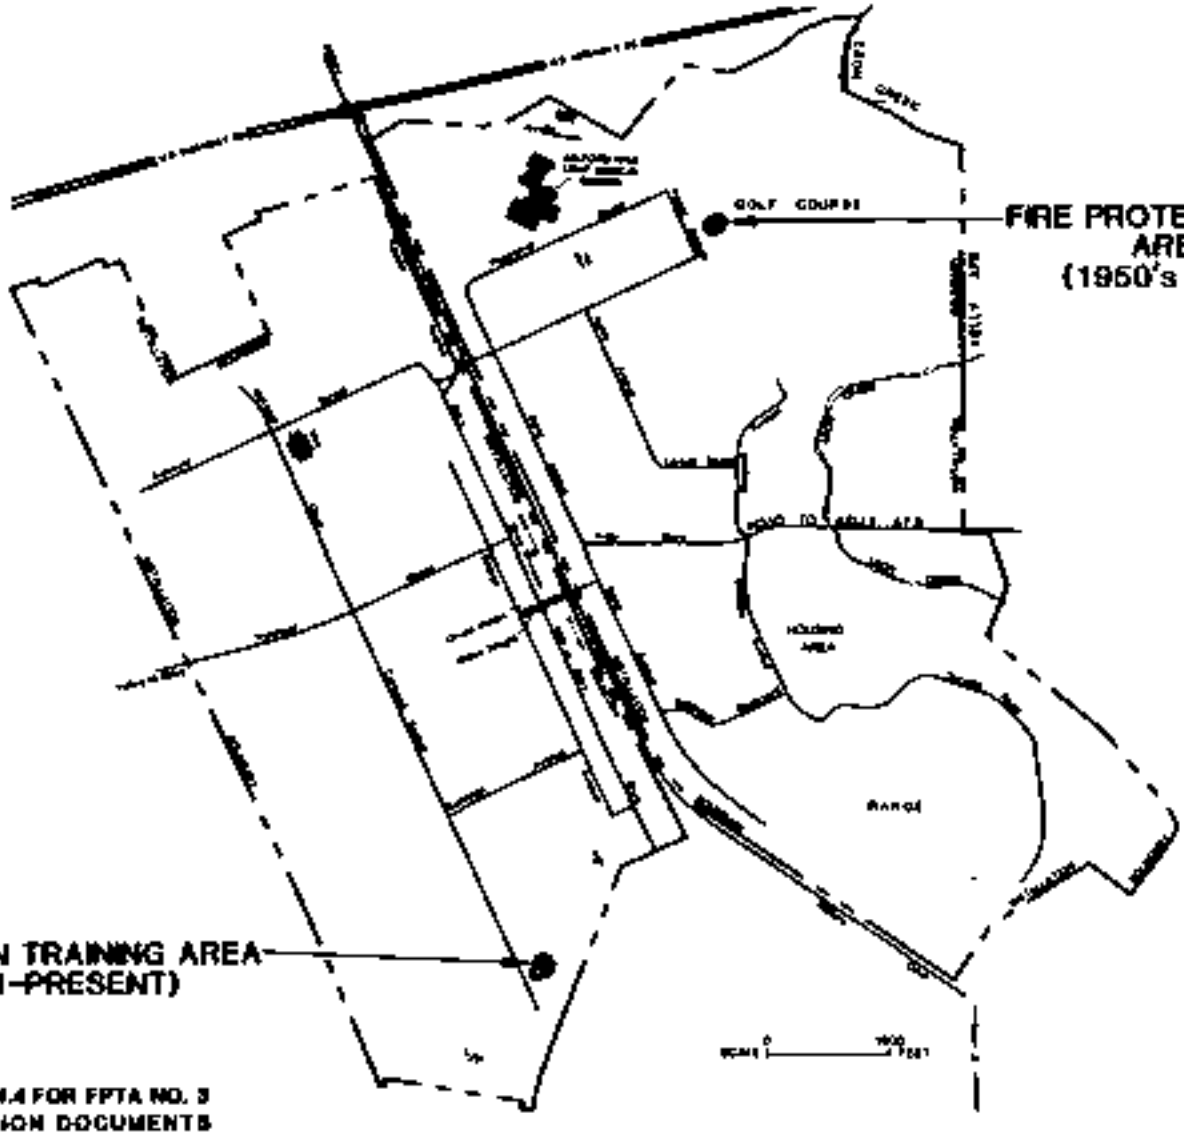
FIGURE 4.3

Fire training activities have been conducted at two locations at Lackland AFB (Figure 4.3). The earliest one known to have operated was located about where Building 2850 now exists. Fire Protection Training Area (FPTA) No.1 was utilized sporadically in the 1950's and 1960's. The site consisted of an old building and a fire pit. Wooden pallets and other solid materials were used to fuel training fires conducted in the building. Waste oils and other liquid industrial wastes (such as solvents) were used for fueling fires in the pit. The frequency of training activities typically consisted of about two fires at the pit per year. For each fire approximately three to four drums of waste liquid were poured on the ground; no water was applied to the ground before the waste liquid.

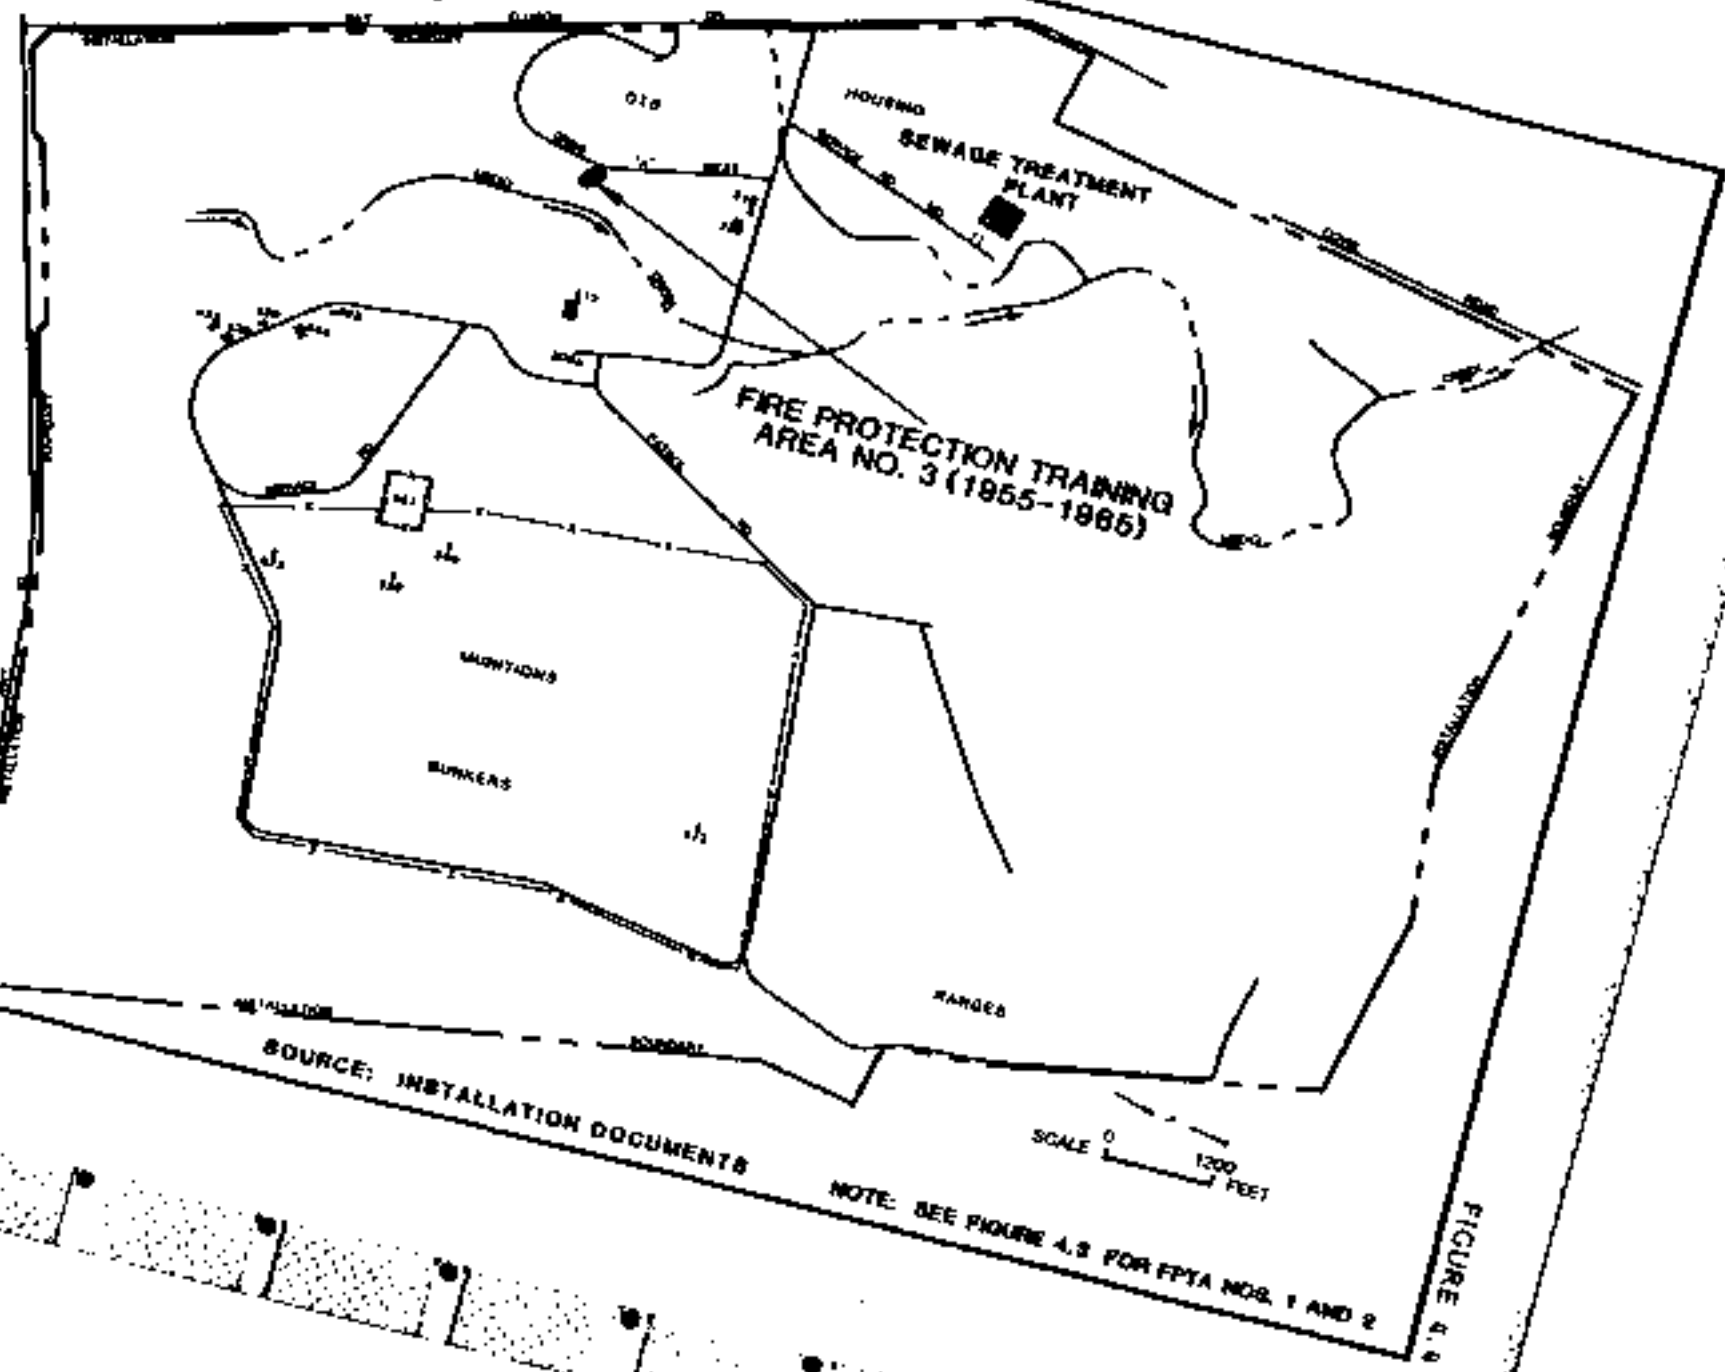
FIGURE 4.6

Fire training activities at the Lackland TA were conducted at one site, FPTA No. 3 in Figure 4.4. The fire training occurred only during the AEC operations (1955-1965) and ceased when the Air Force took over the Medina facility. The training fires were conducted twice a year in a shallow trench about 100 feet long. Two fires were utilized per training exercise or a total of four per year. The fuel was normally supplied by a petroleum company and did not consist of waste liquids from either the AEC operations or Lackland AFB. The fuel used was usually fuel oil. To produce each fire, about 300 to 500 gallons were poured into the trench and ignited without prior soaking of the ground with water. Water was the only extinguishing agent used.

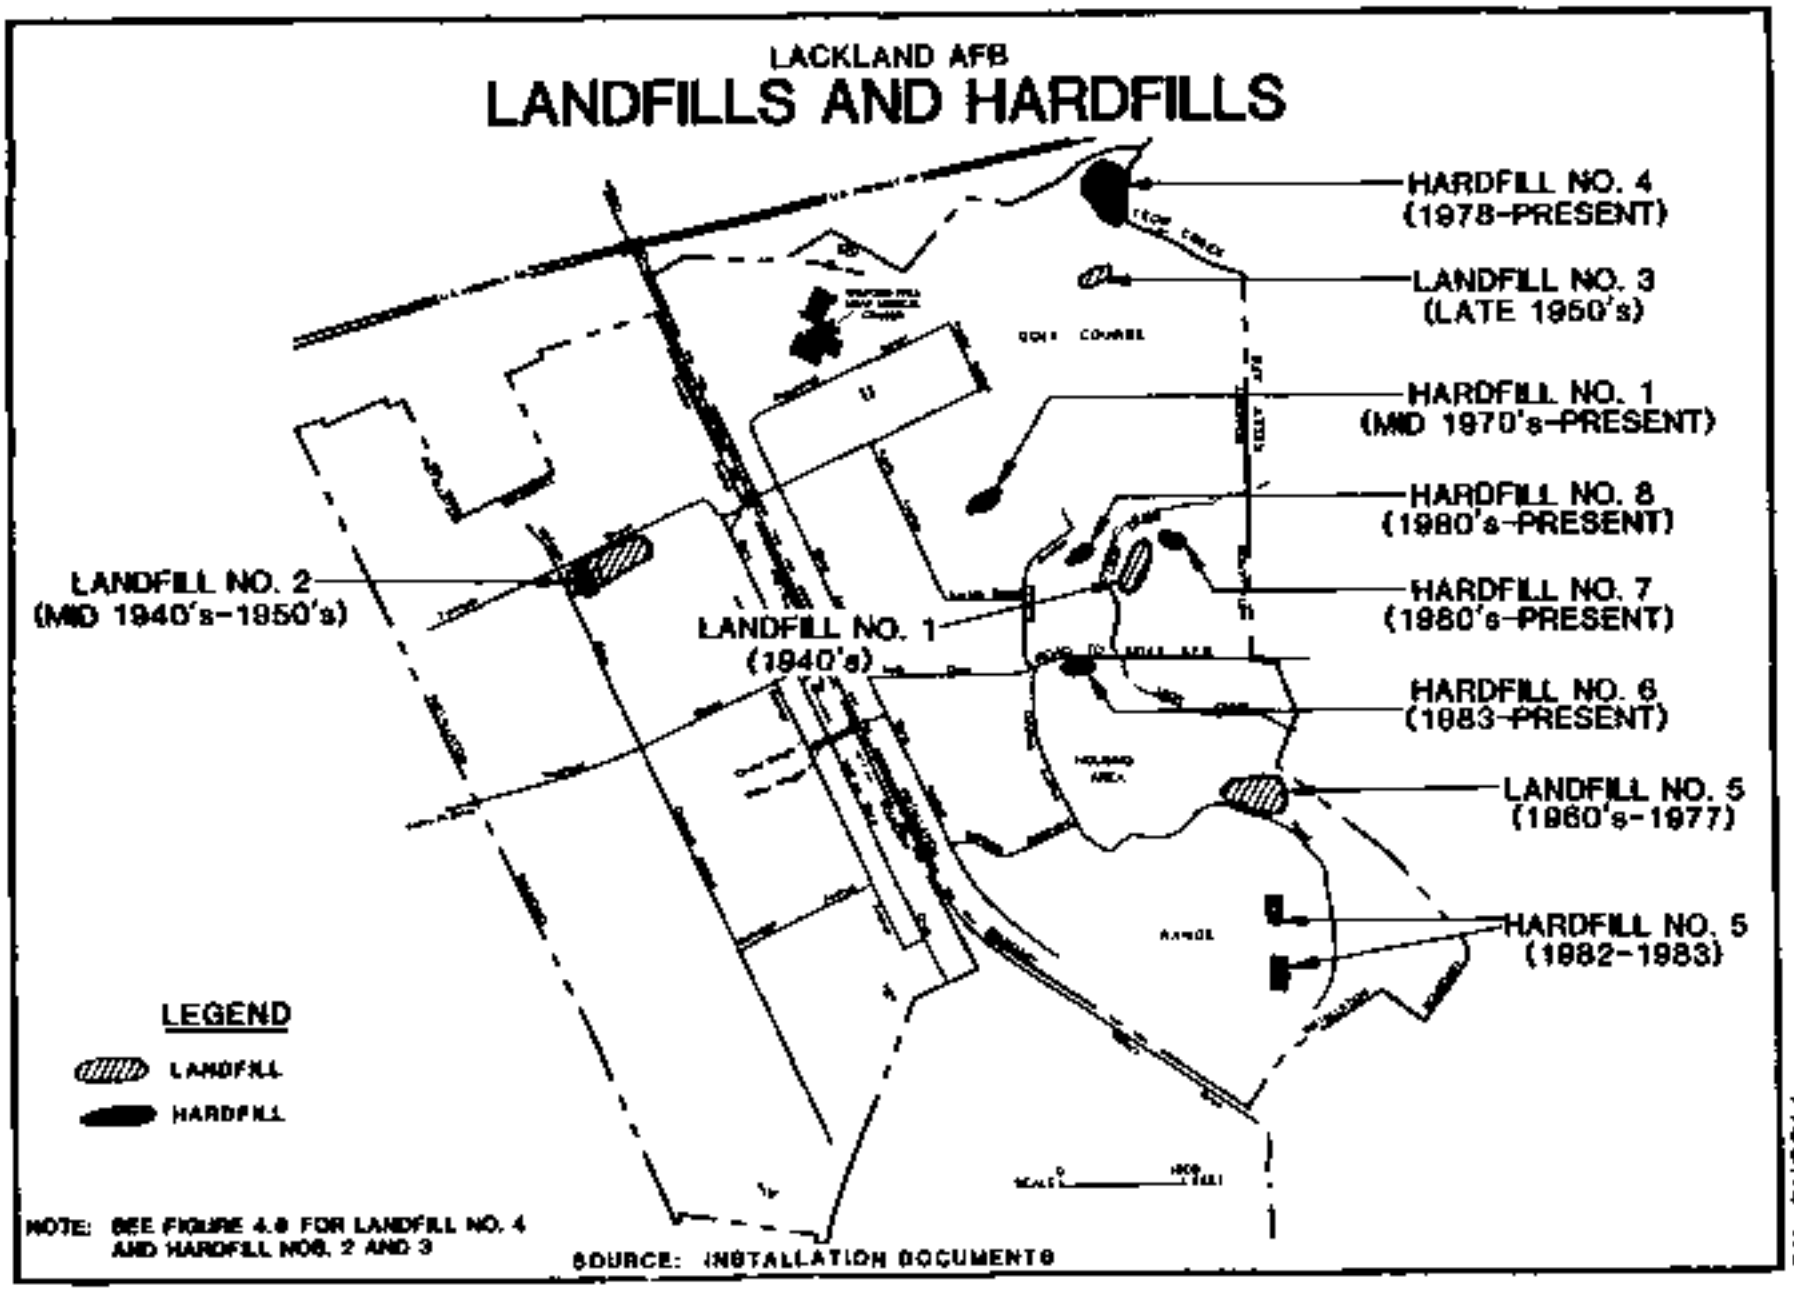
FIGURE 4.5

The second landfill serving the base was located on the site area under and between Facility Nos. 9085, 6590, 6690 and 6691. Landfill No. 2, shown in Figure 4.5, operated from the mid 1940's until the late 1950's. Aerial photographs confirm this general operating period. Wastes received were primarily garbage and refuse. Some empty five-gallon containers were noted by an interviewee but the hazardous materials are believed to be minimal at this site. It was indicated that some refuse from Kelly AFB may have been brought to this site during the 1950's in addition to wastes from Lackland AFB. The filling at this site was to a depth of about 15 feet. An area fill method was apparently used. Table 4.4 summarizes the landfill operations for both Lackland AFB and Lackland TA.

Landfill No. 3 (Figure 4.5) was a small single trench operation at Lackland AFB reported by an employee. This site was operated about two to three years in the late 1950's (concurrently with Landfill No. 2) and

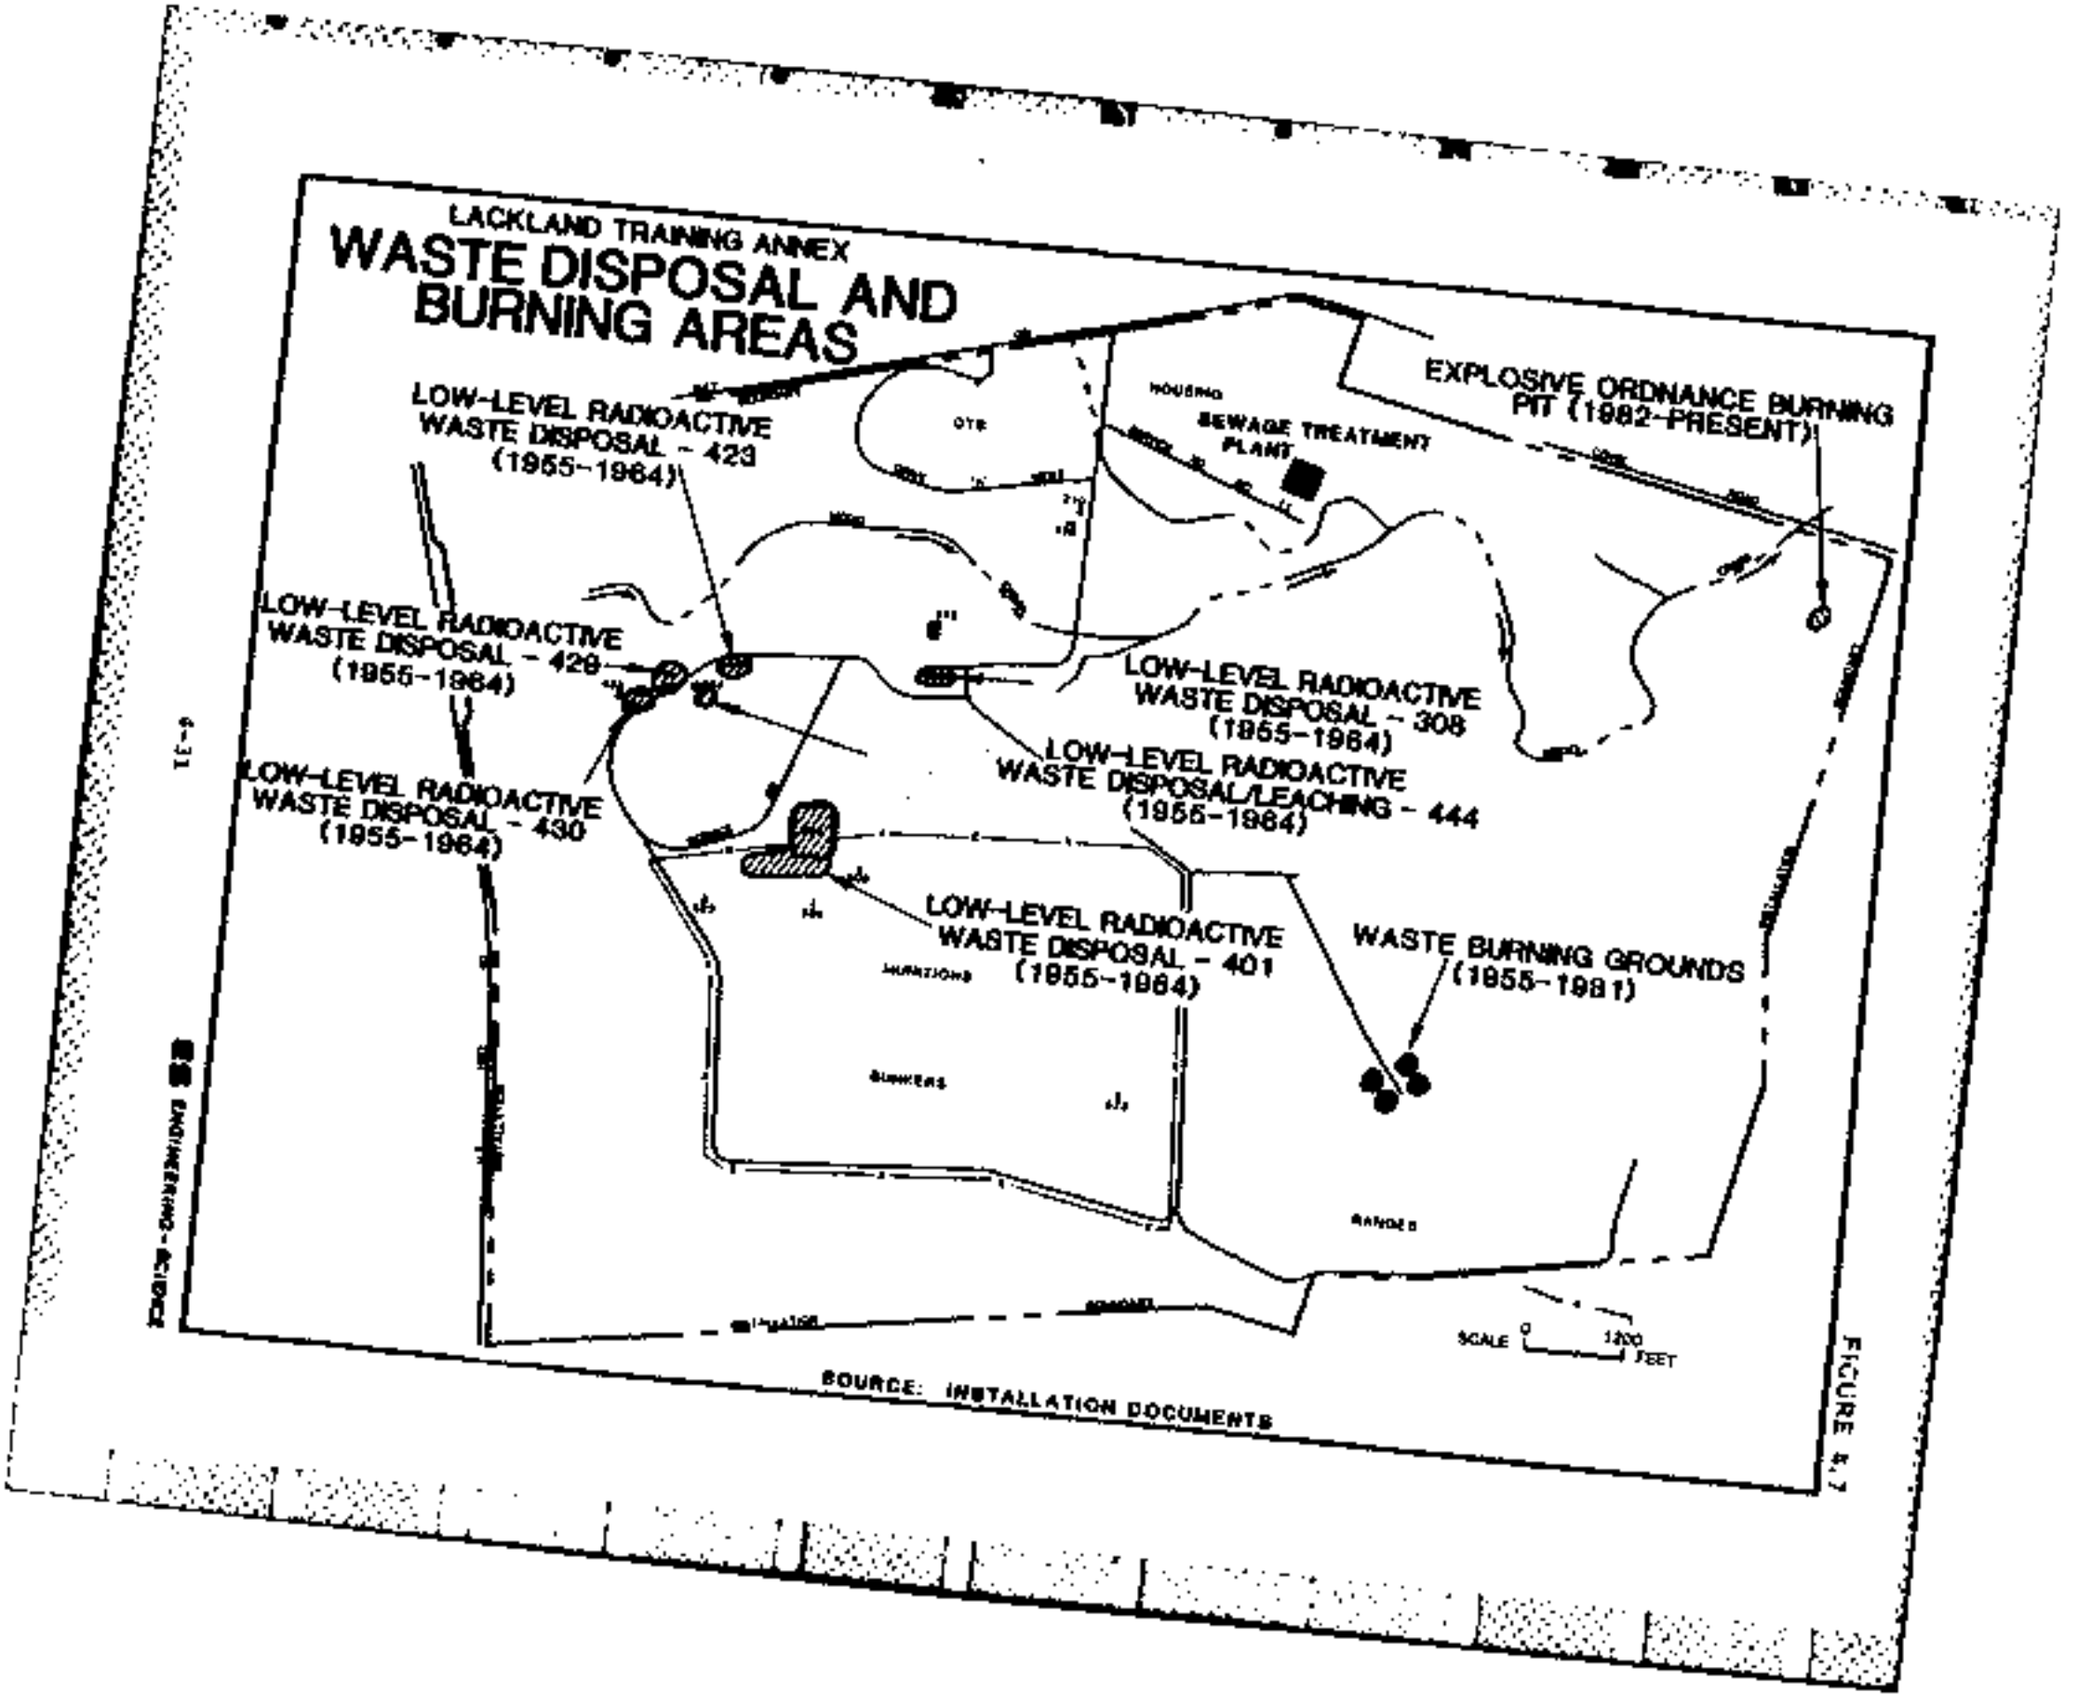
The wastewater storage tanks (308, 423 and 430) are connected to adjacent buildings by floor drains. There are no outlets for these tanks and in practice, they function as holding vessels. The 429 pit was designed to receive dry wastes. A former employee indicated the wastewater discharged to the tanks was very infrequent but the quantities discharged or the number of times they were pumped out are not known. The composition of wastes going to these four facilities is not available. They reportedly received low-level radioactive wastes generated as a part of the weapons maintenance by AEC. The results of analyses conducted in 1971 on two one-gallon samples of the 430 tank contents are presented in Table 4.6. Based upon these analyses, the USAF Radioisotope Committee recommended the tanks be drained to the sanitary sewer system; however, no data is available to indicate whether the tanks were drained or whether any subsequent sampling ever occurred. The tanks have not been tested for leakage since the access pipes are below ground.

In addition to the four facilities described above, Facility 401 was identified on a Real Property map as a low-level radioactive disposal area. However, other correspondence notes that the 401 site was rumored to be the location of a munitions bunker which burned, but no documentation is available to substantiate this. Early correspondence

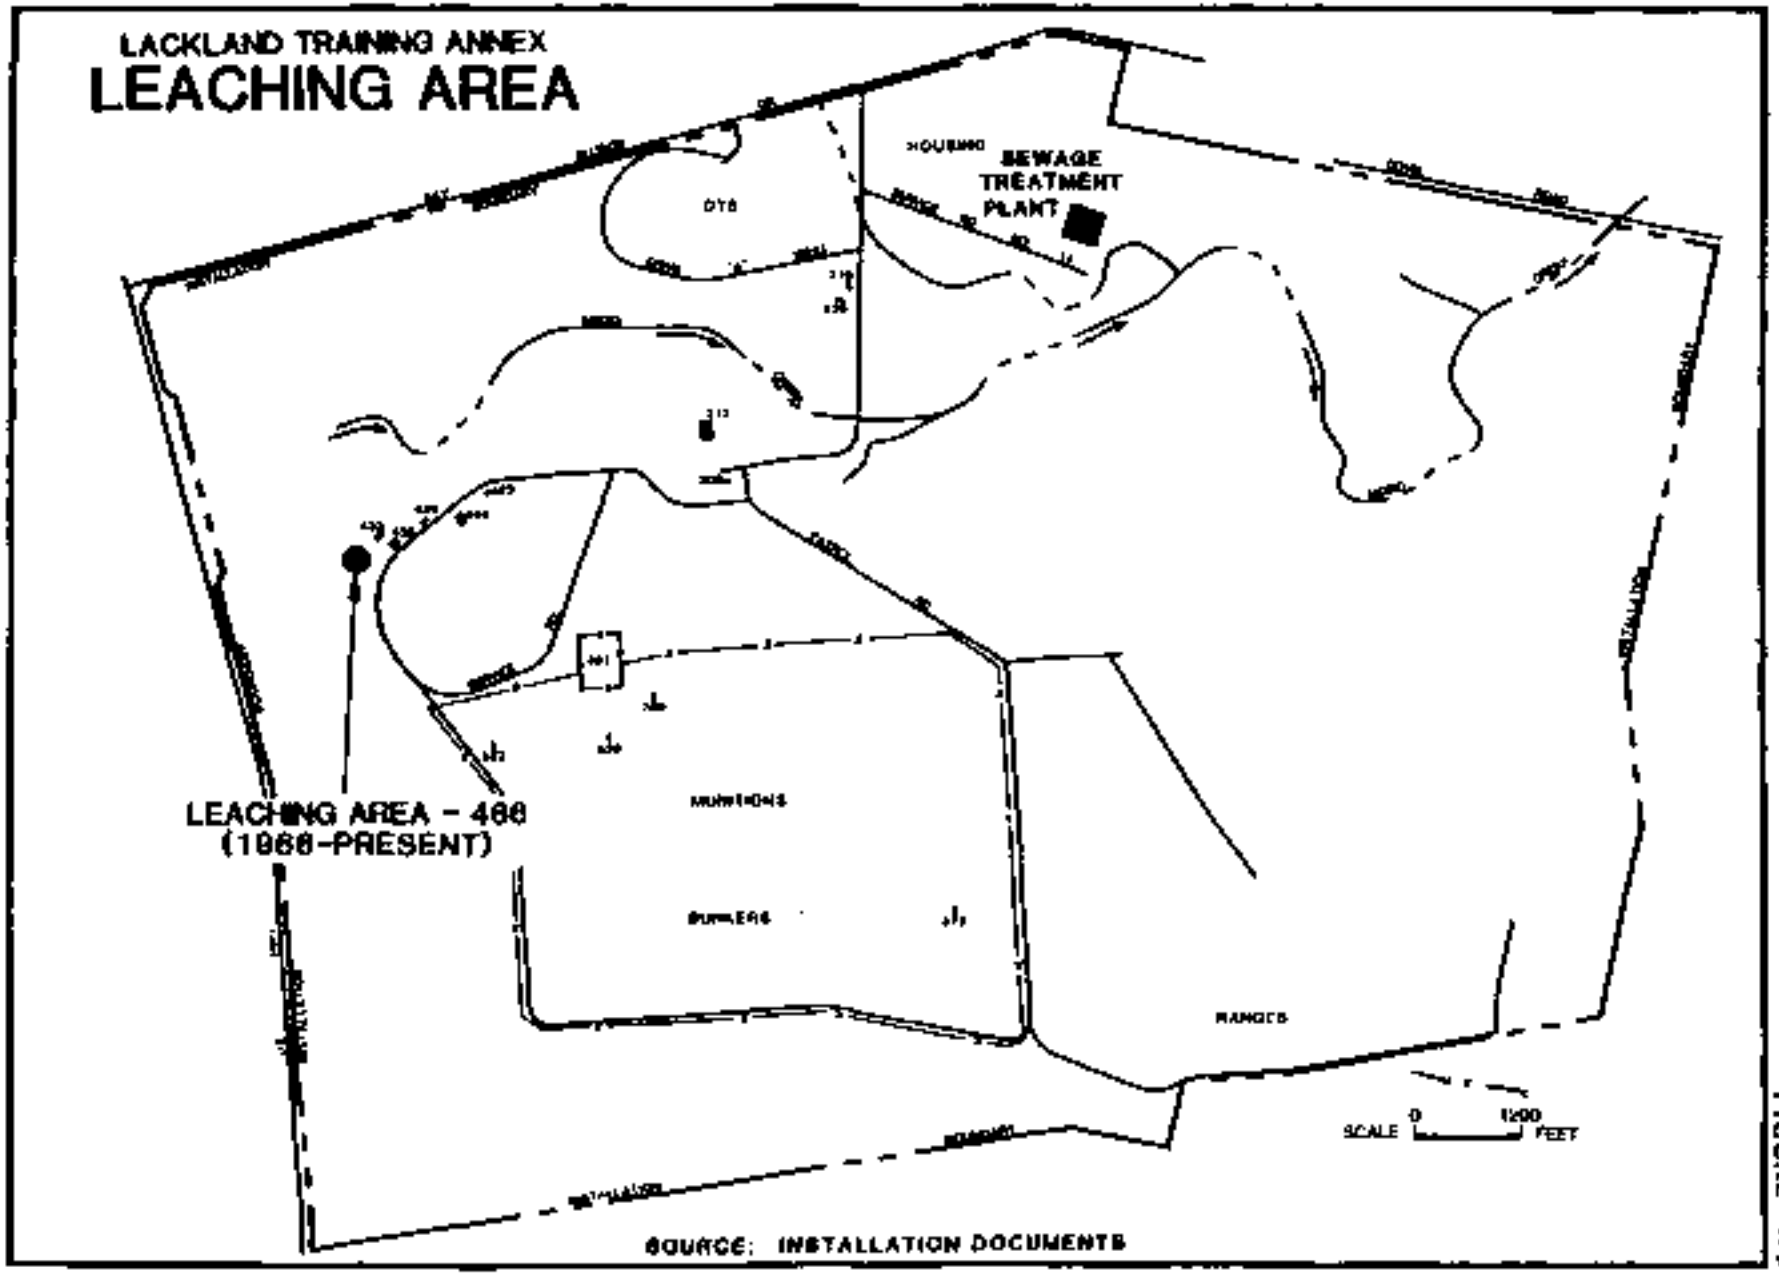
FIGURE 4.9

LACKLAND TRAINING ANNEX
LEACHING AREA
SEWAGE TREATMENT PLANT
LEACHING AREA - 466
(1966-PRESENT)
MUNITIONS
BUNKERS
RANGES
SCALE 0 1200 FEET
SOURCE: INSTALLATION DOCUMENTS
