Report/Article Title Minutes: A/A45Y-1 Internal Defoliant Dispenser System Support Conference, 25 and 26 August 1966

A/A45Y-1 INTERNAL DEFOLIANT DISPENSER SYSTEM

SUPPORT CONFERENCE

25 AND 26 AUGUST 1966

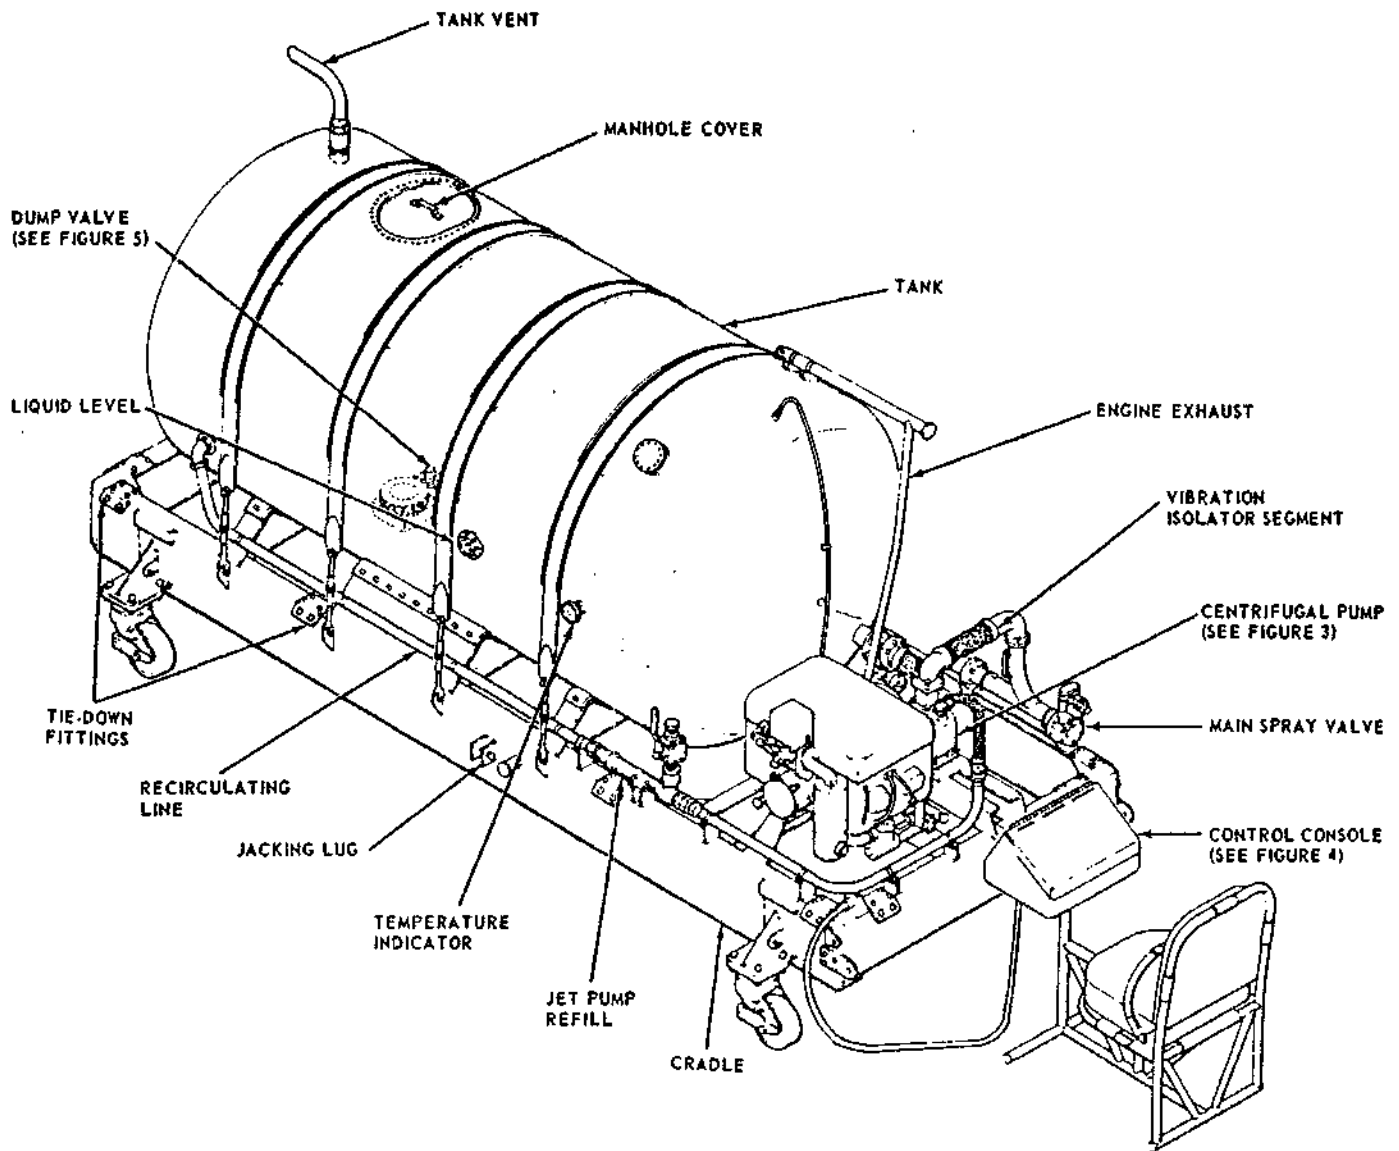
Figure 1. Major Components of Defoliant Dispenser

The internal defoliant dispenser is capable of containing 1000 gallons of defoliant which can be completely dumped overboard by remote control or manually in less than 45 seconds. The pump is capable of maintaining 60 ± 5 psi pressure during the normal 3- to 4-minute period of operational spraying. Refilling the tank assembly is accomplished with power and equipment contained within the defoliation dispensing system.

NOTE:
SEE FIGURE 6 FOR TAIL
BOOM AND FIGURE 7 FOR
WING BOOM. FIGURES 8
AND 9 SHOW A/A45Y-1
INSTALLED IN C-123 AIRCRAFT.

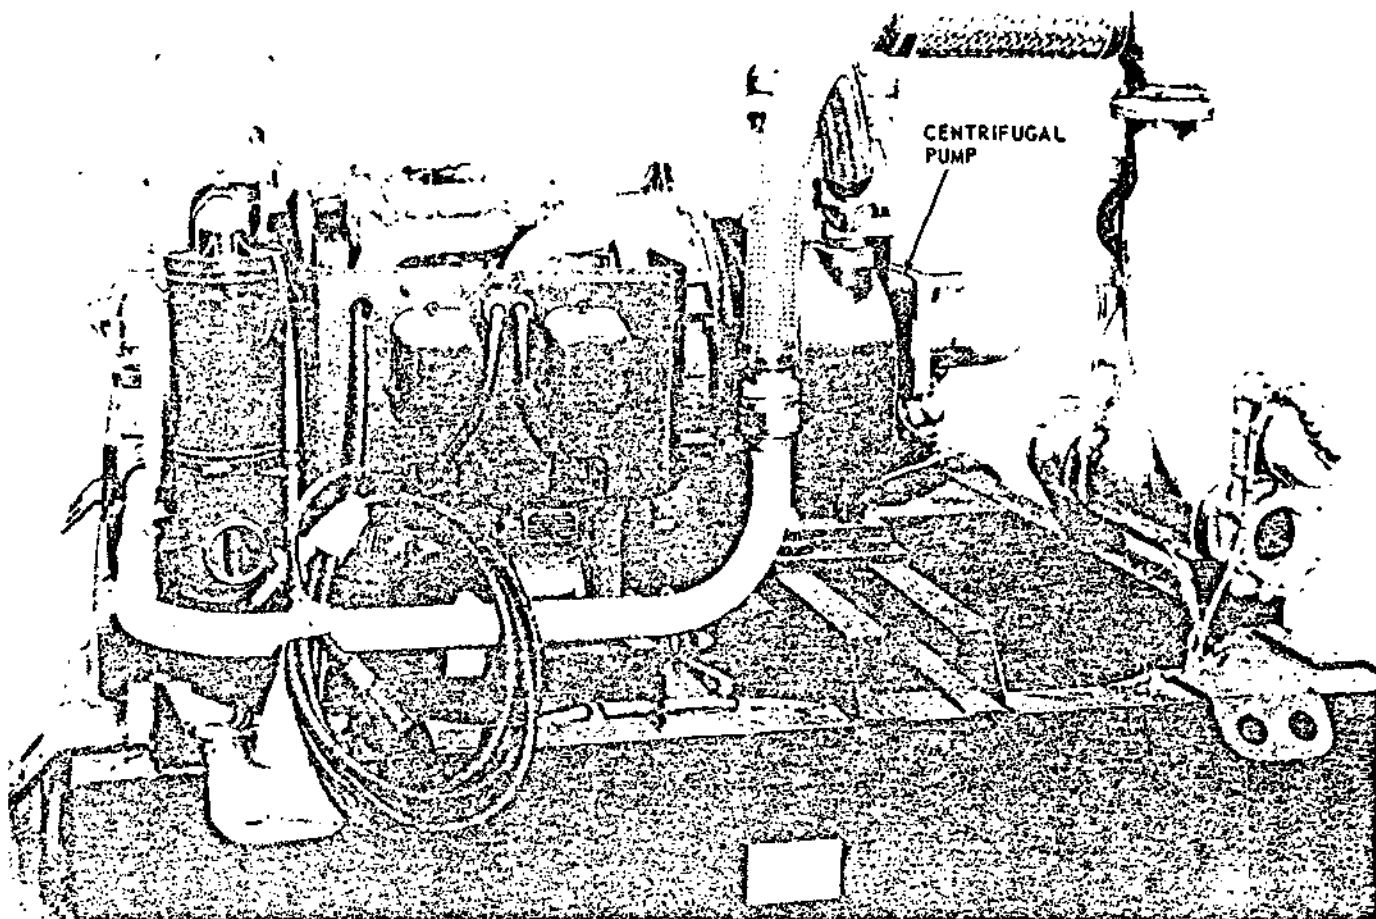
Figure 3. Centrifugal Pump

The centrifugal pump consists essentially of an impeller and a pump body, and is driven by the engine through a direct drive. The engine drives the pump and the speed of the engine controls the quantity of defoliant being dispensed. (See figure 3.)

The tank and cradle assembly is the major unit of the entire system, having a 1000-gallon tank with baffles, manhole, tube connections, and stabilizing and tie-down brackets; an engine and pump assembly which consists of a four cylinder, horizontally opposed air-cooled, engine and pump directly coupled to the engine

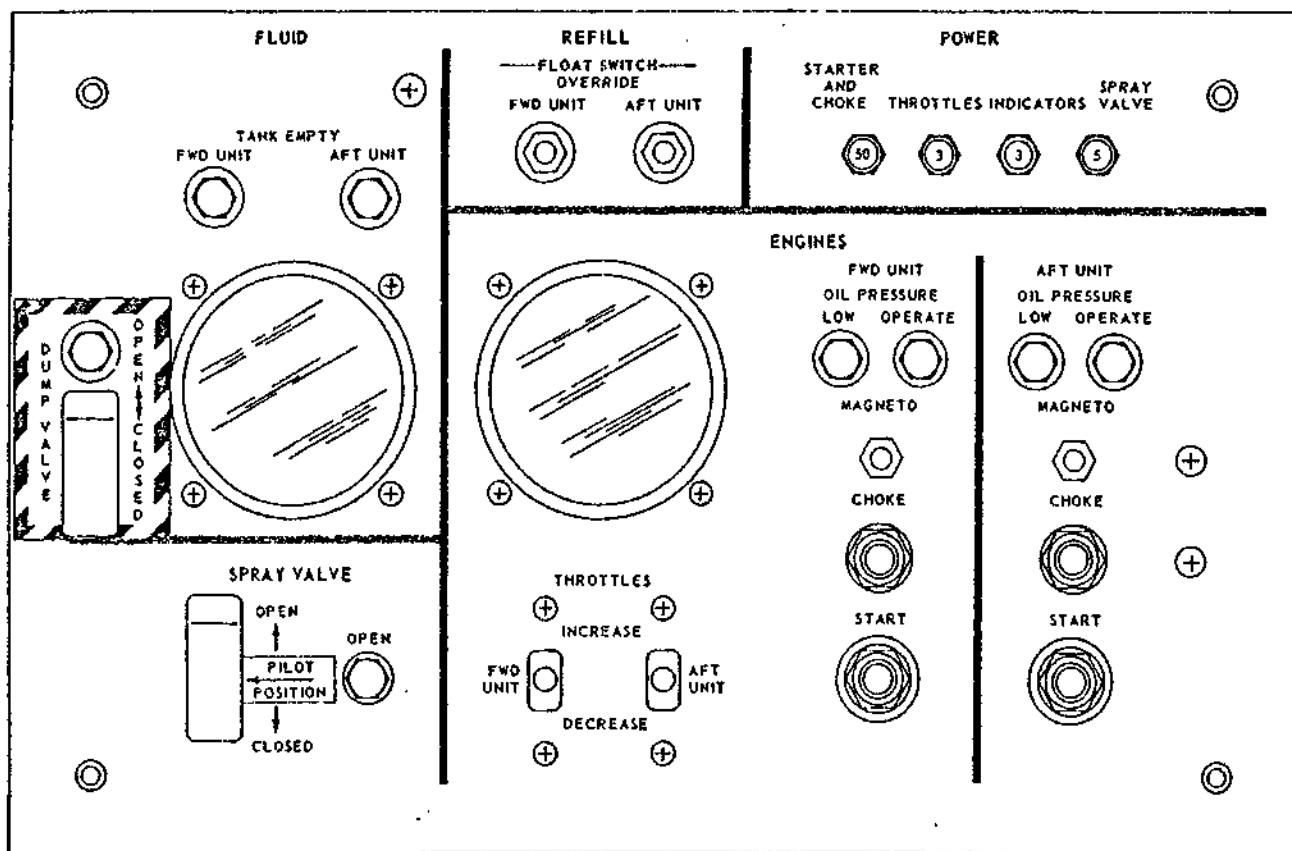
Figure 4. Control Console

The control console is the nerve center of the defoliation system. All functions are controlled from this position; all monitoring equipment is located in this position; and the electrical supply is channeled and protected at this position. Prefabricated electrical cables tie the control console to all related

parts of the system, including the controls on the pilot's instrument panel and the aircraft electrical supply system. Tandem or single installations are controlled and monitored from the control console without any changes or alterations being performed. In the event of electrical power failure of the aircraft electrical system, certain critical functions have an option of manual operation. (See figure 4.)

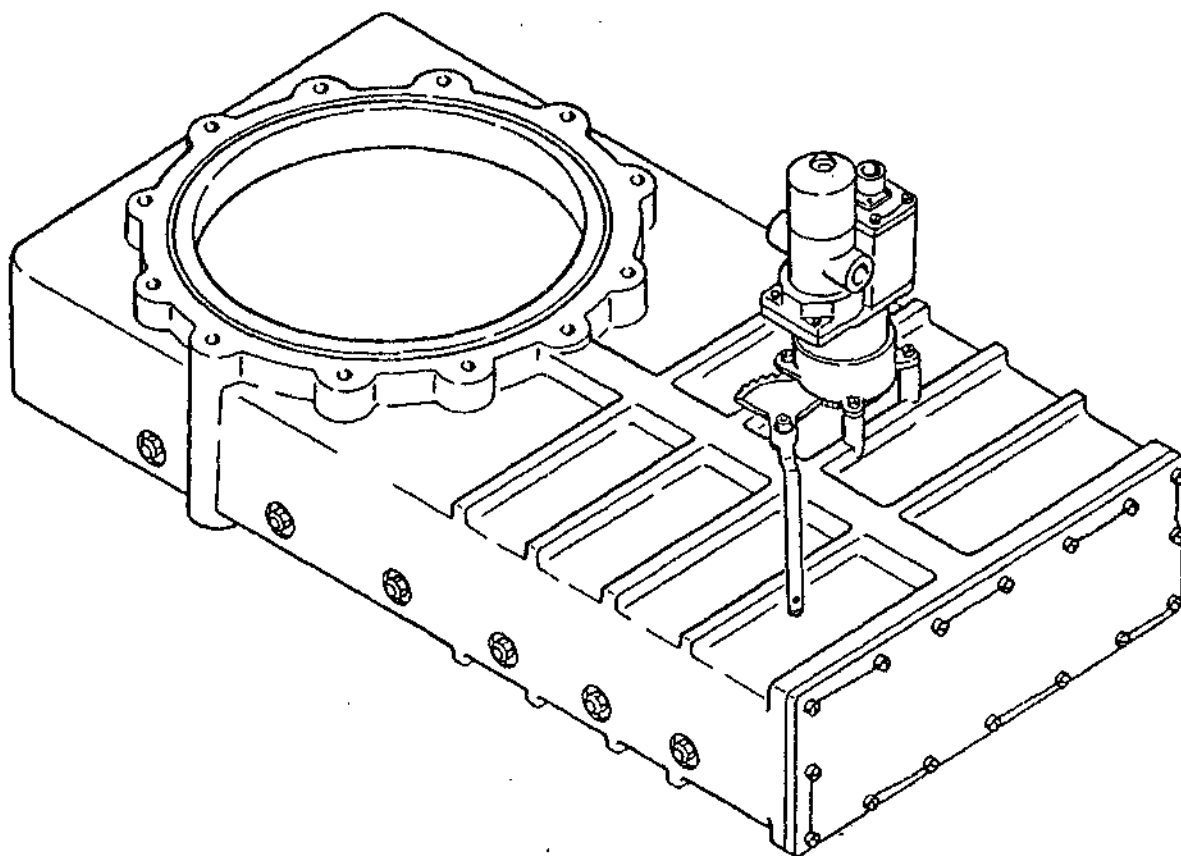
Figure 5. Dump Valve

The dump valve is a 10 inch gate valve having both electrical or manual activation. It is designed for horizontal (vertical flow) installation and liquid flow in only one direction. The bottom of the defoliant tank incorporates a vortex interrupter and adapter to which the dump valve is secured and is in perfect alignment with an opening and spring loaded door in the belly of the aircraft. A high speed motor coupled to an actuator provides 2 second operation of the dump valve in either direction and circuit manipulation to indicate open condition. (See figure 5.)

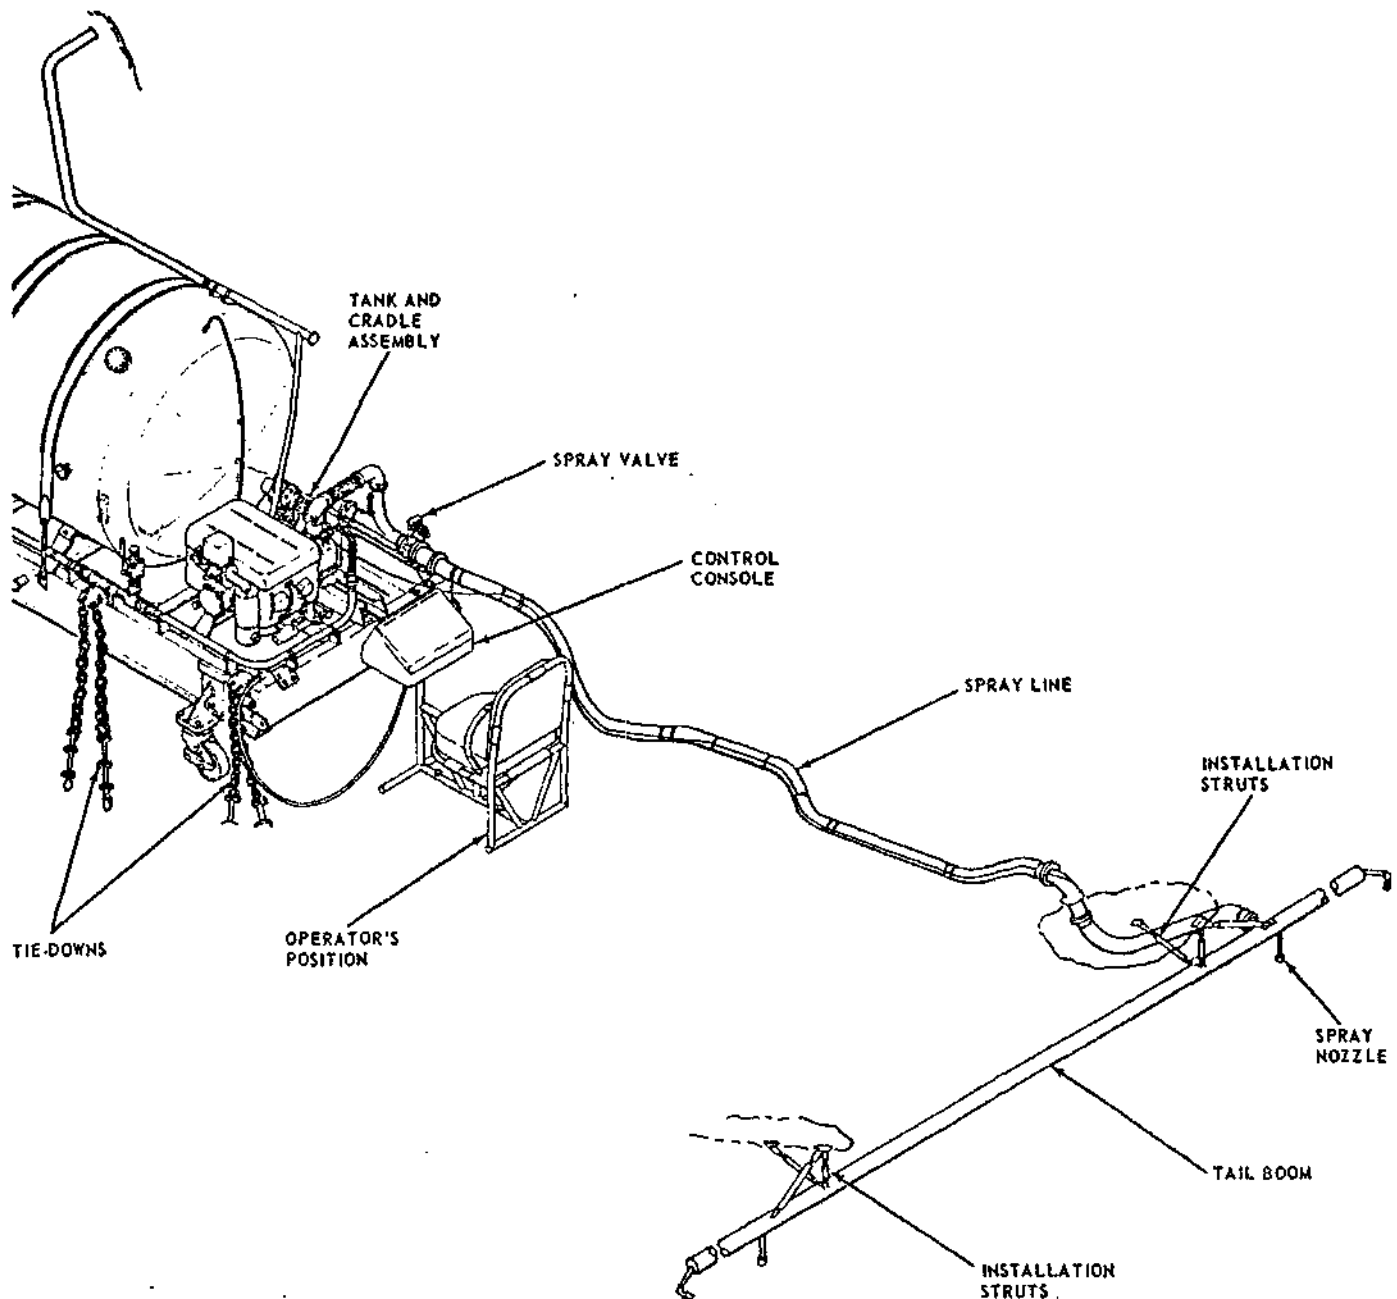
Figure 6. Tail Spray Boom and Associated Plumbing

The tail spray boom (figure 6) is mounted outside the aircraft, approximately midway of the aft cargo loading door. It is designed for simple and fast installation and removal and provides coverage of a 250 foot strip.

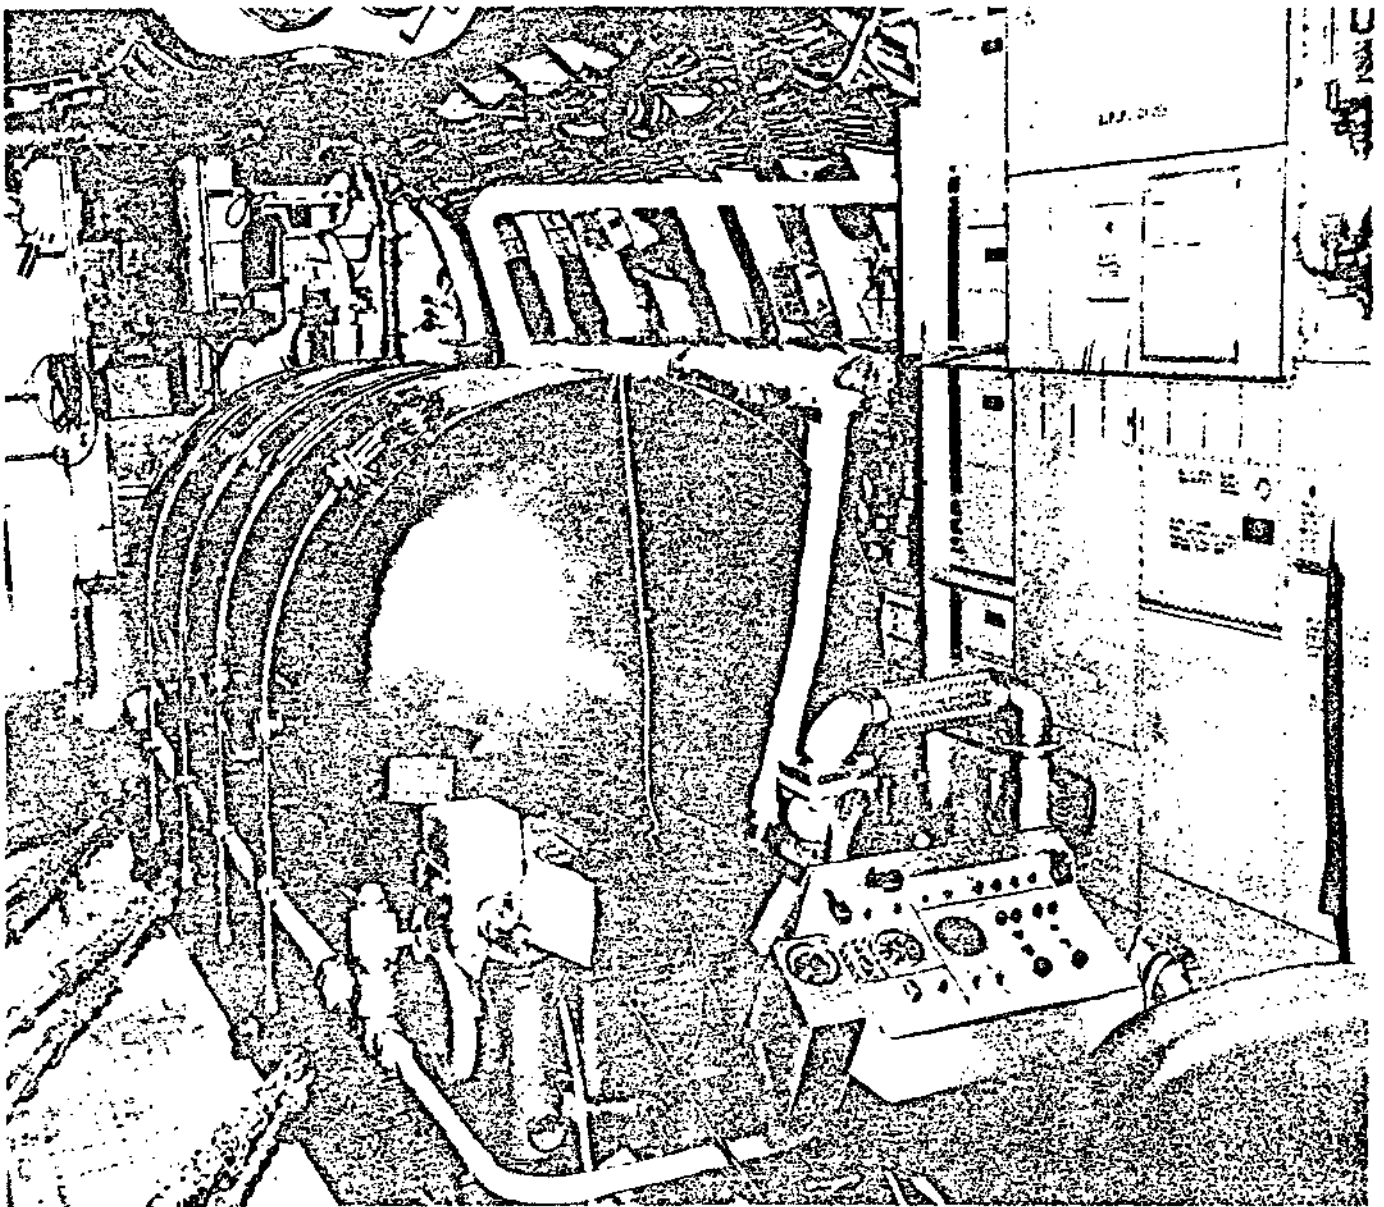
Figure 8. Installation in C-123 (left side)

The dispenser installation in C-123 aircraft consists of towing the tank and cradle assembly (unfilled) into the aircraft and securing it to the aircraft floor utilizing twenty 10,000-pound hook and chain assemblies and the cargo floor tie-down fittings (figures 8 and 9). All piping, hose assemblies and electrical cables are installed which tie the A/A45Y-1 dispenser into the aircraft (as modified) systems, and the control console is secured to the aircraft floor; thus, making the aircraft-dispenser combination ready for servicing and operation.

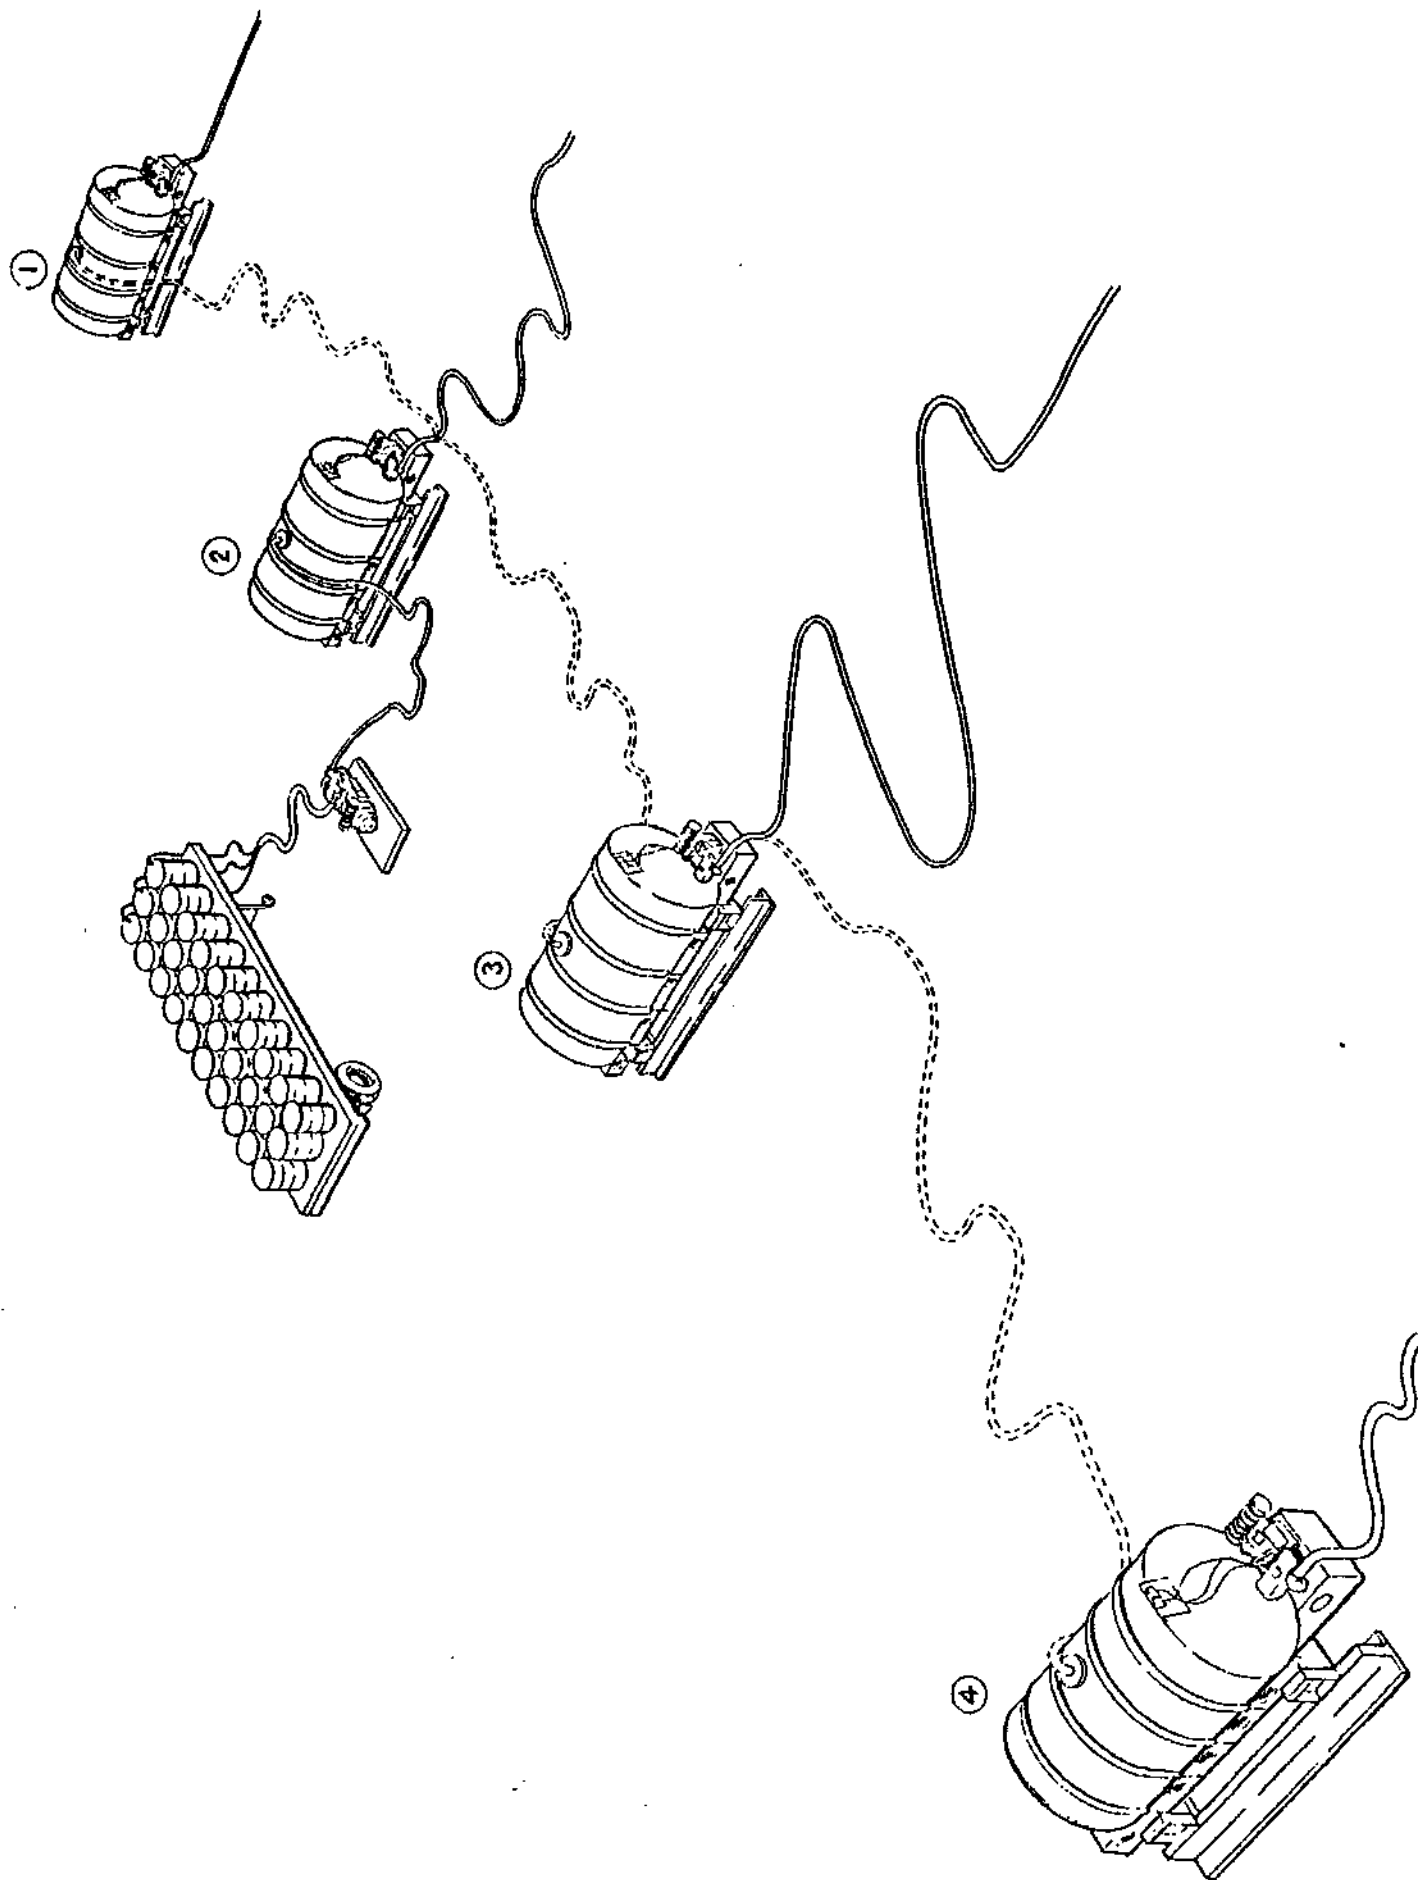
Figure 10. Existing Defoliant Transfer System Tan Son Nhut Air Base, Viet Nam

Upon return from a mission, the aircraft is backed as close as possible to the refill tanks and the systems are refilled with agent using a commercial fire hose. After completion of the days work the HOURGLASS tanks are filled and the agent transferred into the aircraft. The refill tanks are then refilled in preparation for a second mission. Due to the long time needed to fill from the drums, the RANCH HAND crews are limited to only one turn around, or a total of two missions.

A big disadvantage of refilling in this manner is the problem of contamination to the agent. Foreign matter gets into the refill tanks and from there into aircraft defoliant dispensing system. The rubber inside lining of fire hoses, presently used, is acted upon by the defoliant and causes large pieces of rubber to be released into the defoliant stream, thereby reducing the system effectiveness. See figures 11 thru 14 for potographic on-site refill operations.

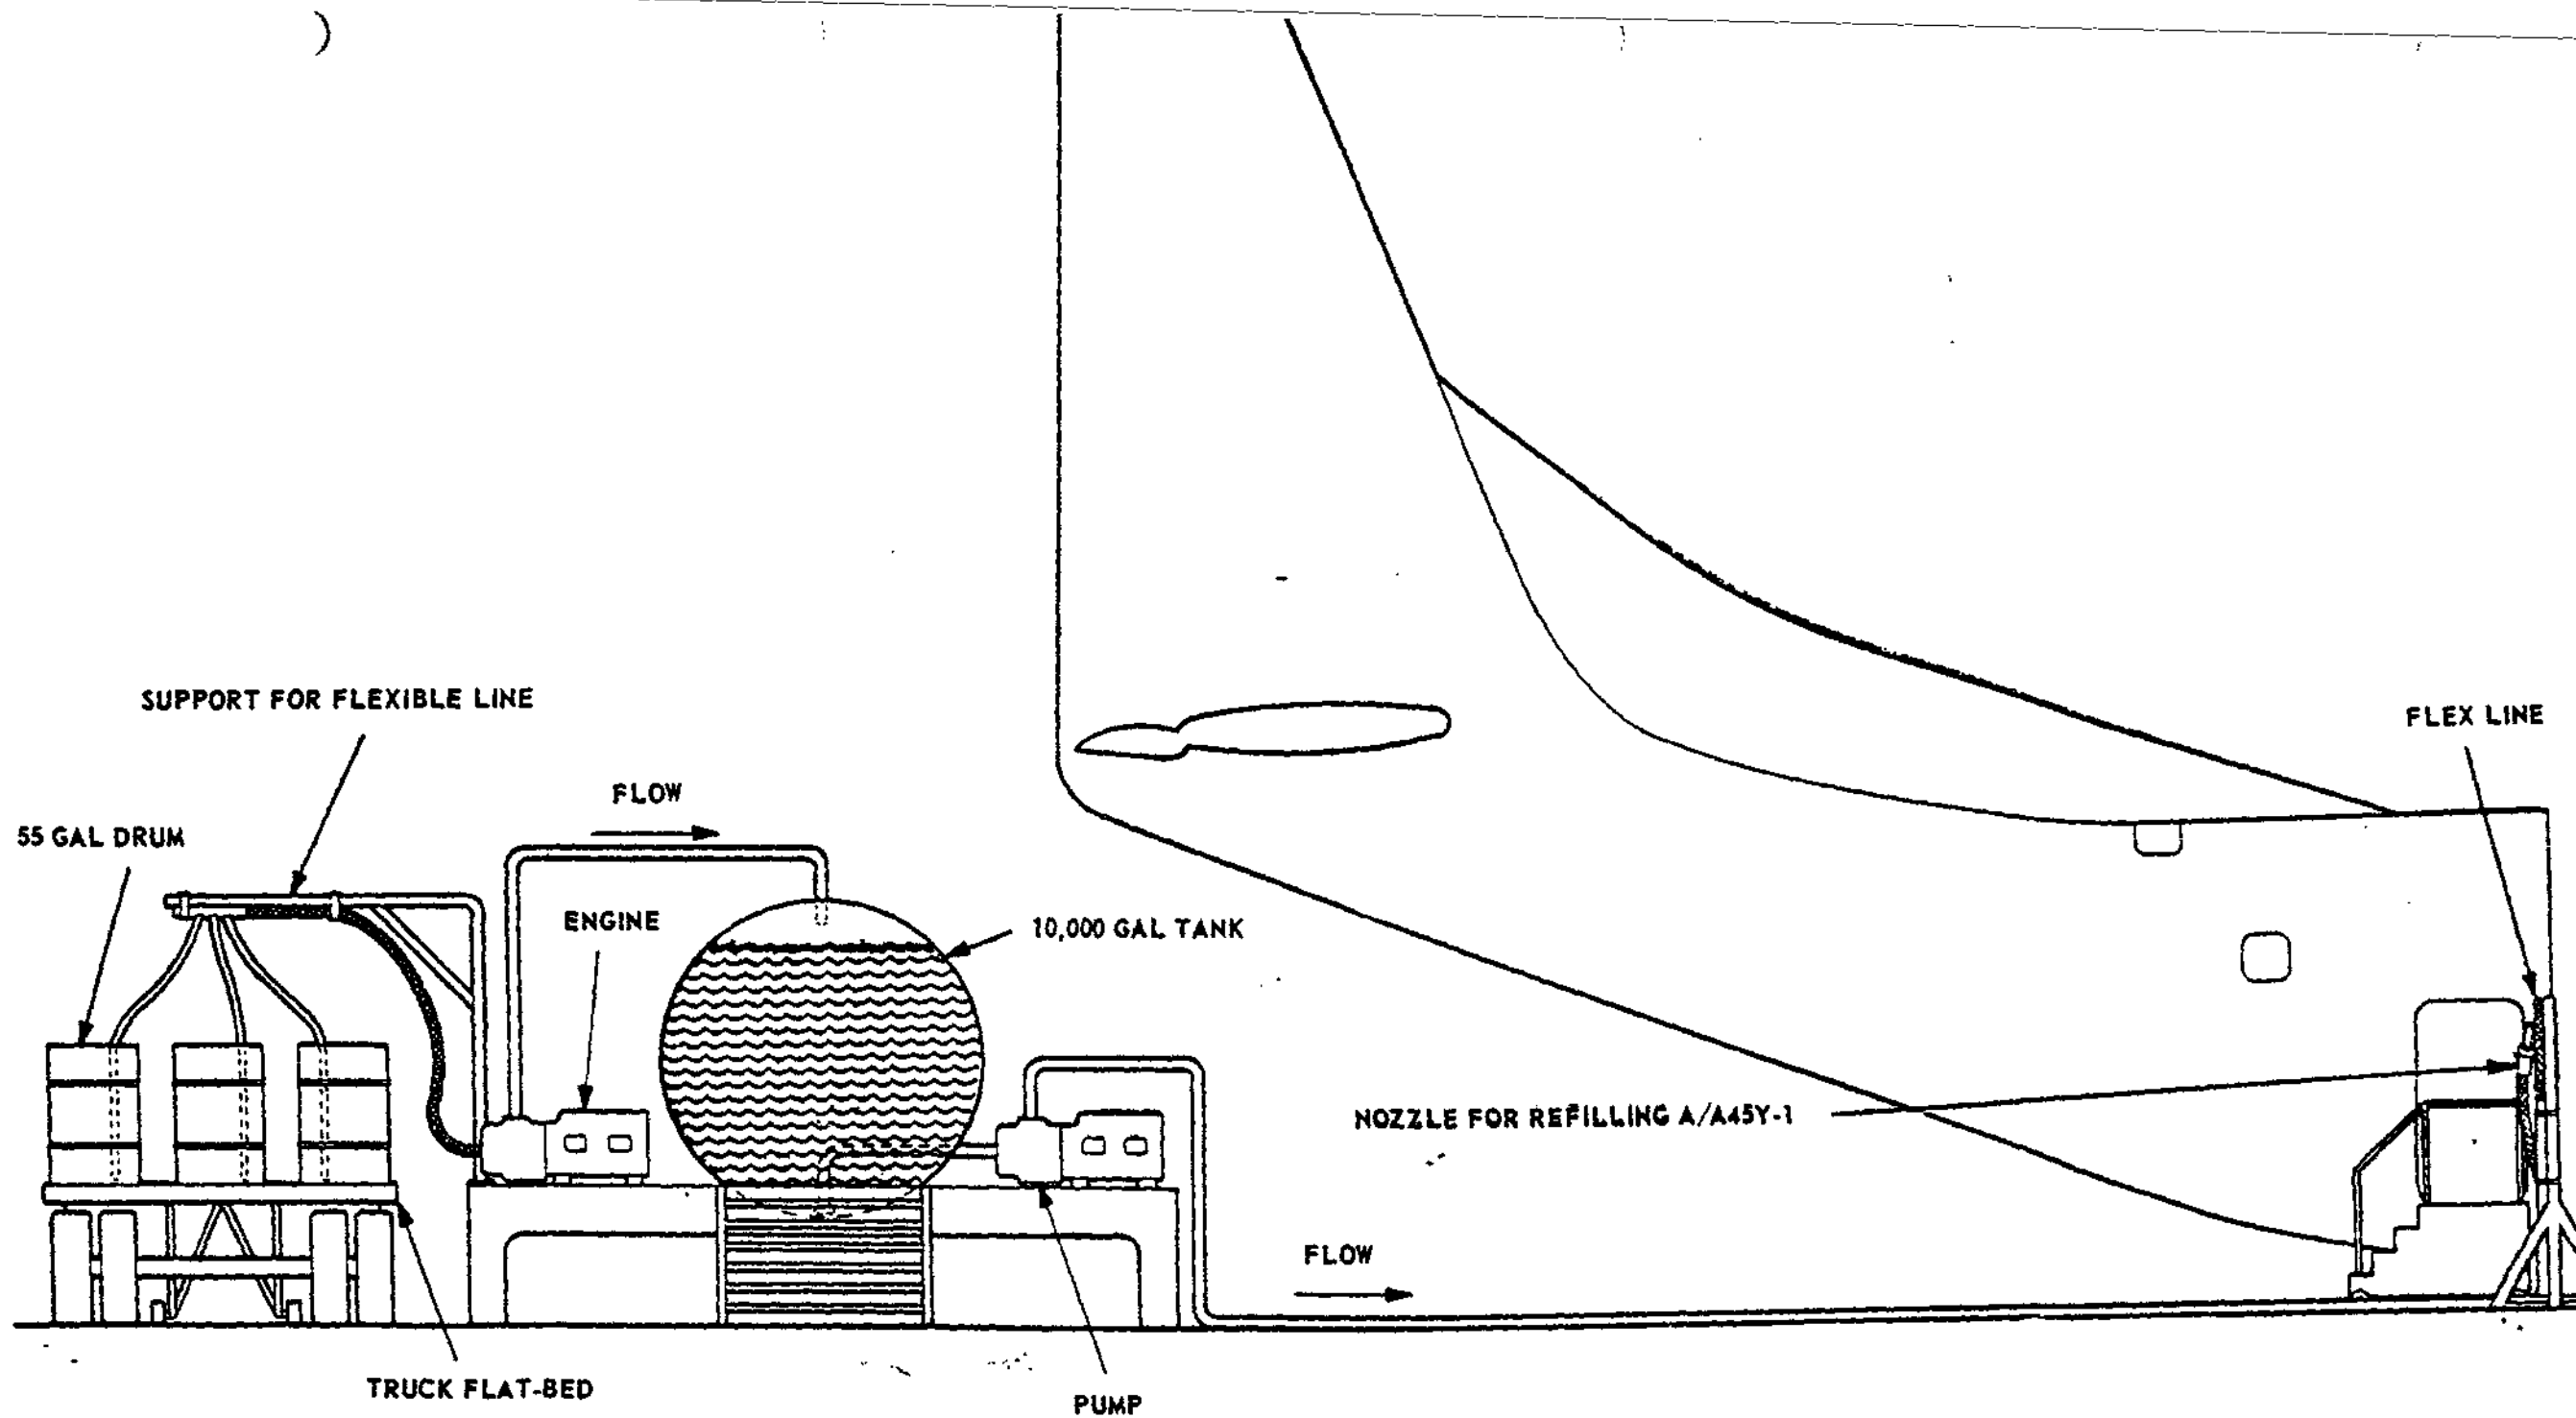
re 16. Defoliant Handling System Components

of defoliant under sustained operation. The engine is a government standard, air-cooled, four cylinder, four stroke cycle, horizontally opposed model modified for remote control when mated with the control console. The engine is available in large quantities, economical to operate, proven in performance, and easily maintained due to maximum accessibility. It is designed to operate a minimum of 1500 hours at rated load and speed between major overhauls. Its extensive use in defoliation operations tends to standardize maintenance and provide a spare parts source through controlled cannibalization.

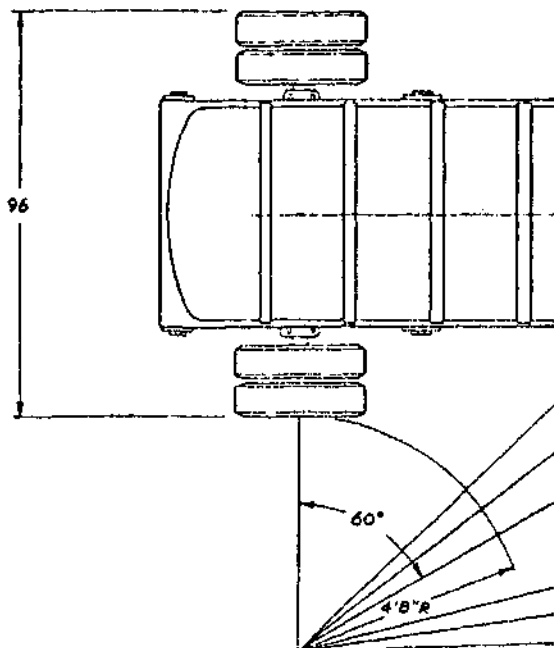
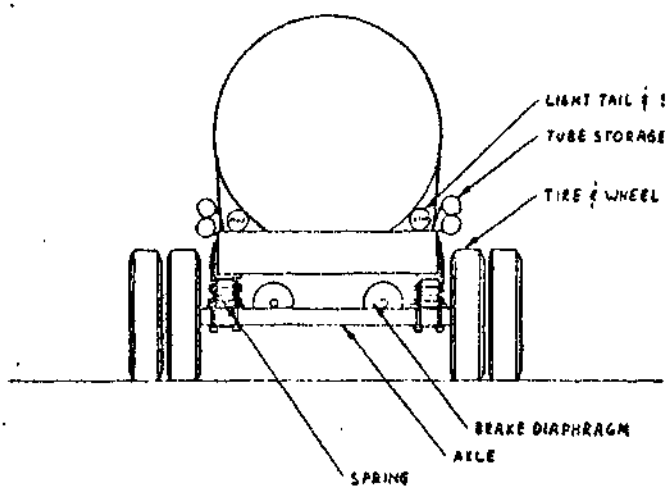
Figure 17. Tank Trailer De

The portable defoliant handling unit idea is conceived for military installations where limited servicing of A/A45Y-1 dispensers might be required. The trailer is capable of traveling at faster speeds and for greater distances than the A/A45Y-1 dispenser and, being a powered unit, it speeds up the servicing of the dispensers installed in aircraft. Overall dimensions are kept within limits which will permit air transportation of loaded units to isolated landing fields or airstrips.

Technical data and capabilities are contained in figure 17.
