Vietnam: Environmental Remediation of Dioxin Contamination at Danang Airport

Progress Report: September 1, 2013 to September 30, 2013

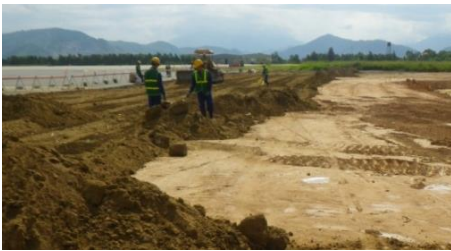
Backfilling at the former Mixing and Loading Area (Photo: CDM Smith)

Site restoration continued in areas that were excavated and are now considered “clean”, as verified by confirmation soil sample results with dioxin concentrations below the cleanup goal. The excavation in the former Mixing and Loading Area were backfilled with clean soil, the runway apron was restored, and grass replanting began.

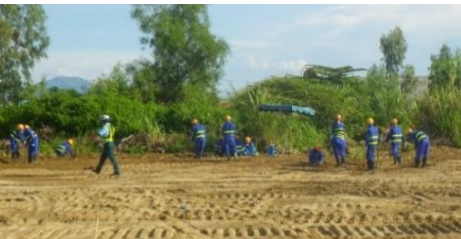
Grass replanting at the former Mixing and Loading Area (Photo: CDM Smith)

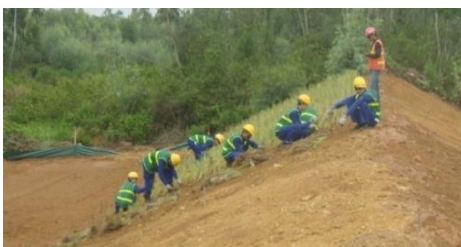
Replanting at the former Pacer Ivy Storage Area (Photo: CDM Smith)

The Pacer Ivy Storage Area was also replanted with grass following excavation.

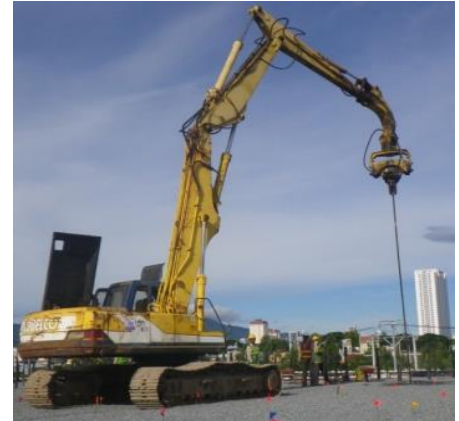
Installing heater cans into the containment structure

The containment structure is at one hundred percent capacity and full with 45,000 cubic meters of dioxin-contaminated soil. USAID contractors continued installing the thermal treatment system in the containment structure. To construct the treatment system, the contractors covered the contaminated soil with a layer of gravel, and installed a total of 1,520 heater casings, temperature monitoring pipes, pressure monitoring pipes, and air inlet pipes through the contaminated soil inside the containment structure.

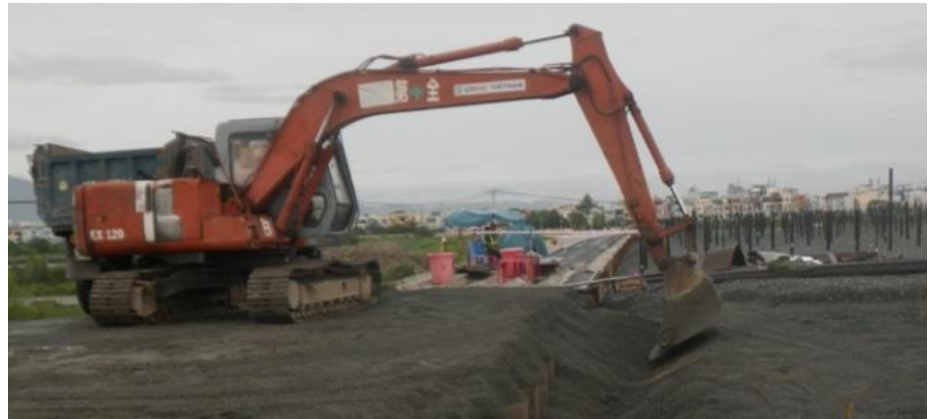
Placing gravel on top of the pile structure

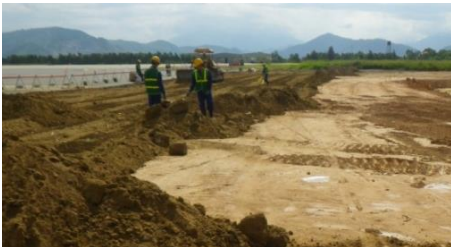
Lấp lại đất ở Khu Pha trộn và Chuyển tải trước đây (Ảnh: CDM Smith)

Công tác phục hồi mặt bằng tiếp tục được triển khai ở các khu vực đào xúc được khẳng định là “sạch” qua qua các mẫu đất có nồng độ dioxin nằm dưới ngưỡng cho phép. Vùng đào xúc ở Khu Pha trộn và Chuyển tải trước đây được lấp lại bằng đất sạch, đường chạy được tái lập, và đã bắt đầu trồng lại thảm cỏ.

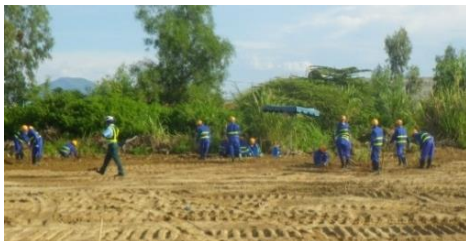
Trồng cỏ mới ở Khu Pha trộn và Chuyển tải trước đây (Ảnh: CDM Smith)

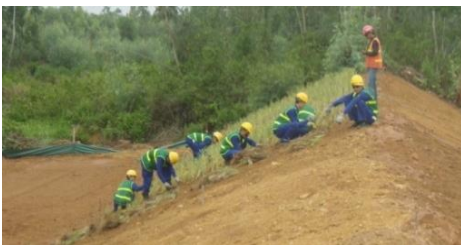
Trồng cỏ mới ở Khu Lưu trữ Pacer Ivy trước đây (Ảnh: CDM Smith)

Khu Lưu trữ Pacer Ivy cũng đã được trồng cỏ mới sau khi đào xúc xong.

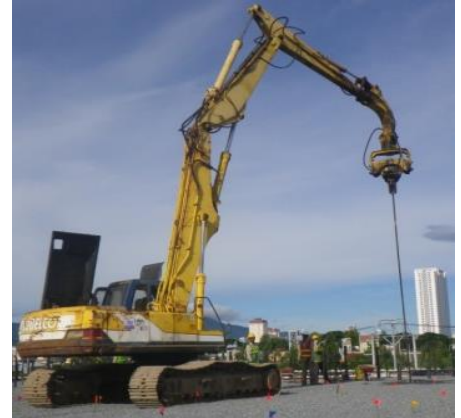
Lắp đặt ống truyền nhiệt vào kết cấu móng (Ảnh: CDM Smith)

Kết cấu móng xử lý đã được lấp đầy với 45.000 mét khối đất bị nhiễm bản dioxin. Các nhà thầu của USAID tiếp tục lắp đặt hệ thống xử lý nhiệt trong kết cấu móng. Để xây dựng hệ thống xử lý, các nhà thầu phủ một lớp đá dăm lên đất bị nhiễm bản và lắp đặt tổng cộng 1.520 ống truyền nhiệt, các ống theo dõi nhiệt độ, ống theo dõi áp suất, ống dẫn không khí vào qua lớp đất nhiễm bản trong kết cấu móng

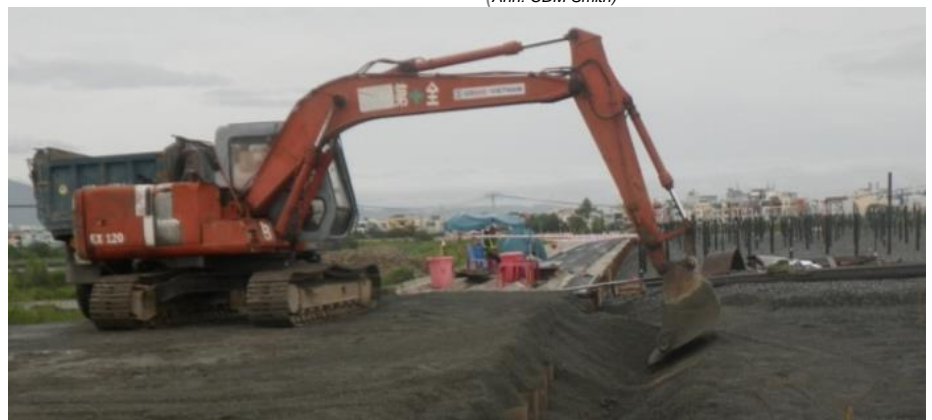
Phủ lớp đá dăm lên bề mặt đỉnh của kết cấu móng (Ảnh: CDM Smith)
