# Vietnam: Environmental Remediation of Dioxin Contamination at Danang Airport

## Progress Report: July 1, 2014 to July 31, 2014

# Việt Nam: Xử lý Môi trường Ô nhiễm Dioxin tại Sân bay Đà Nẵng

## Báo cáo Tiến độ: Từ 1 tháng 7 năm 2014 đến 31 tháng 7 năm 2014

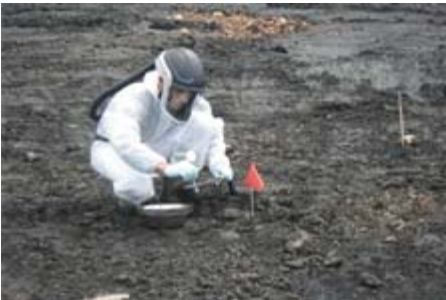
*Collecting confirmation samples from the bottom of Sen Lake after excavation*  
(Photo: CDM Smith)

These activities include collecting confirmation samples from the bottom and sidewalls of the excavated areas to ensure the remaining soil and sediment meet the Project cleanup objectives. If confirmation sample results indicate that dioxin levels still exceed the cleanup objectives, then additional excavation is conducted. After the additional excavation is conducted, confirmation samples are again collected from the new limits of excavation to ensure the cleanup objectives have been achieved.

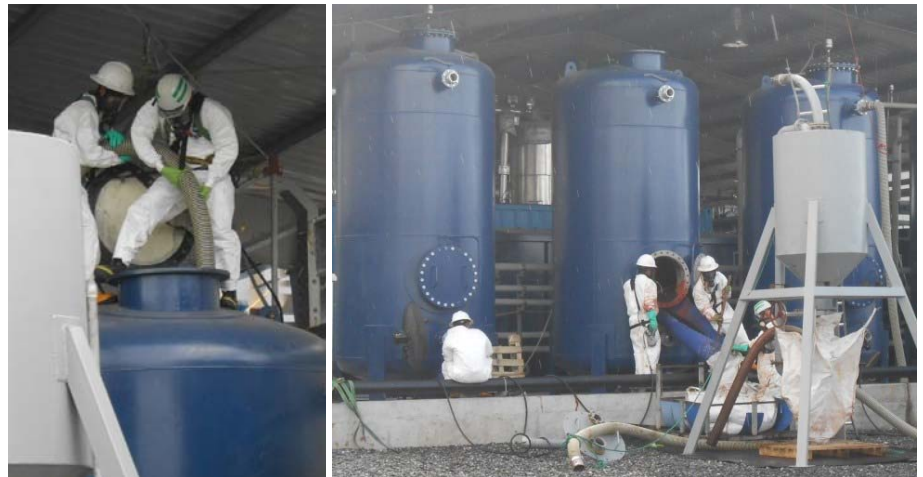
*Changing out carbon media in the liquid treatment vessels*

Phase 1 treatment of approximately 45,000 cubic meters of dioxin-contaminated soil and sediment continued until the treatment system was temporarily shut down starting July 22. USAID contractors changed out several different media that are used to remove organic and inorganic contaminants in liquid and vapor to ensure that contaminants are not discharged to the environment at unsafe levels.

The system will be restarted in early August to continue heating the contaminated soil and sediment inside the treatment pile until the temperature reaches 335 degrees Celsius which is the target treatment temperature to destroy dioxin. Liquid and vapor sampling after each major treatment component and at the final liquid and vapor effluent points will continue until treatment of the pile is complete to monitor project performance.

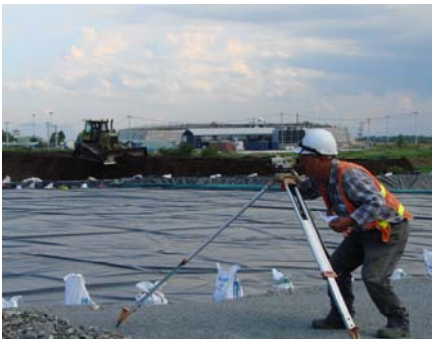
*Surveying the limits of excavation in Sen Lake*  
(Photo: TetraTech)

While Phase 1 soil and sediment is being treated, USAID contractors continue to excavate Phase 2 soil and sediment from Sen Lake and the surrounding wetlands in the northern portion of the Project site. While excavating these areas, USAID contractors control and monitor dust and liquid discharges to ensure contamination does not leave the Project site. The excavated material is being temporarily stored in a lined and covered pile while it awaits treatment during Phase 2.

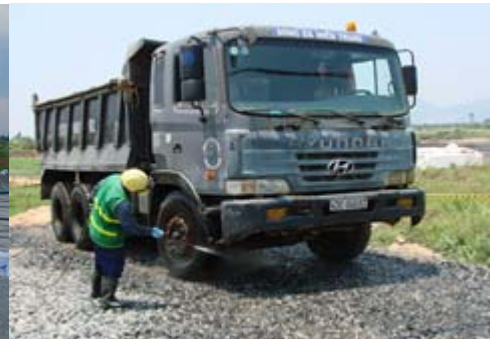
*Washing truck tires to prevent contamination from leaving the project site*  
(Photo: TetraTech)

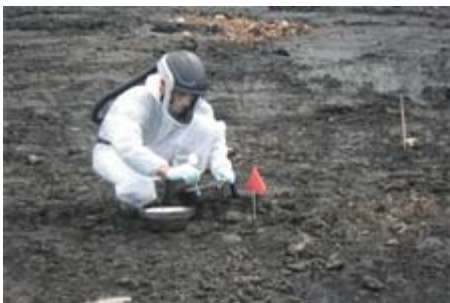
Lấy mẫu xác nhận từ đáy Hồ Sen sau khi đào xúc

Các hoạt động này cũng bao gồm lấy mẫu xác nhận từ đáy và vách khu vực đào xúc nhằm đảm bảo đất và bùn còn lại thỏa mãn các tiêu chí làm sạch của Dự án. Nếu các mẫu xác nhận cho thấy dioxin vẫn còn hàm lượng vượt quá tiêu chí làm sạch, thì sẽ tiến hành đào xúc thêm. Sau khi đã đào xúc thêm, mẫu xác nhận từ giới hạn mới của khu vực đào xúc sẽ được tiếp tục thu thập nhằm đảm bảo đạt các tiêu chí làm sạch.

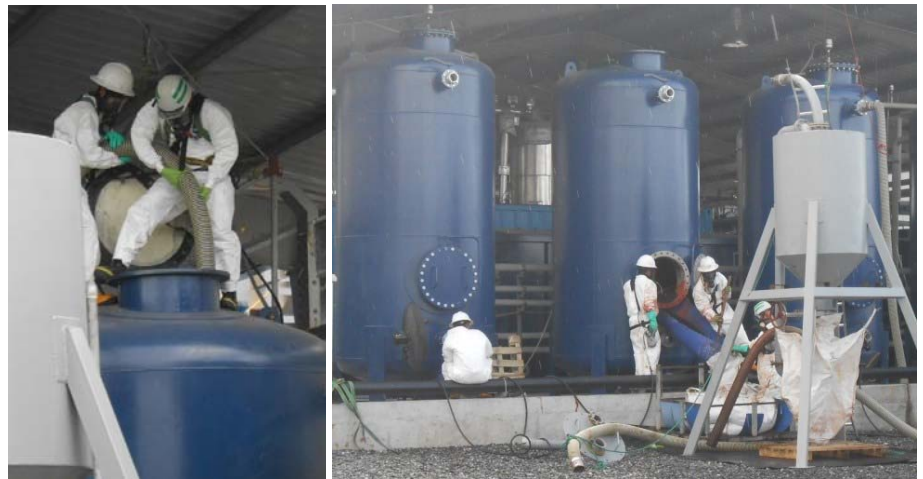
Thay đổi chất liệu cacbon trong bể xử lý chất lỏng

Việc xử lý giai đoạn 1 gồm khoảng 45.000 mét khối đất và bùn nhiễm dioxin được tiếp tục cho đến khi hệ thống xử lý tạm thời ngưng lại bắt đầu từ ngày 22/7. Các nhà thầu USAID đã thay đổi vài chất liệu khác nhau nhằm loại bỏ chất nhiễm bẩn hữu cơ và vô cơ trong chất lỏng và hơi nhằm đảm bảo các chất nhiễm bẩn này không thoát ra khỏi môi trường ở nồng độ thiếu an toàn.

Hệ thống sẽ được tái khởi động vào đầu tháng 8 nhằm tiếp tục nung nóng đất và bùn bên trong mố xử lý cho đến khi nhiệt độ đạt đến 335 °C, mức nhiệt độ mục tiêu để phá hủy dioxin. Nhằm theo dõi kết quả của Dự án, việc lấy mẫu chất lỏng và hơi từ mỗi đơn nguyên xử lý chính và từ các điểm xả chất lỏng và hơi cuối cùng sẽ được tiếp tục cho đến khi việc xử lý mố hoàn tất.

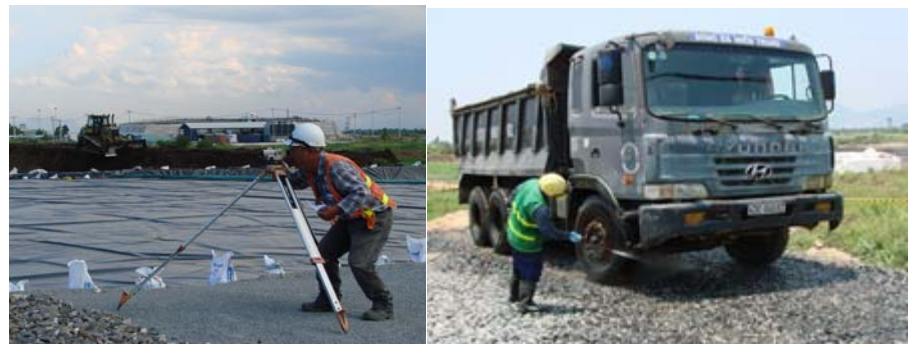
Kiểm tra giới hạn đào xúc ở Hồ Sen

Rửa bánh xe để tránh chất nhiễm bẩn lan ra ngoài khu vực dự án

Trong khi đất và bùn đang được nung nóng trong Giai đoạn 1, các nhà thầu của USAID tiếp tục đào xúc đất và bùn Giai đoạn 2 ở đầu bắc của khu vực Dự án. Trong khi đào xúc ở các vùng này, các nhà thầu của USAID vẫn kiểm tra và theo dõi bụi và nước thải nhằm đảm bảo các chất nhiễm bẩn không thoát ra bên ngoài khu vực Dự án. Đất và bùn đào xúc được tập kết tạm thời ở một khu vực được lót nền và che phủ trên mặt trong khi chờ xử lý trong Giai đoạn 2.
