GAO

April 1987

HAZARDOUS WASTE

DOD Installations in Guam Having Difficulty Complying With Regulations

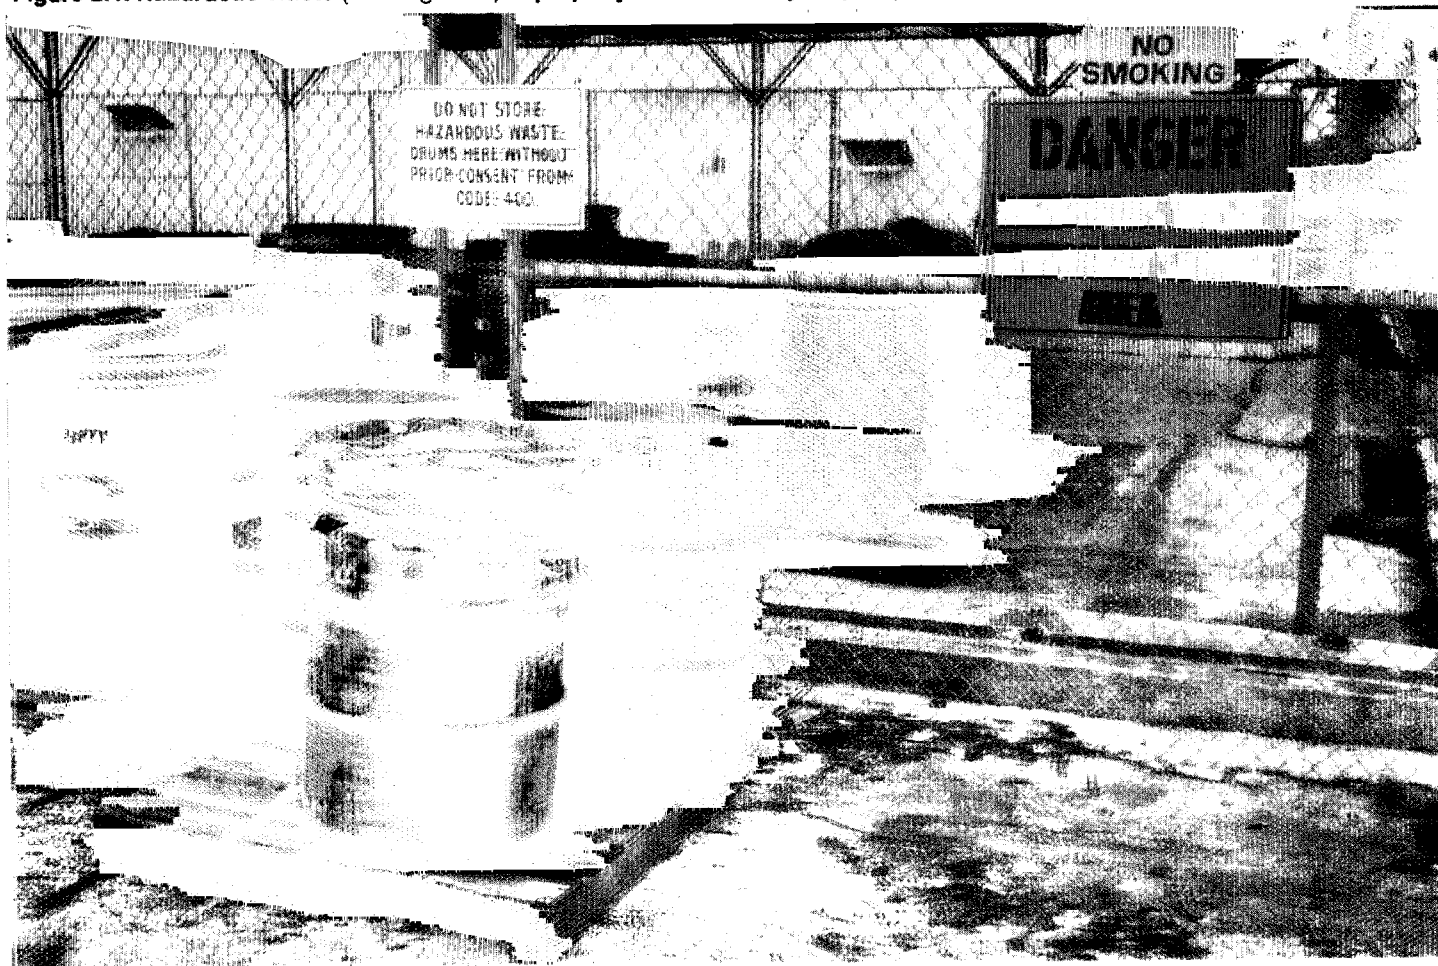
Figure 2.1 illustrates a Class I violation of both the use and management of containers and general facilities requirements—an improperly stored drum containing a hazardous waste solvent. Adequate steps had not been taken to keep the waste from entering the ground in the event of a leak: the waste had not been stored on an impermeable floor, there were no raised edges or dikes to contain a spill, and there was no protection from the weather, as required by RCRA. Figure 2.2 shows a punctured container of hazardous waste, which is a violation of the requirements associated with the use and management of containers.

Figure 2.1: Hazardous Waste (in Foreground) Improperly Stored at Navy Ship Repair Facility in Guam
